# RESTORATION TREATMENT REPORT

## THE STORY OF MOSES KAREL JOSEF MORAVINI

wall painting in the interior of chamber in a ground floor of southwest part of castle Kácov  
1730s  
private owner

Alžběta Mirjam Procházková  
Academy of Fine Arts in Prague  
Studio of Restoration of Painted Artworks and Polychrome Sculpture  
akademic years 2022/2023 - 2022/2024

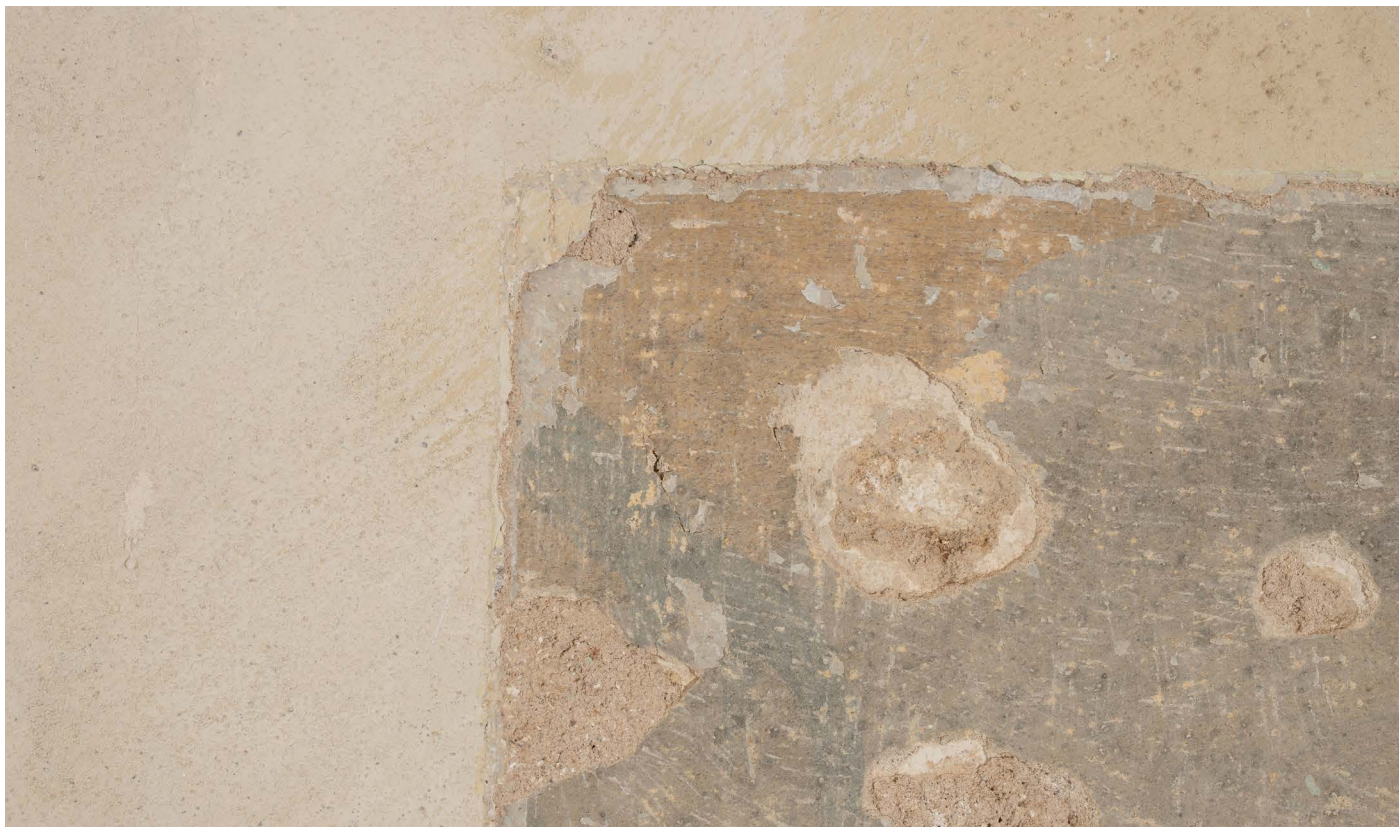
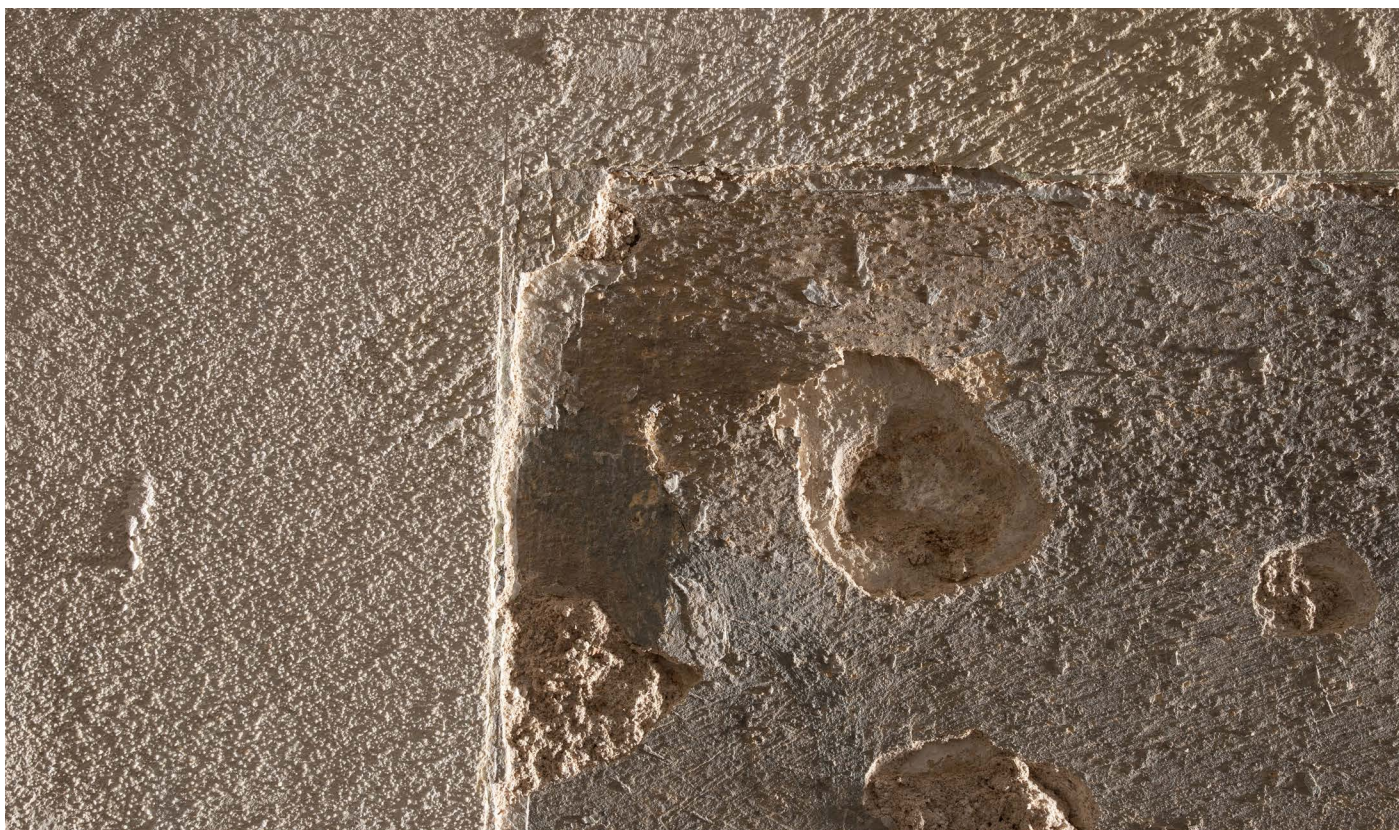
detail of the original painting inside the probe made during technological building survey by different restorer  
macrophotographs in day and raking light

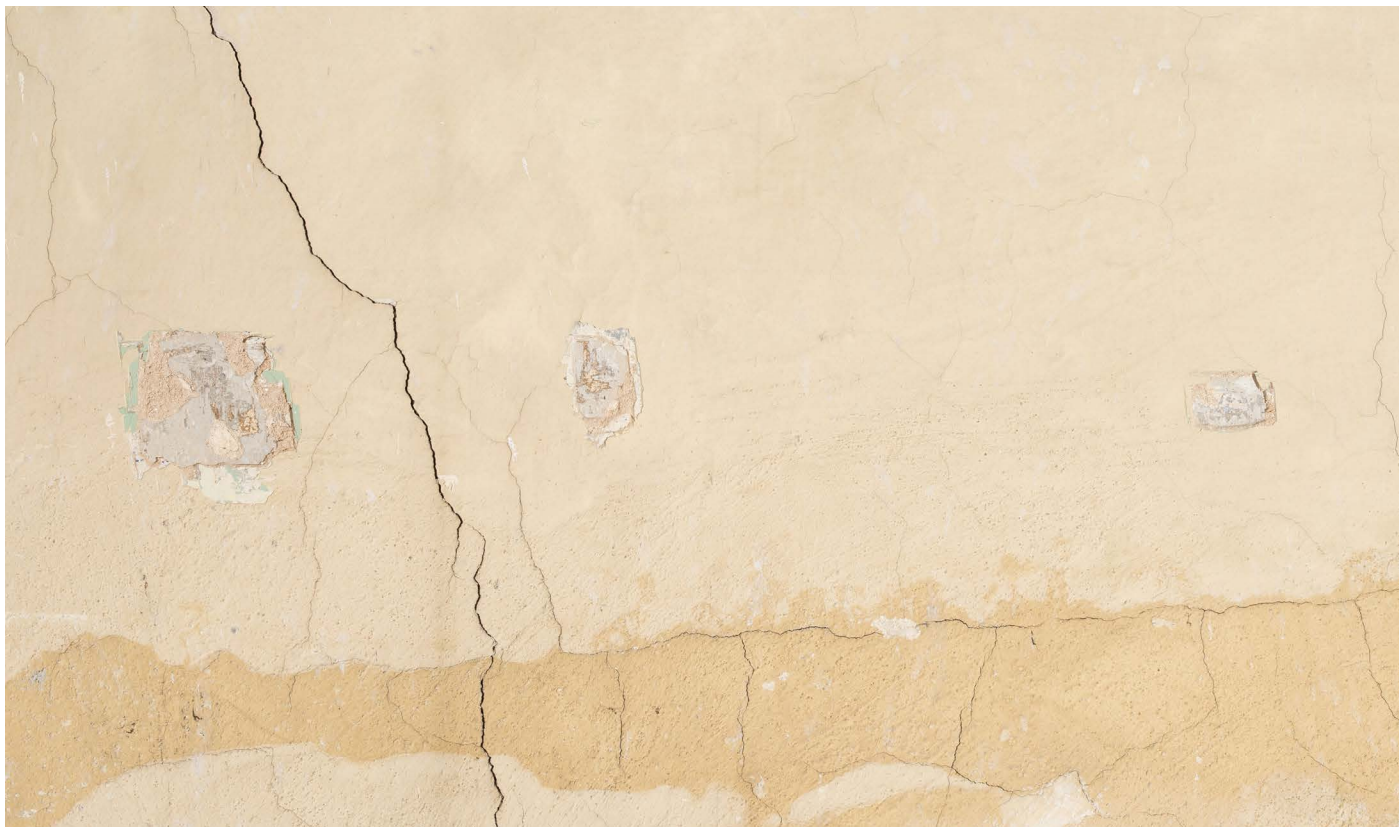
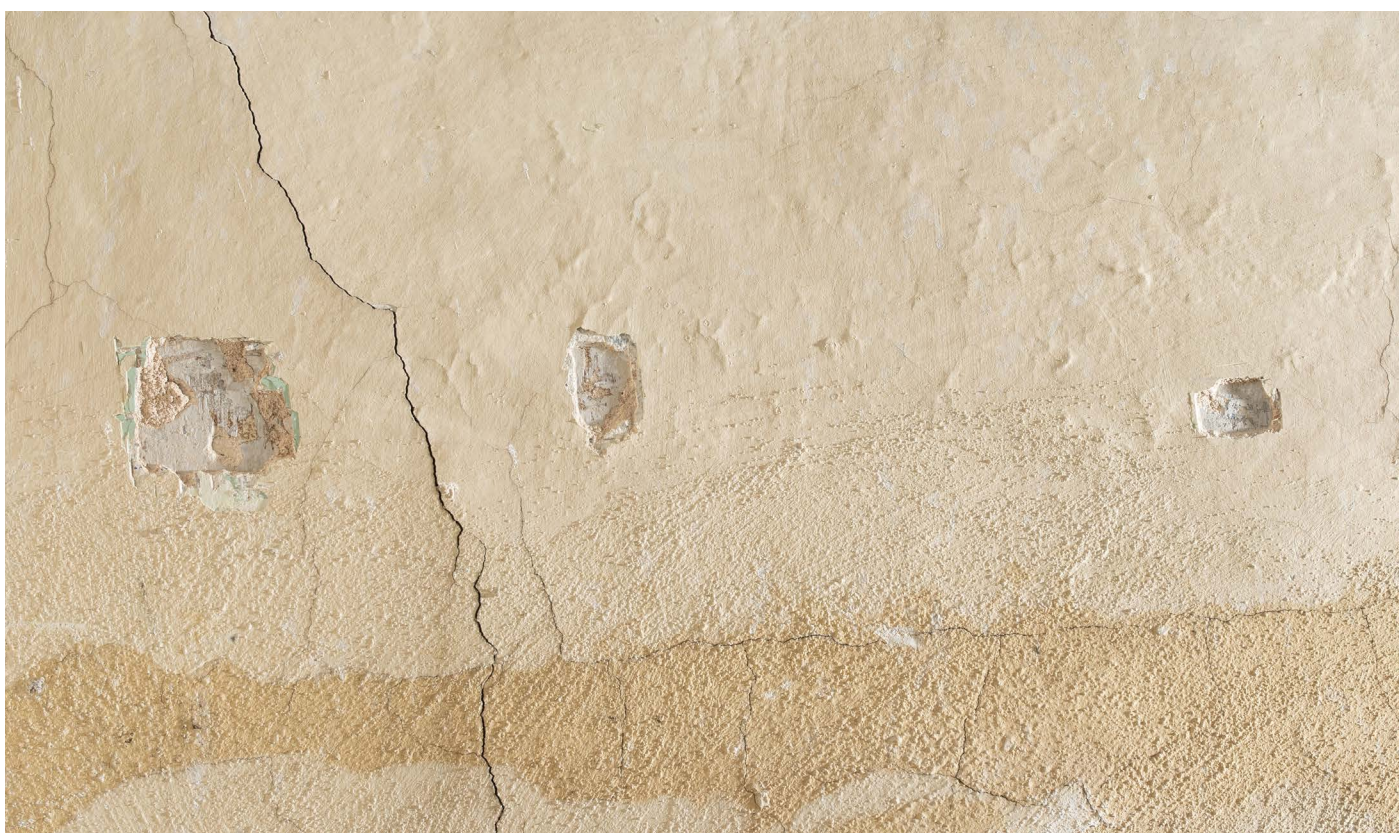
detail of the original loosened painting inside the probe made during technological building survey by different restorer  
macrophotographs in day and raking light

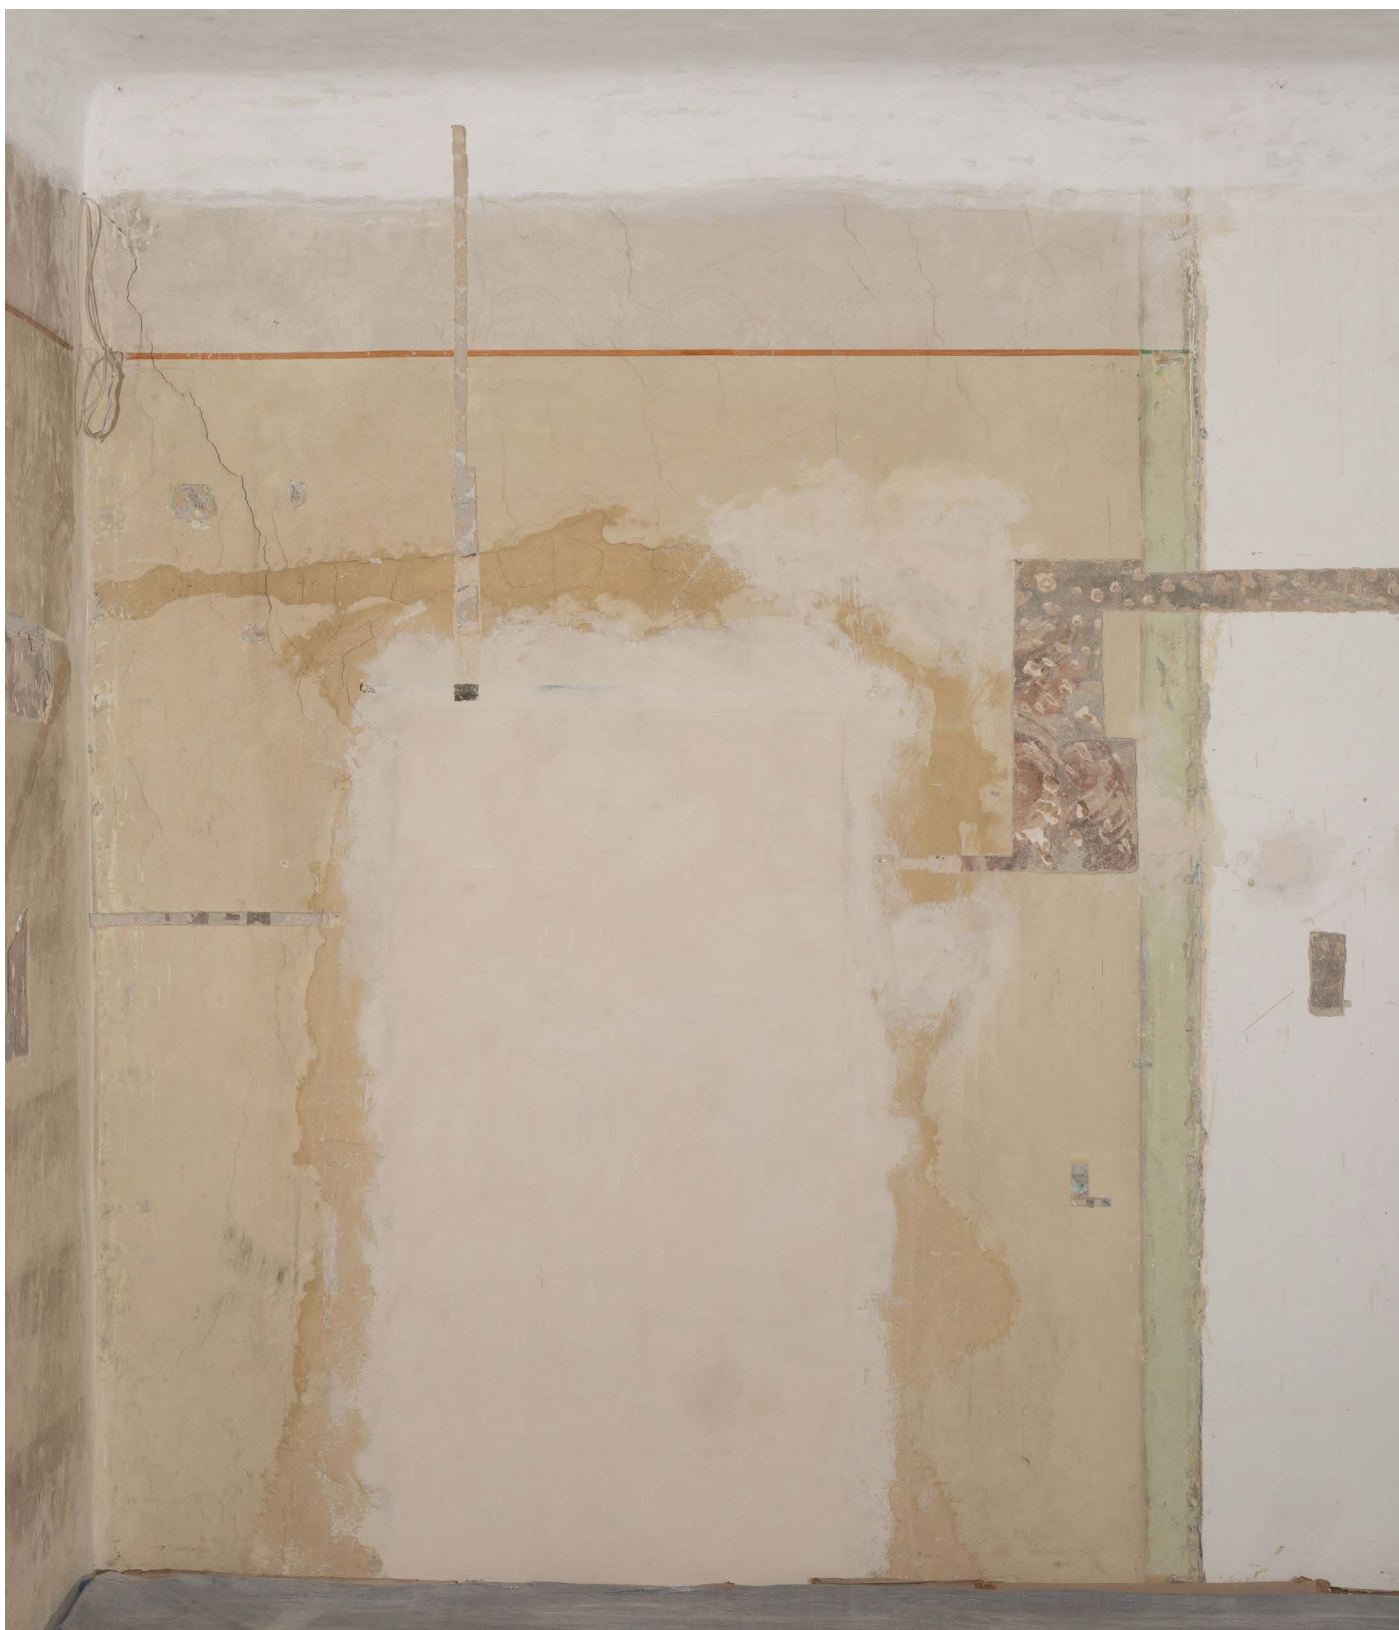
condition after examination of the strato of plasters on the wall within the stratigrafic and strip probes  
photography in day light

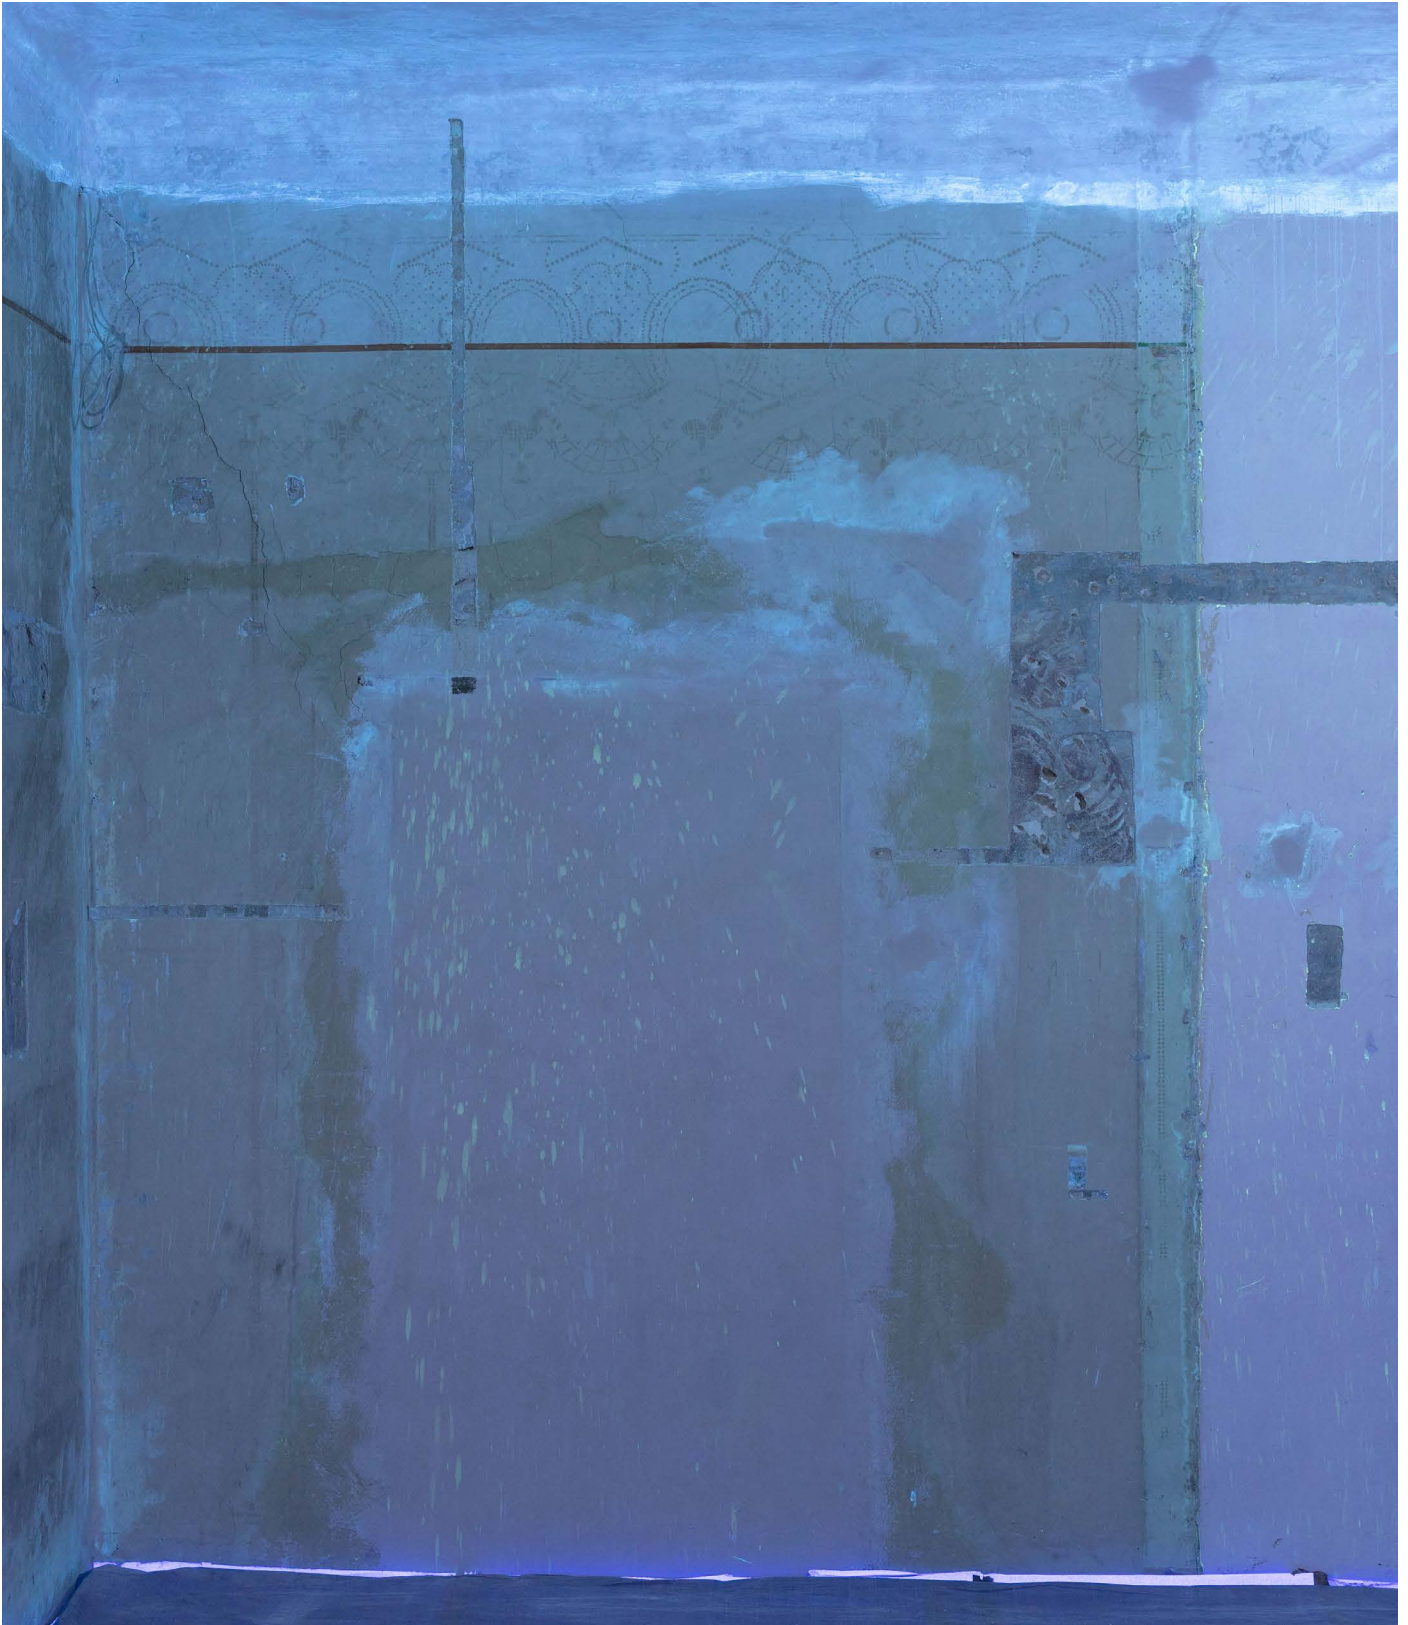
condition after examination of the strato of plasters on the wall within the stratigrafic and strip probes  
photography in UV luminescence

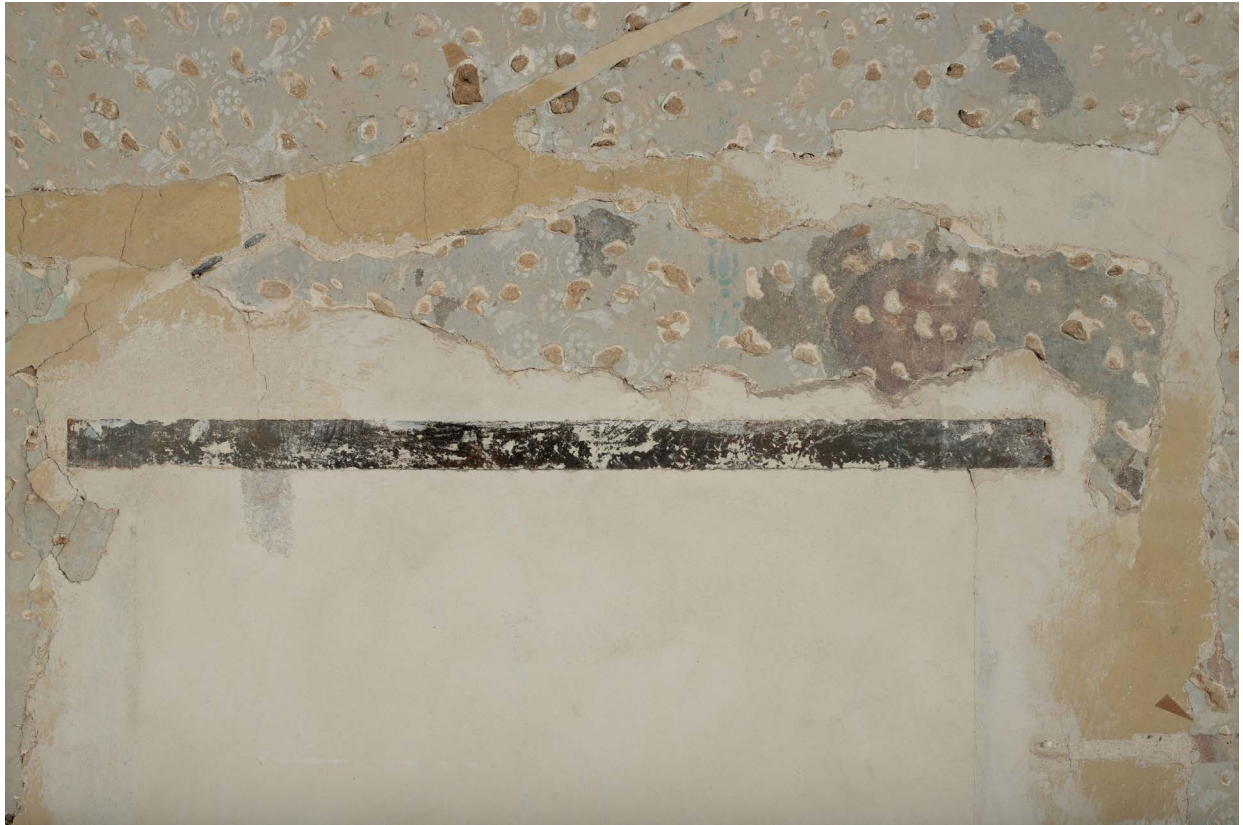
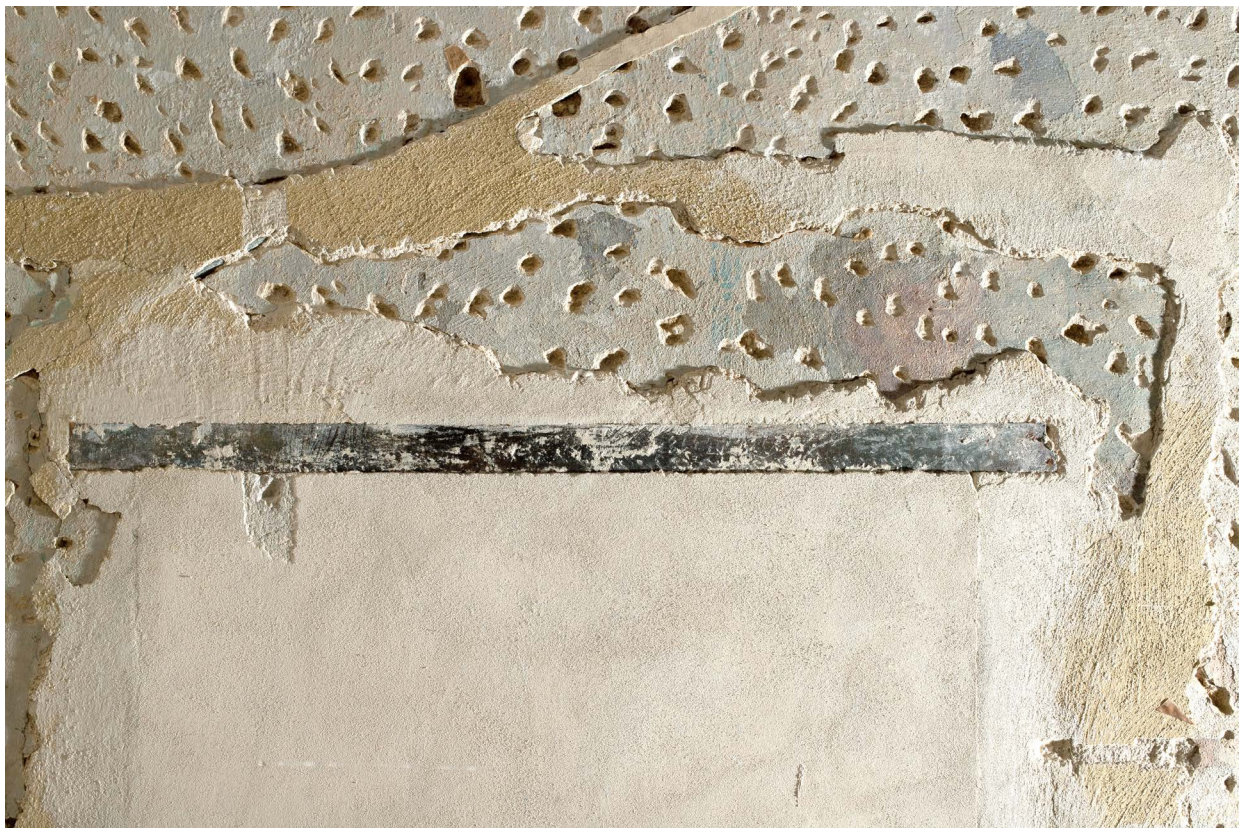
condition after the removal of the modern plaster layers on the second oldest plaster layer, partially exposing the original painted plaster layer  
photographs in day and raking light, detail

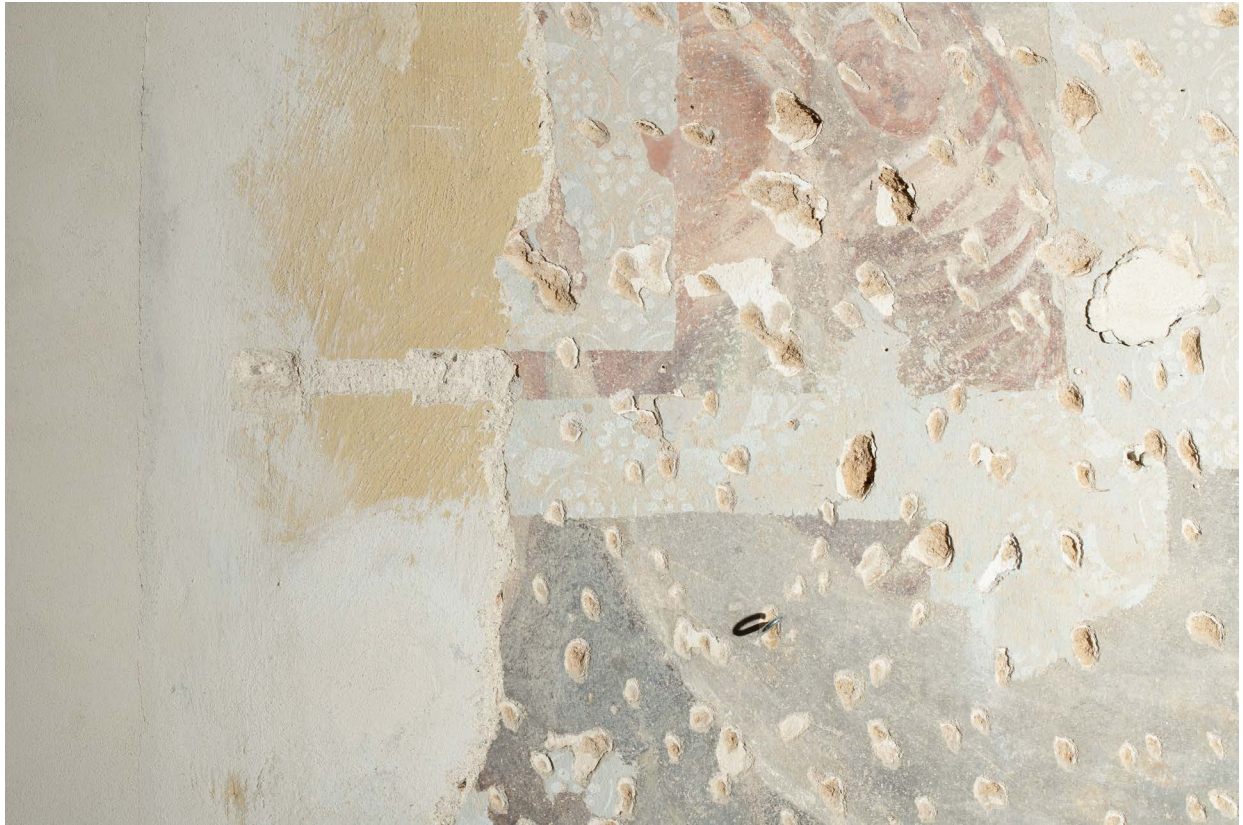
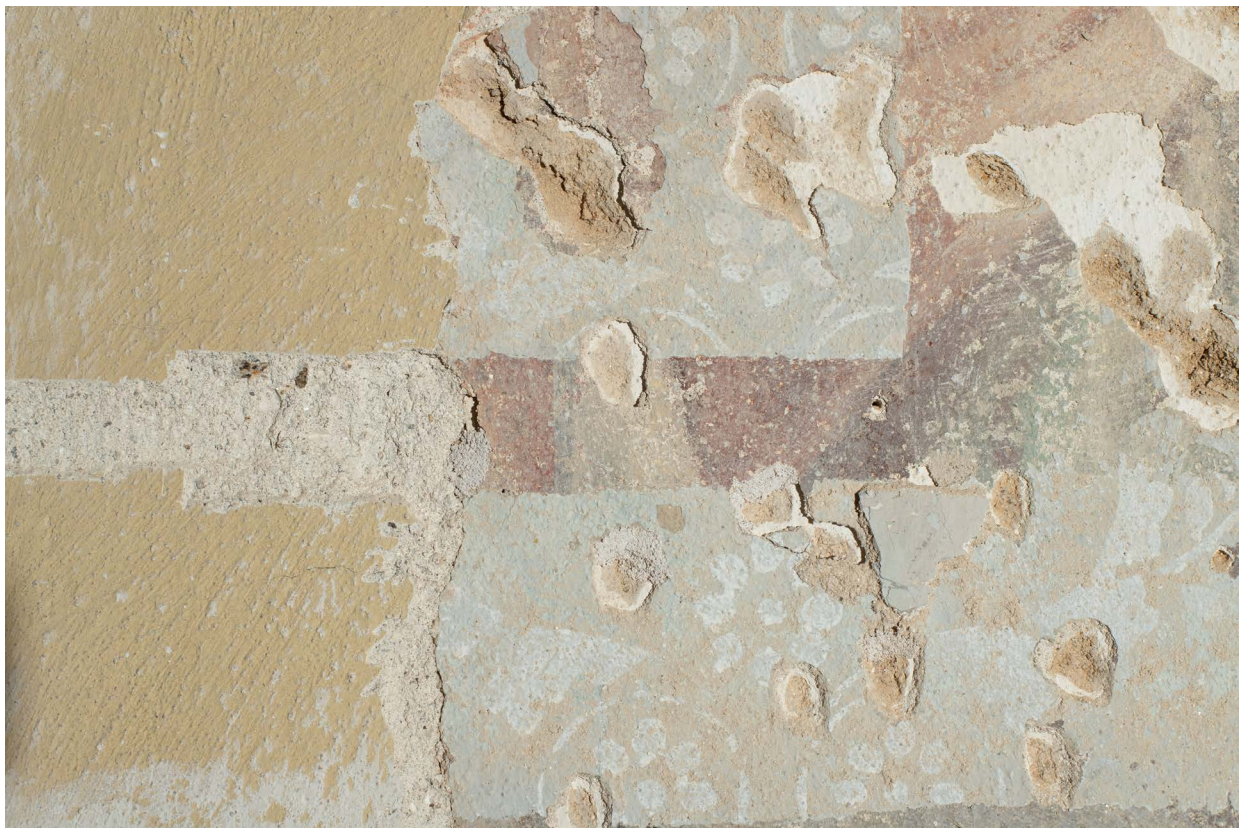
condition after the removal of the modern plaster layers on the second oldest plaster layer, partially exposing the original painted plaster layer  
photographs in day and raking light, detail

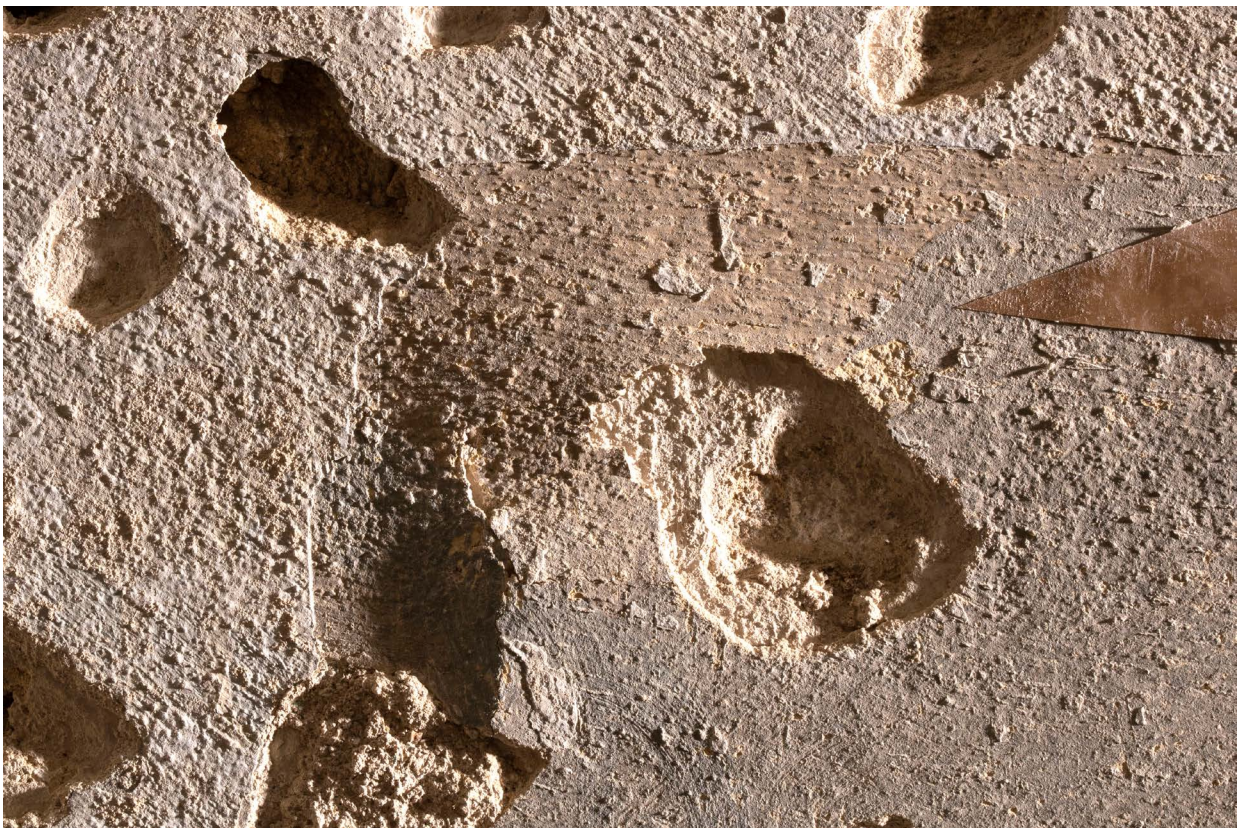
condition after the removal of the modern plaster layers on the second oldest plaster layer, partially exposing the original painted plaster layer  
details of defects and loosened plaster layers  
photographs in day and raking light, detail

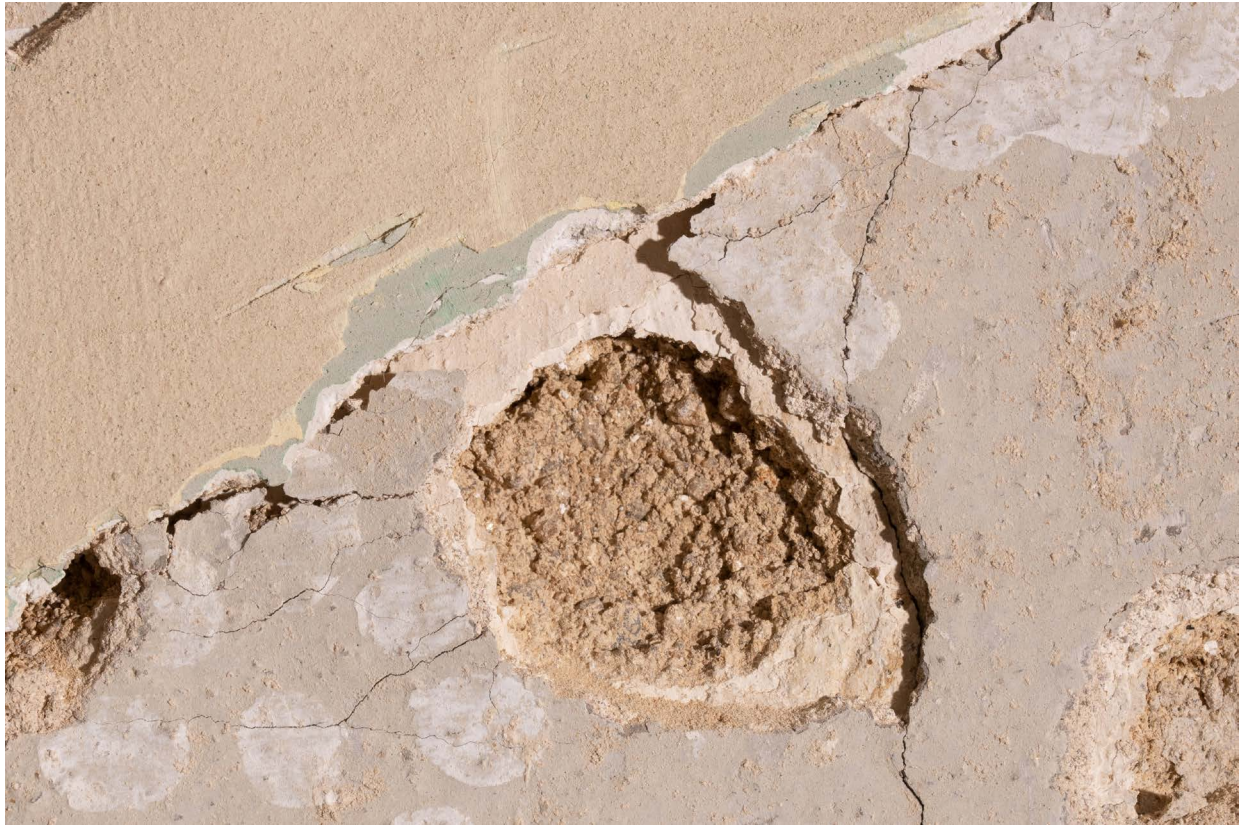
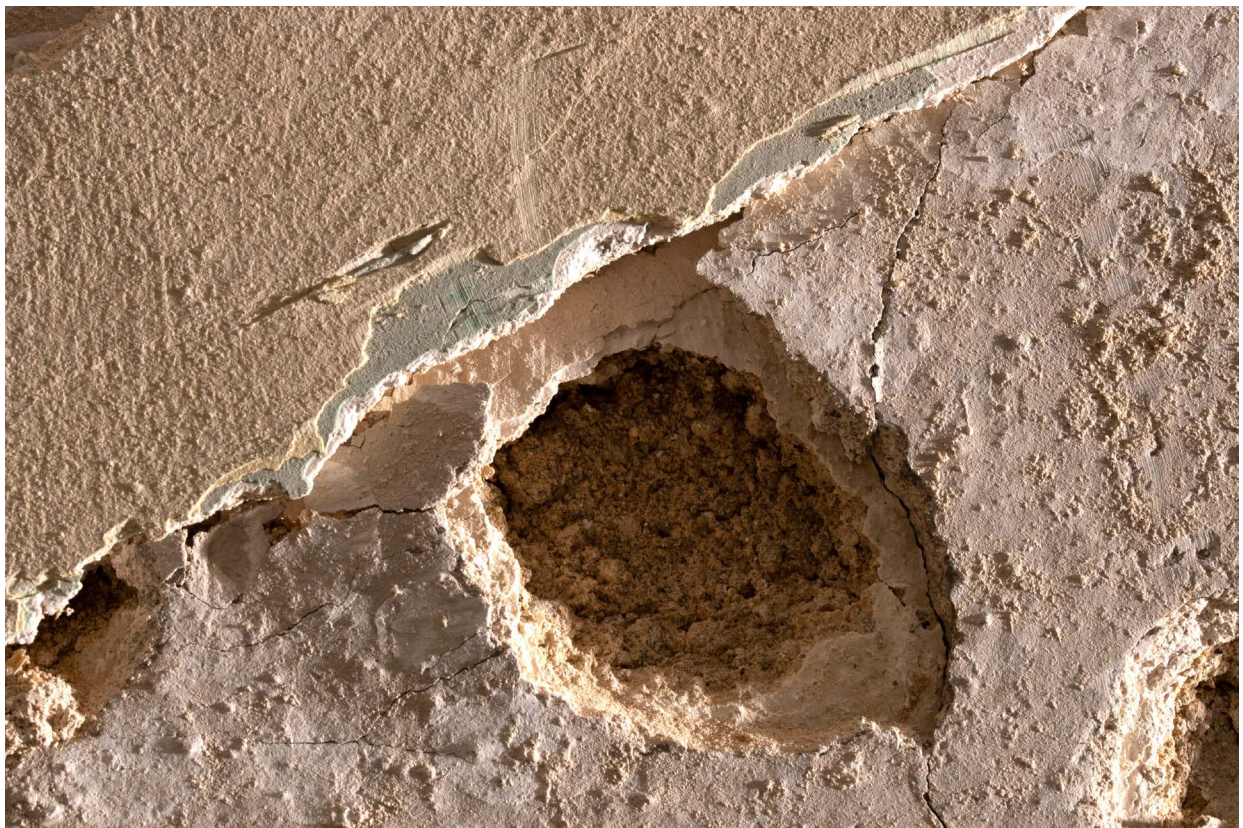
condition after the removal of the modern plaster layers on the second oldest plaster layer, partially exposing the original painted plaster layer  
details of defects and loosened plaster layers around the pecks and electricity cables covered by plaster  
photographs in day and raking light, detail

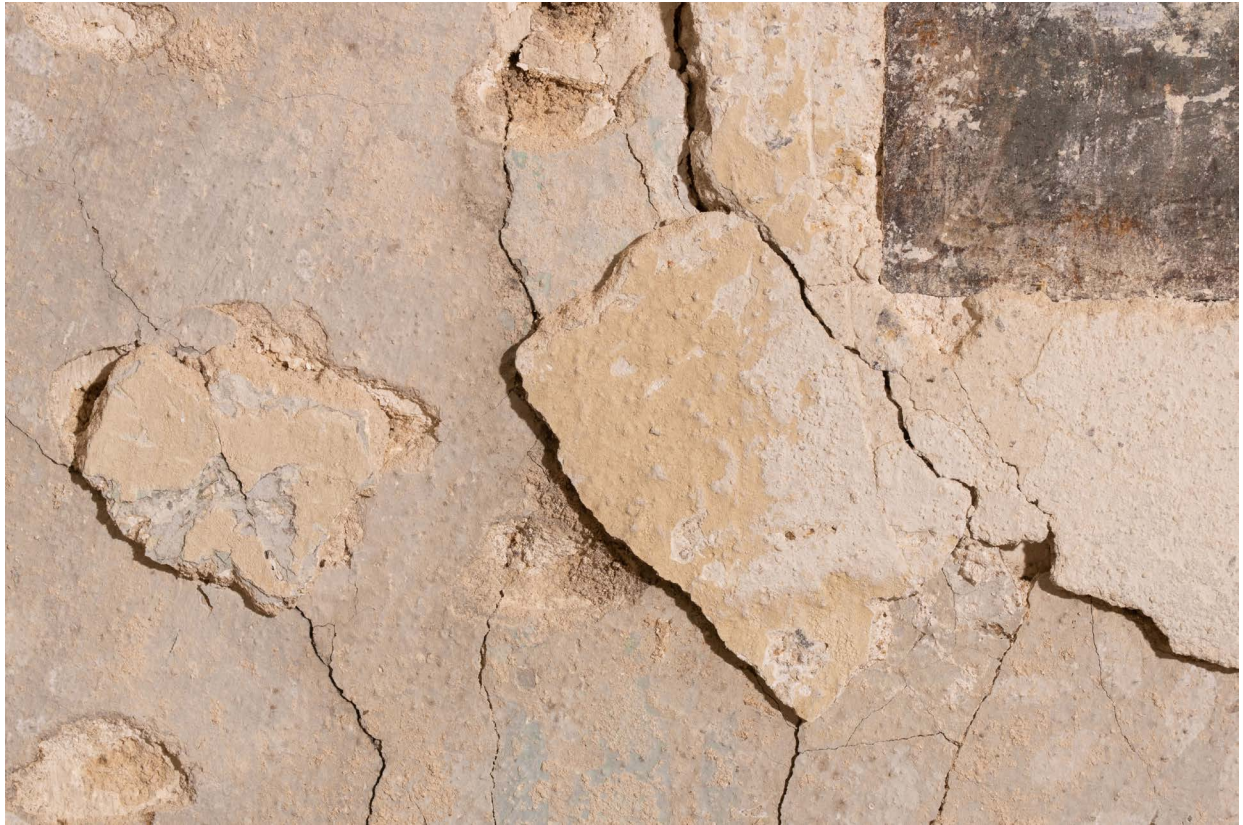
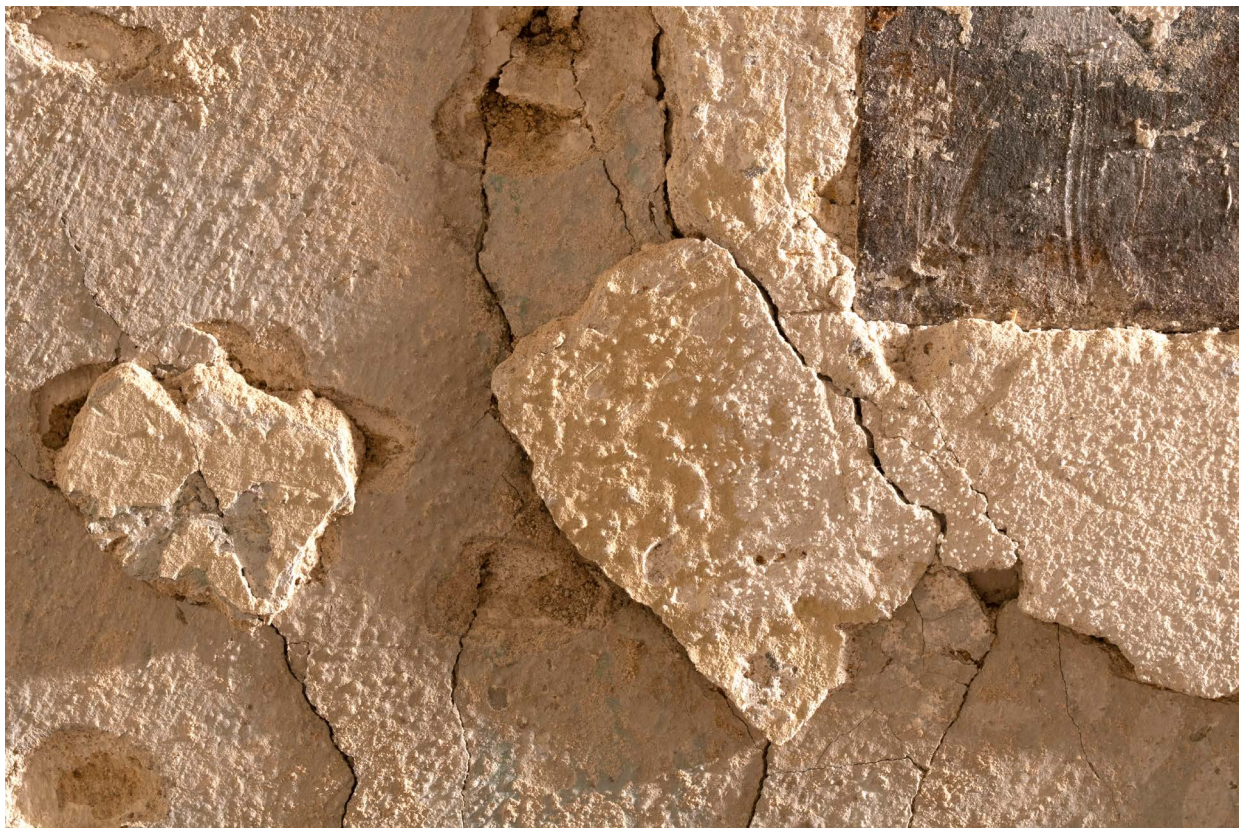
condition after the removal of the modern plaster layers on the second oldest plaster layer, partially exposing the original painted plaster layer  
details of defects and loosened plaster layers around the traverse  
photographs in day and raking light, detail

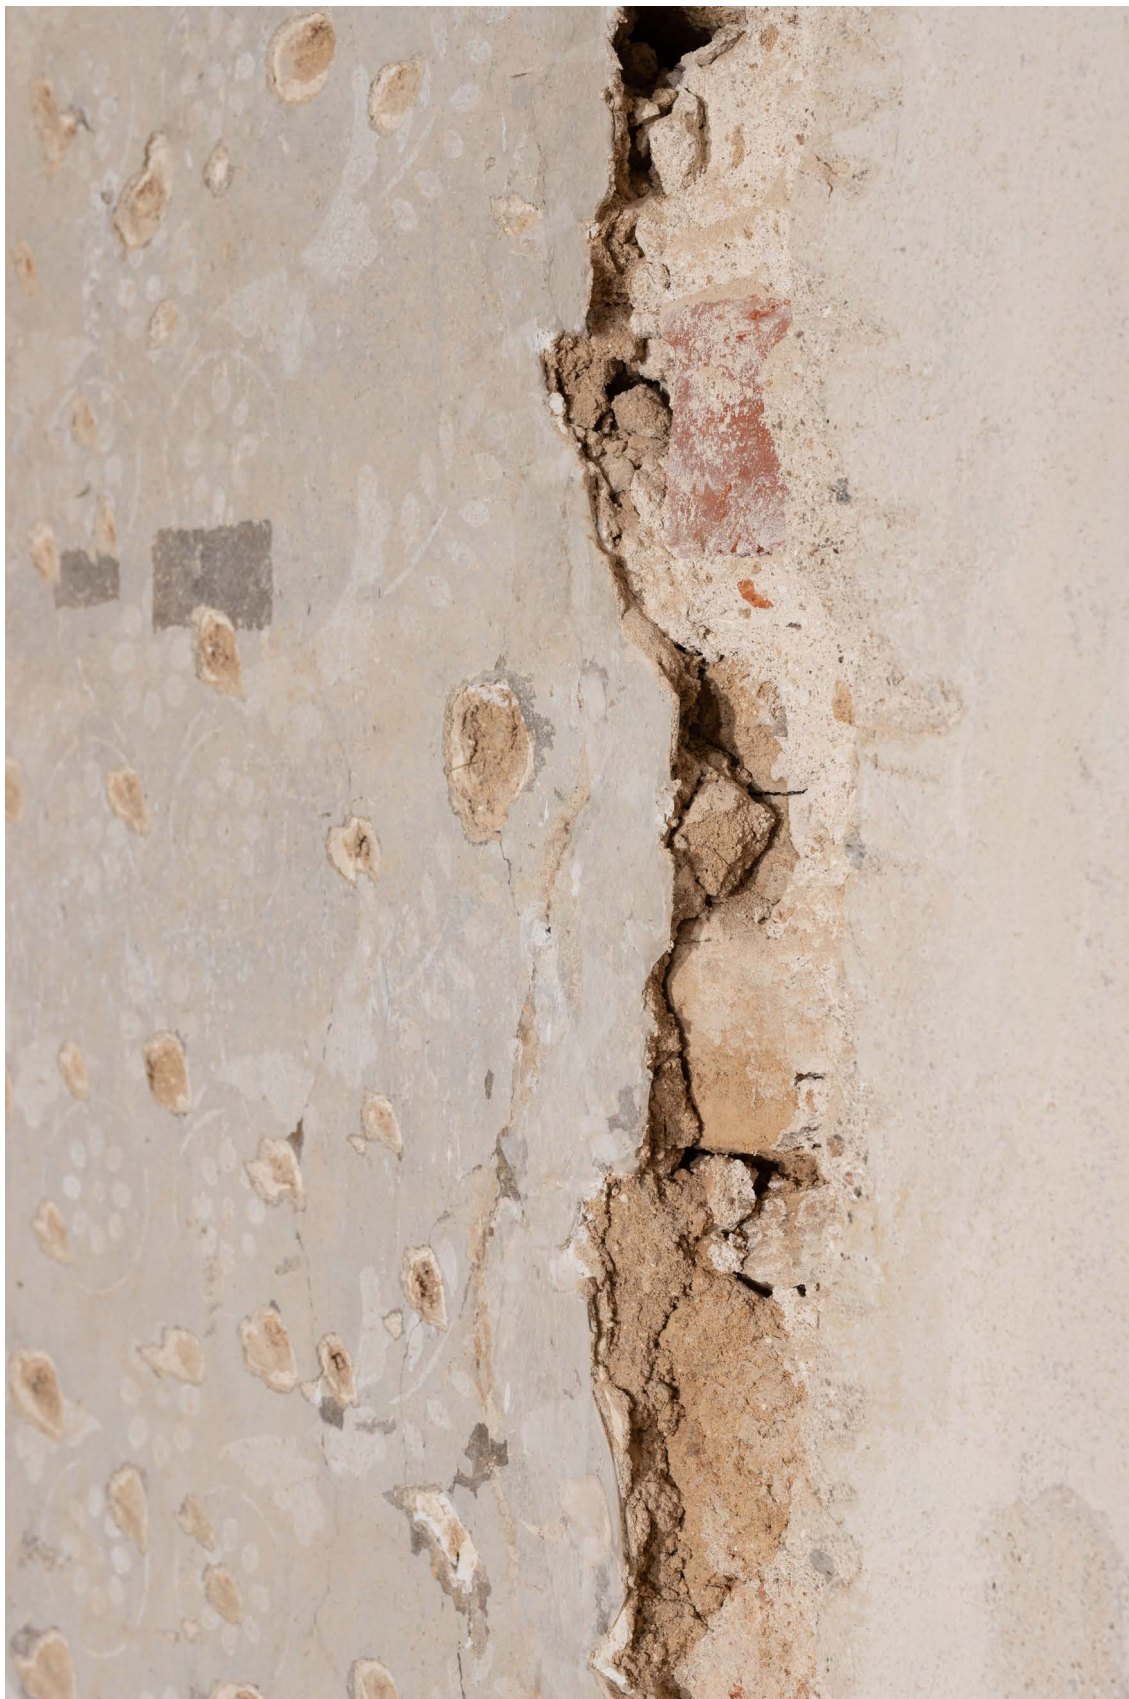
progress of the removal of modern plaster around the walled door  
detail of the range of defects and loosened original painted plaster  
photography in day light

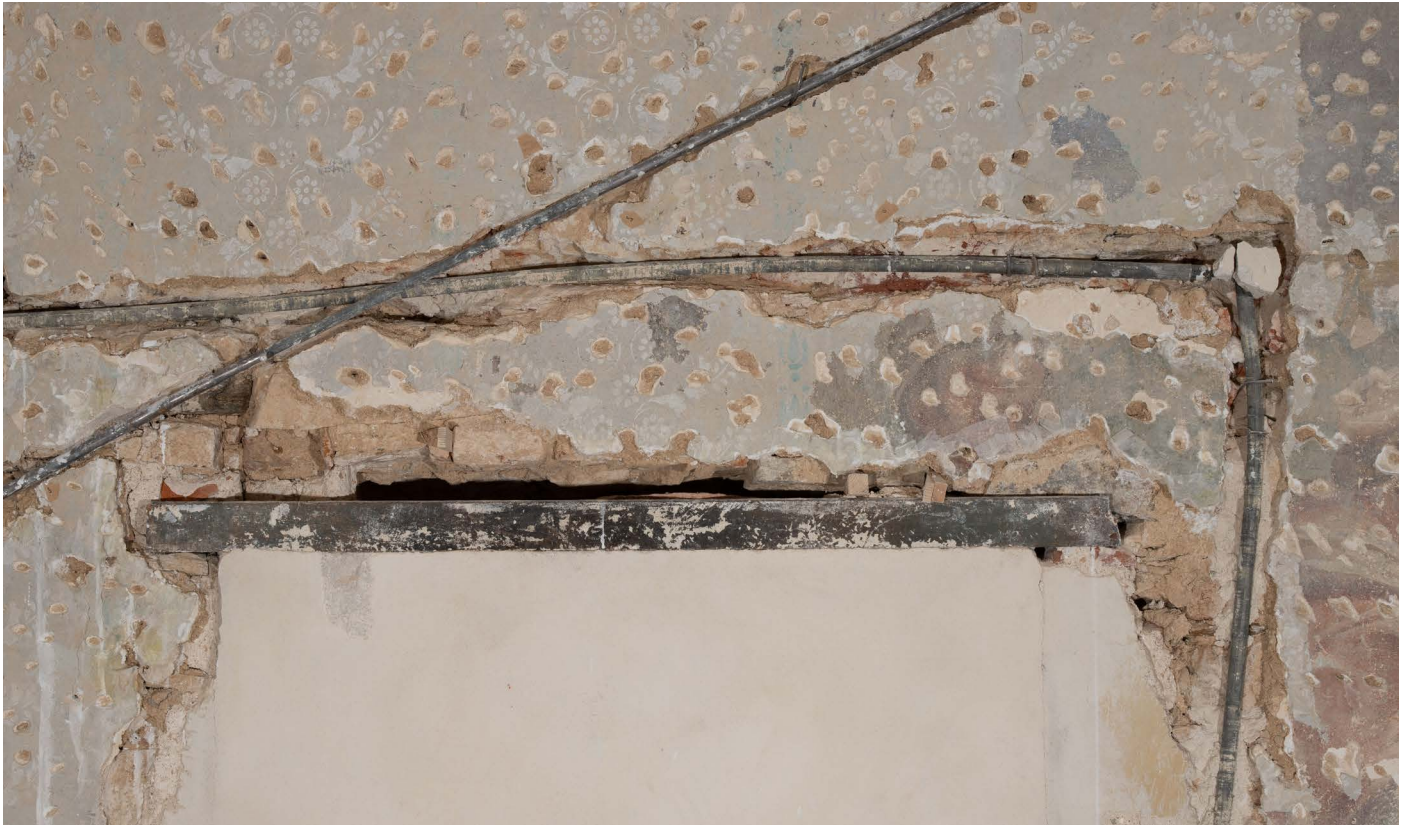
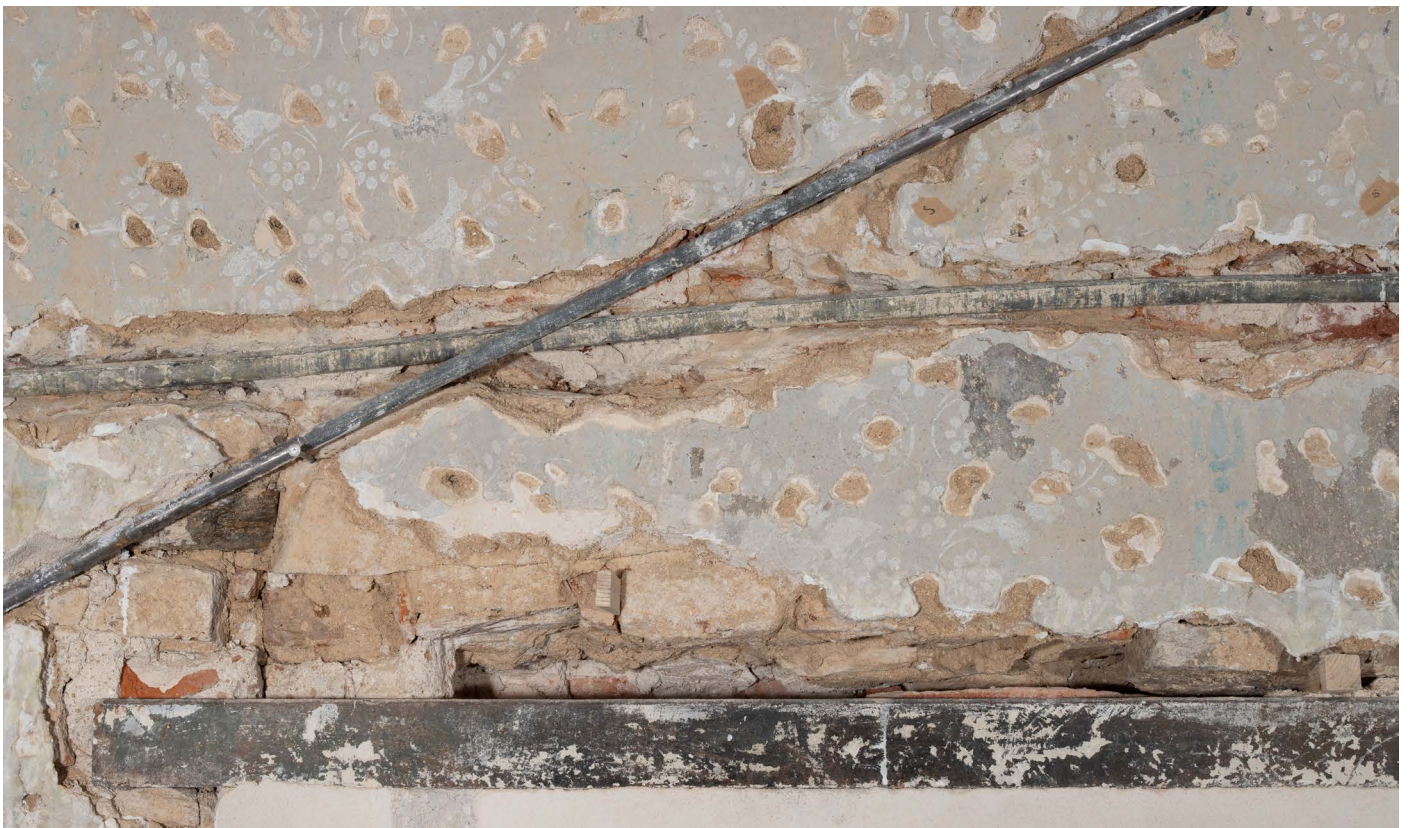
condition after the removal of modern plaster around the walled door  
detail of range of structural defects in wall and lost of original painted plaster layer around the traverse and electricity cables  
photographs in day light
