# RESTORATION TREATMENT REPORT

## THE STORY OF MOSES KAREL JOSEF MORAVINI

wall painting in the interior of chamber in a ground floor of southwest part of castle Kácov  
1730s  
private owner

Alžběta Mirjam Procházková  
Academy of Fine Arts in Prague  
Studio of Restoration of Painted Artworks and Polychrome Sculpture  
akademic years 2022/2023 - 2022/2024

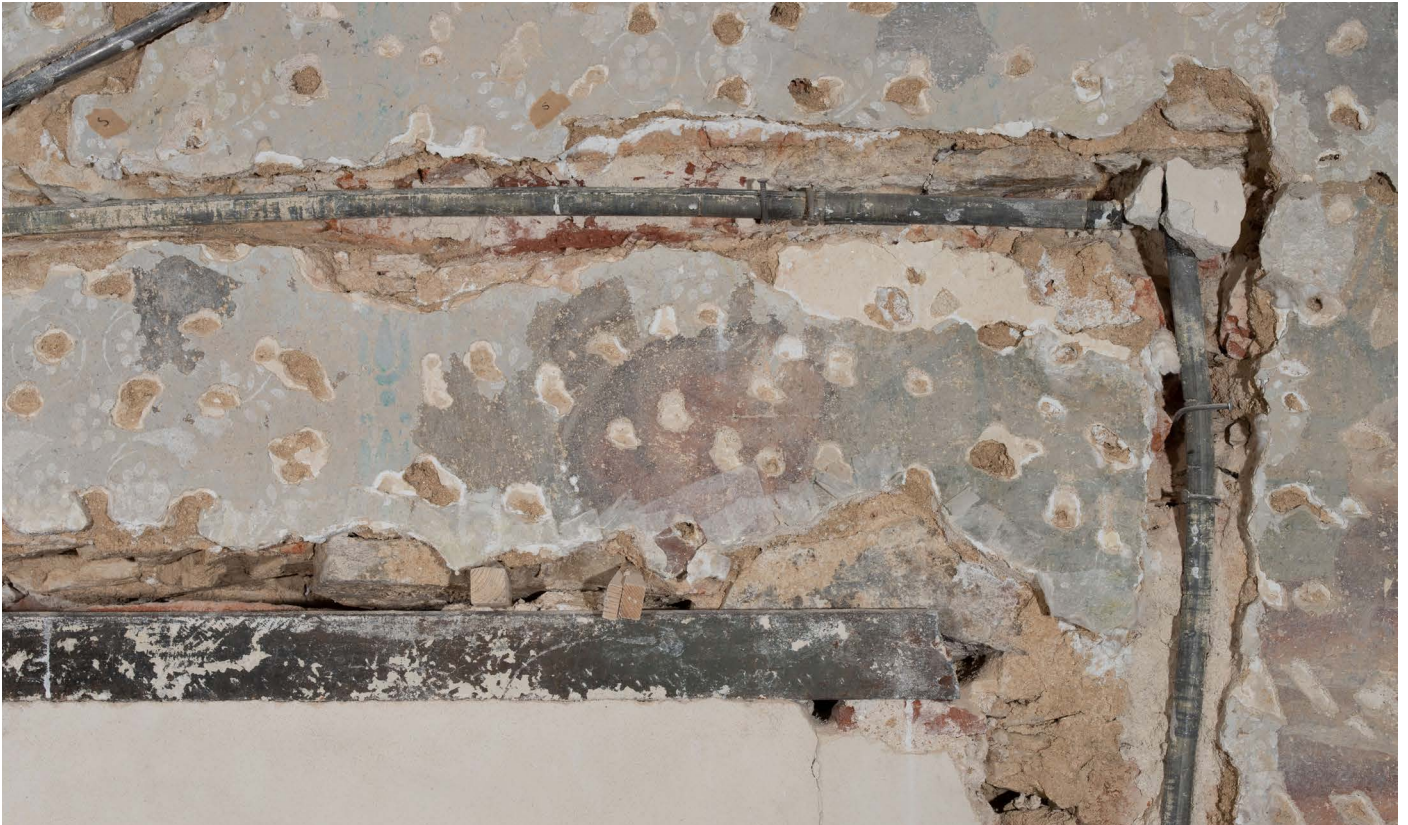
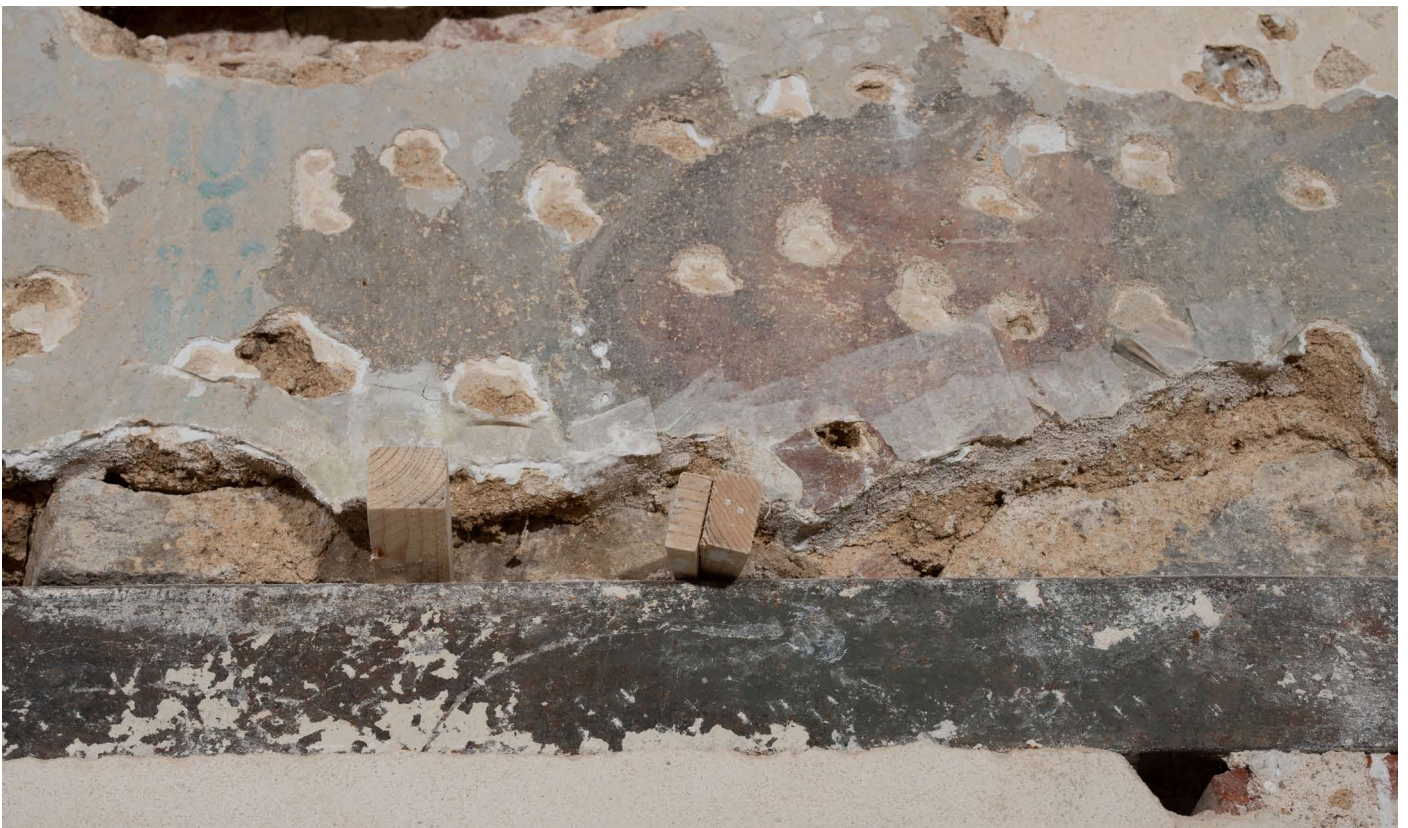
condition after the removal of modern plaster around the walled door  
detail of range of defects in wall and lost of original painted plaster layer around the traverse and electricity cables and fixation of the plaster with original wall painting in the position by wooden pins  
photographs in day light

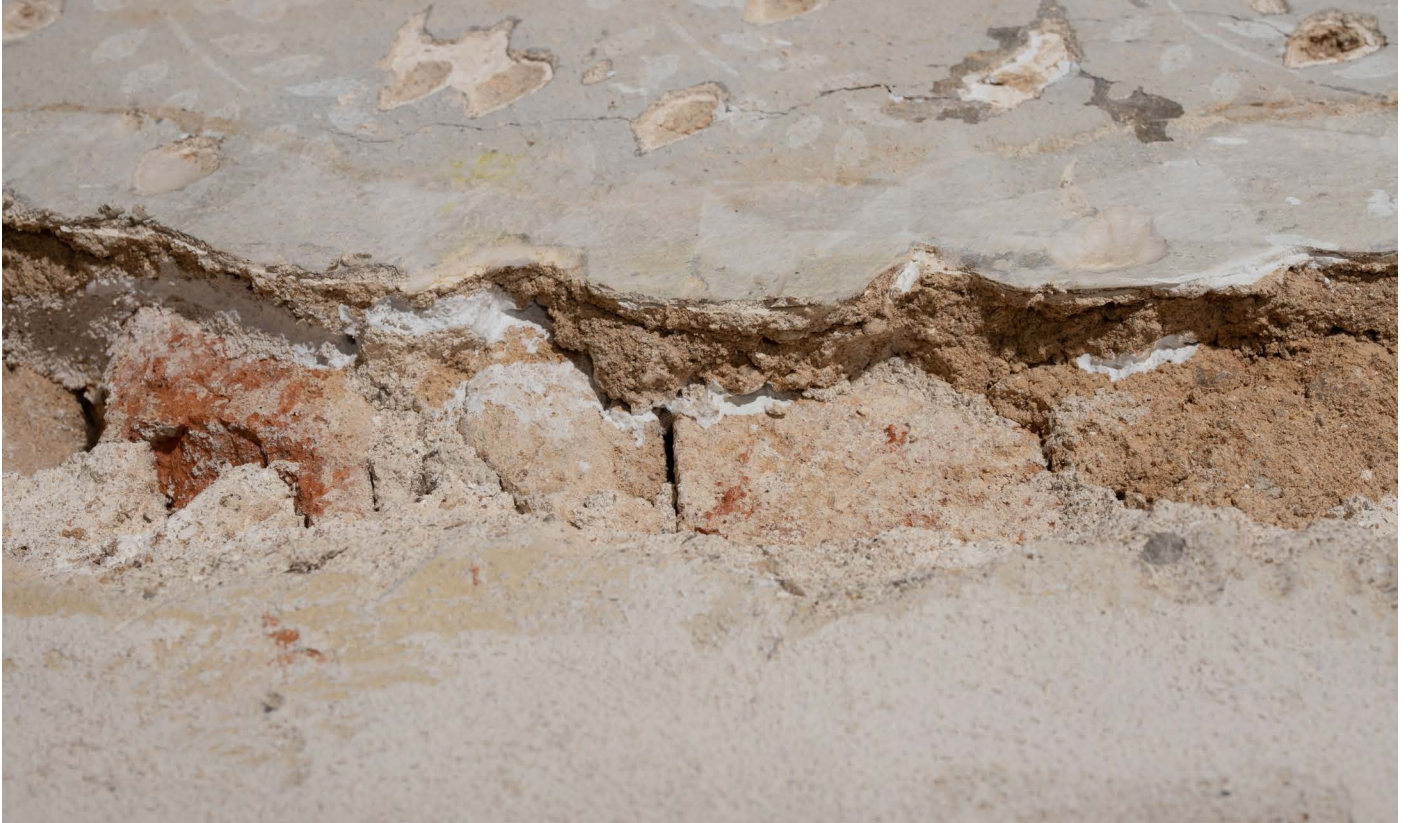
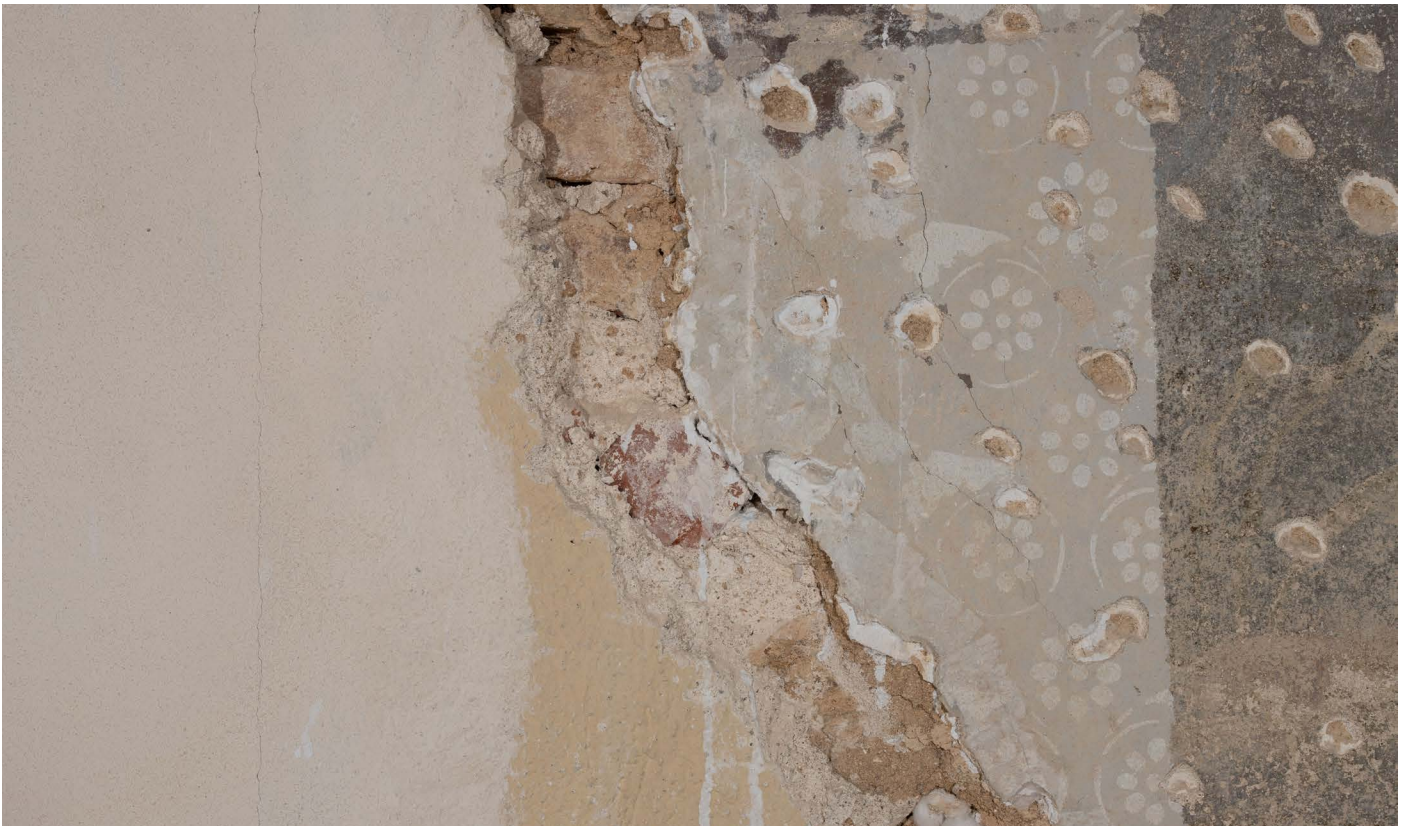
condition after the removal of modern plaster around the walled door  
detail of range of defects and lost of original painted plaster layer around the walled door  
photographs in day light

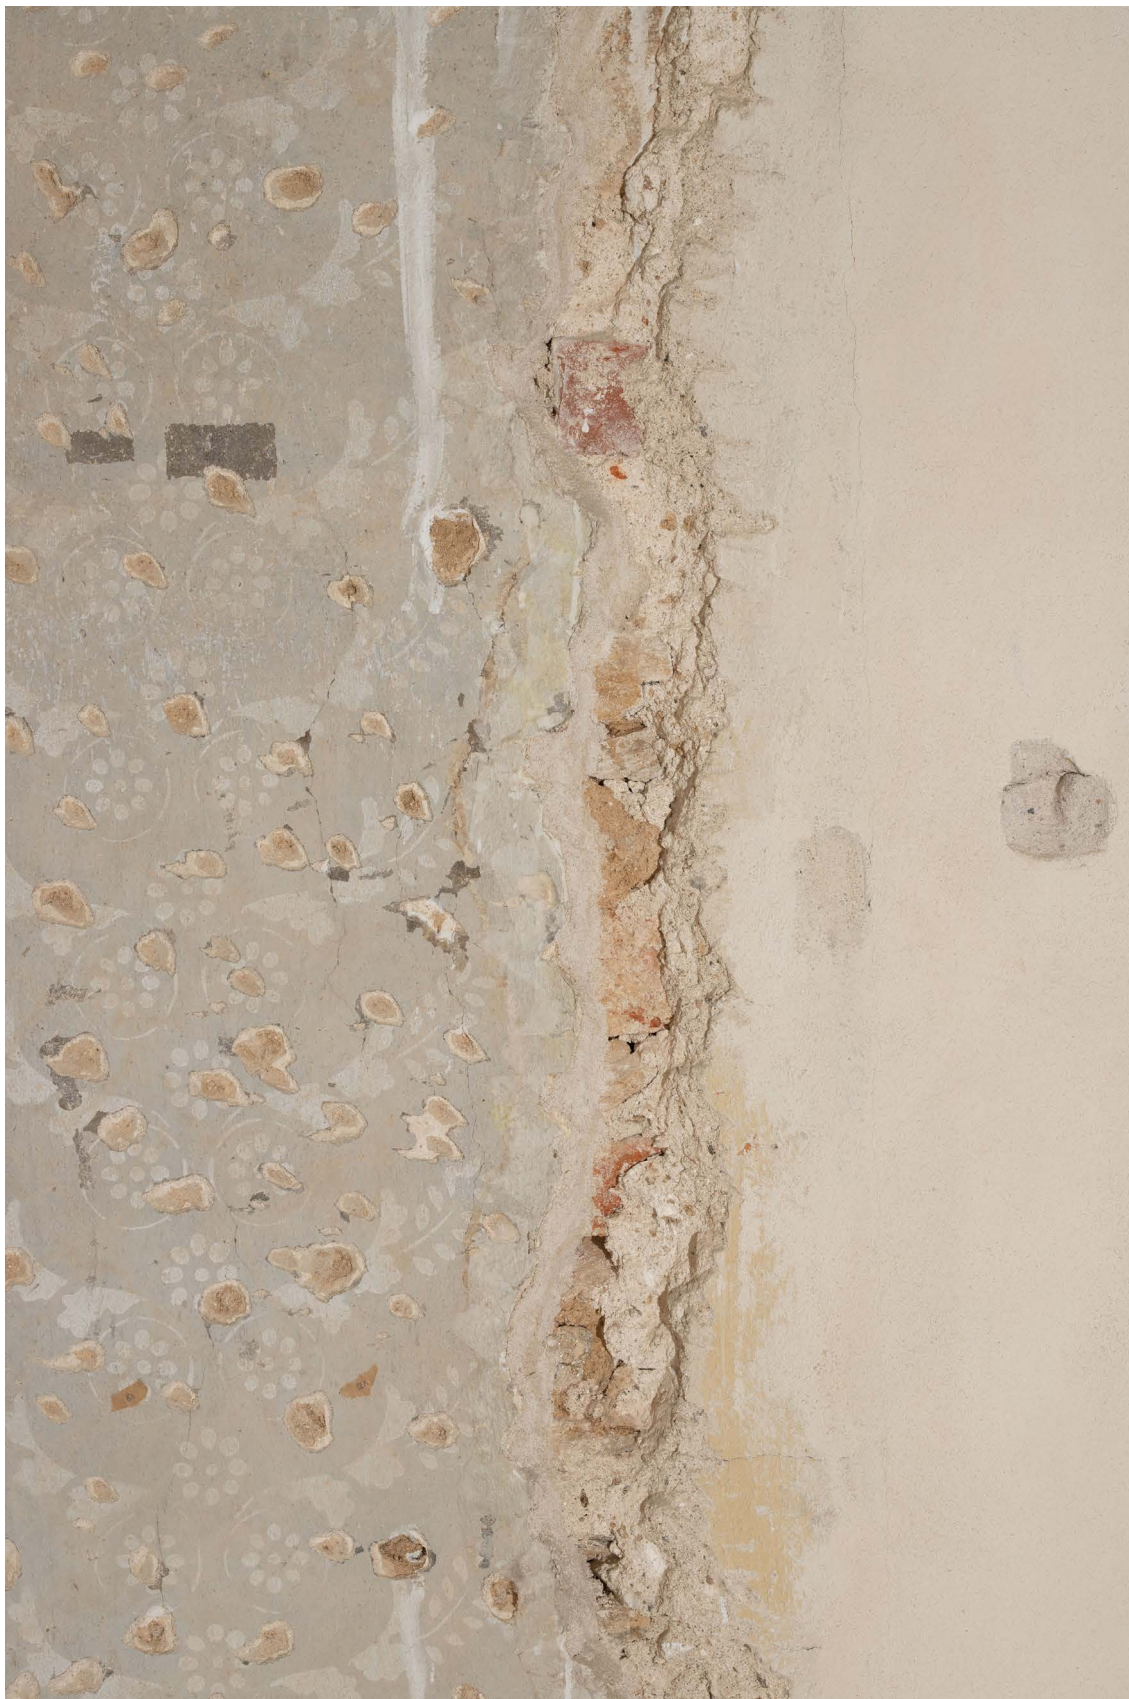
condition after the removal of modern plaster around the walled door  
detail of range of defects and lost of original painted plaster layer around the walled door  
photography in day light

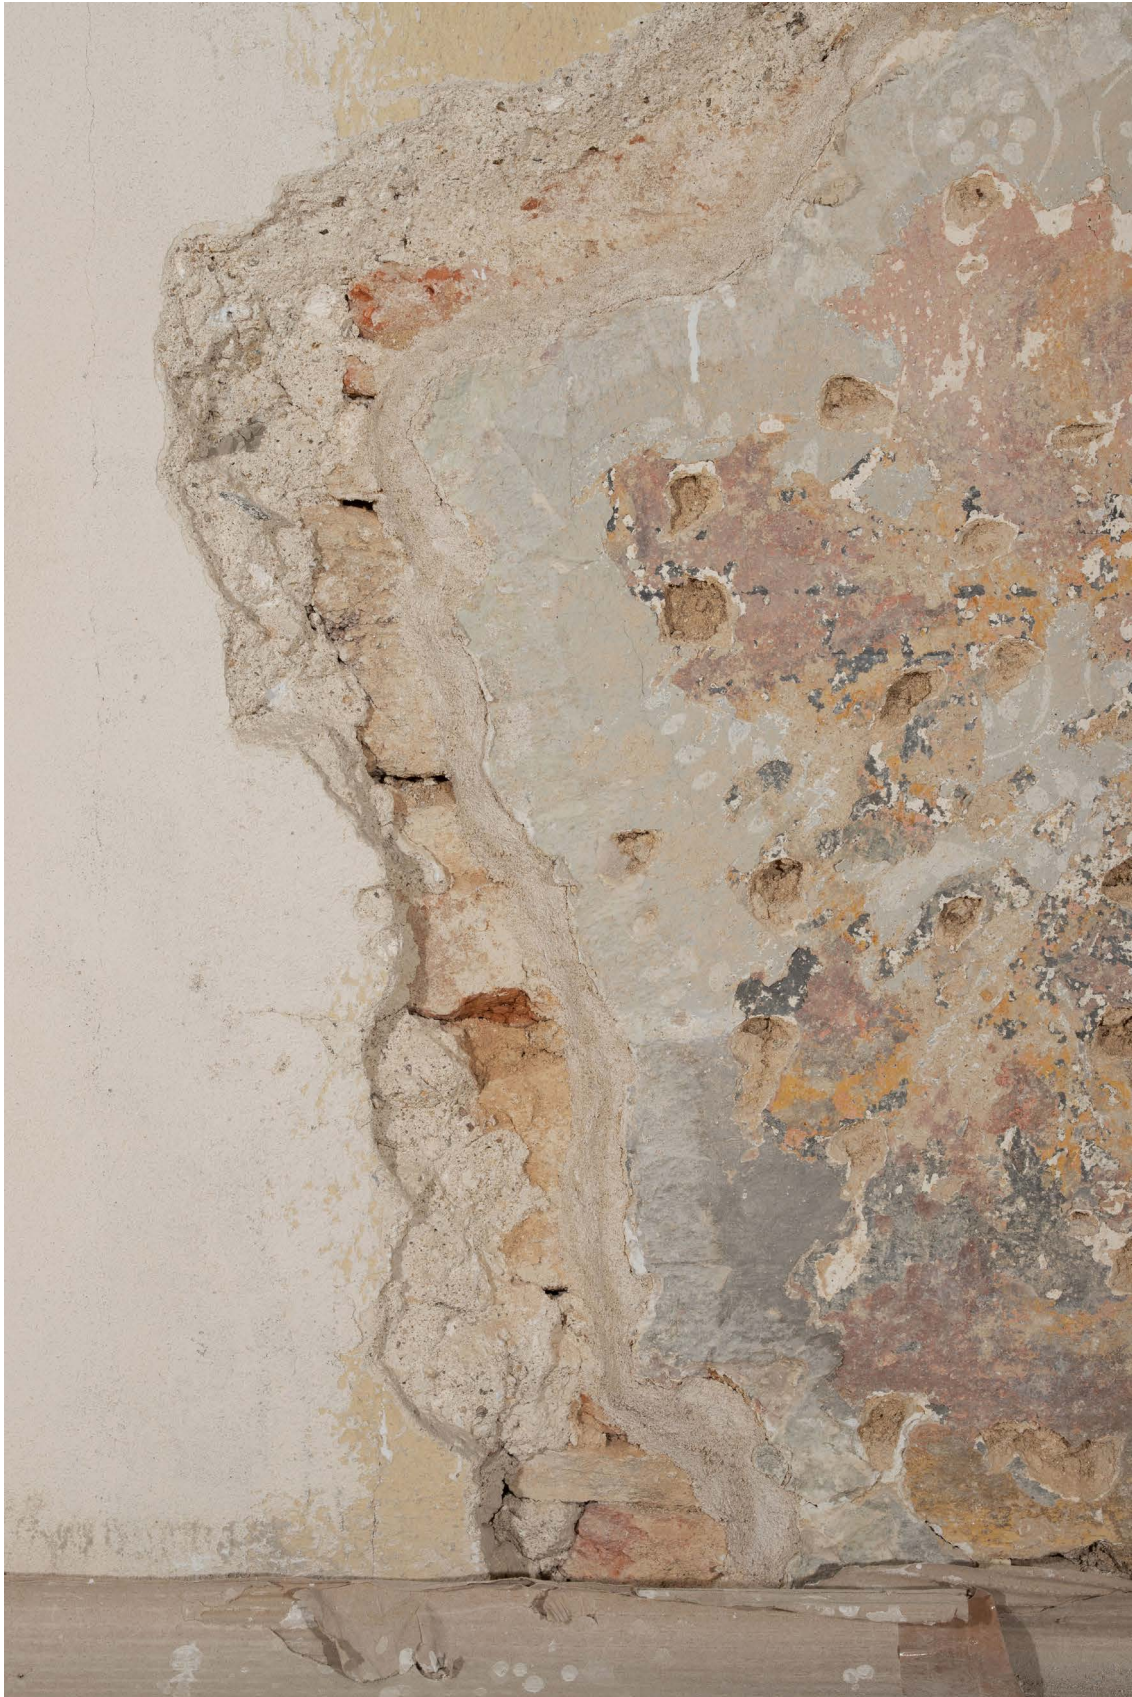
condition after the removal of modern plaster around the walled door  
detail of range of defects and lost of original painted plaster layer around the walled door  
photography in day light

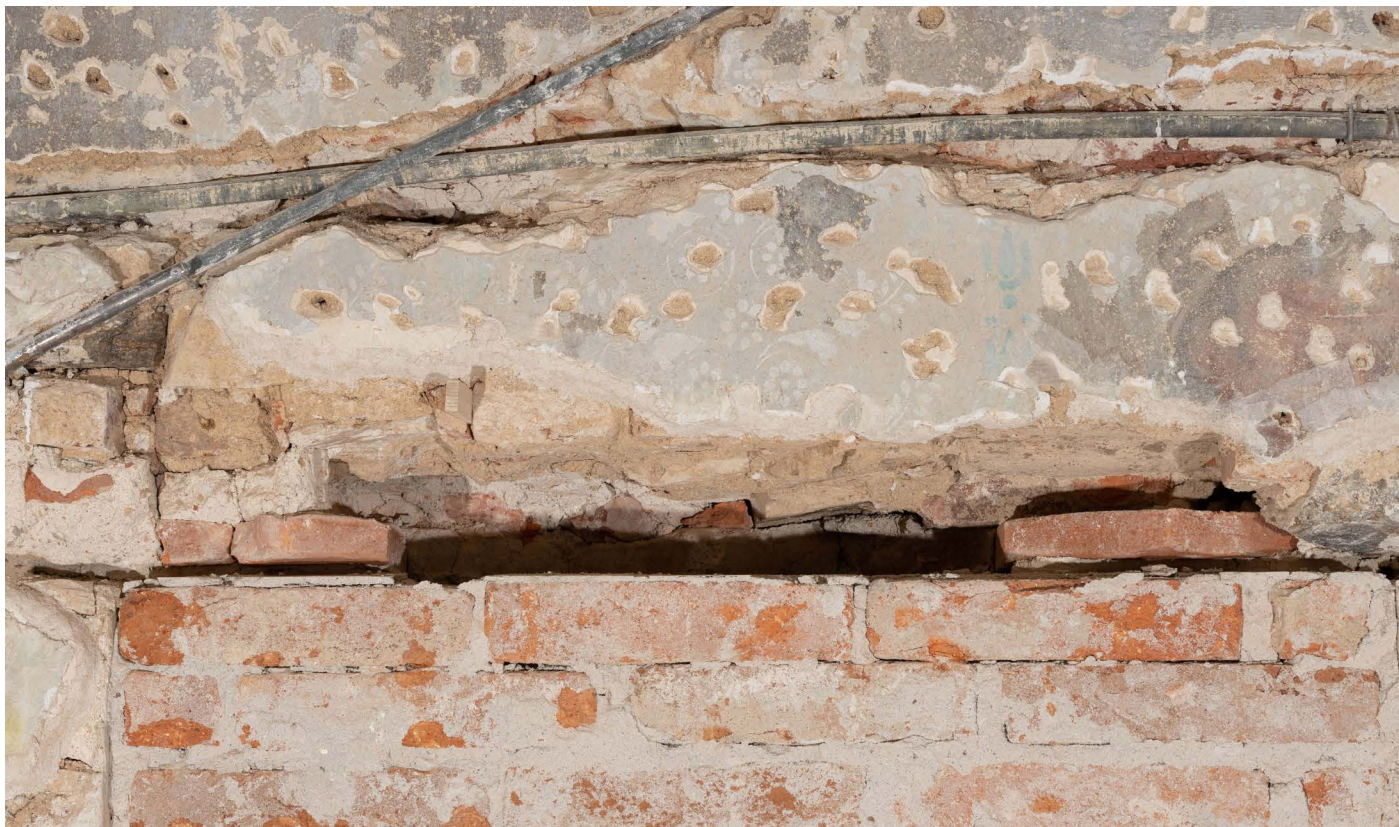
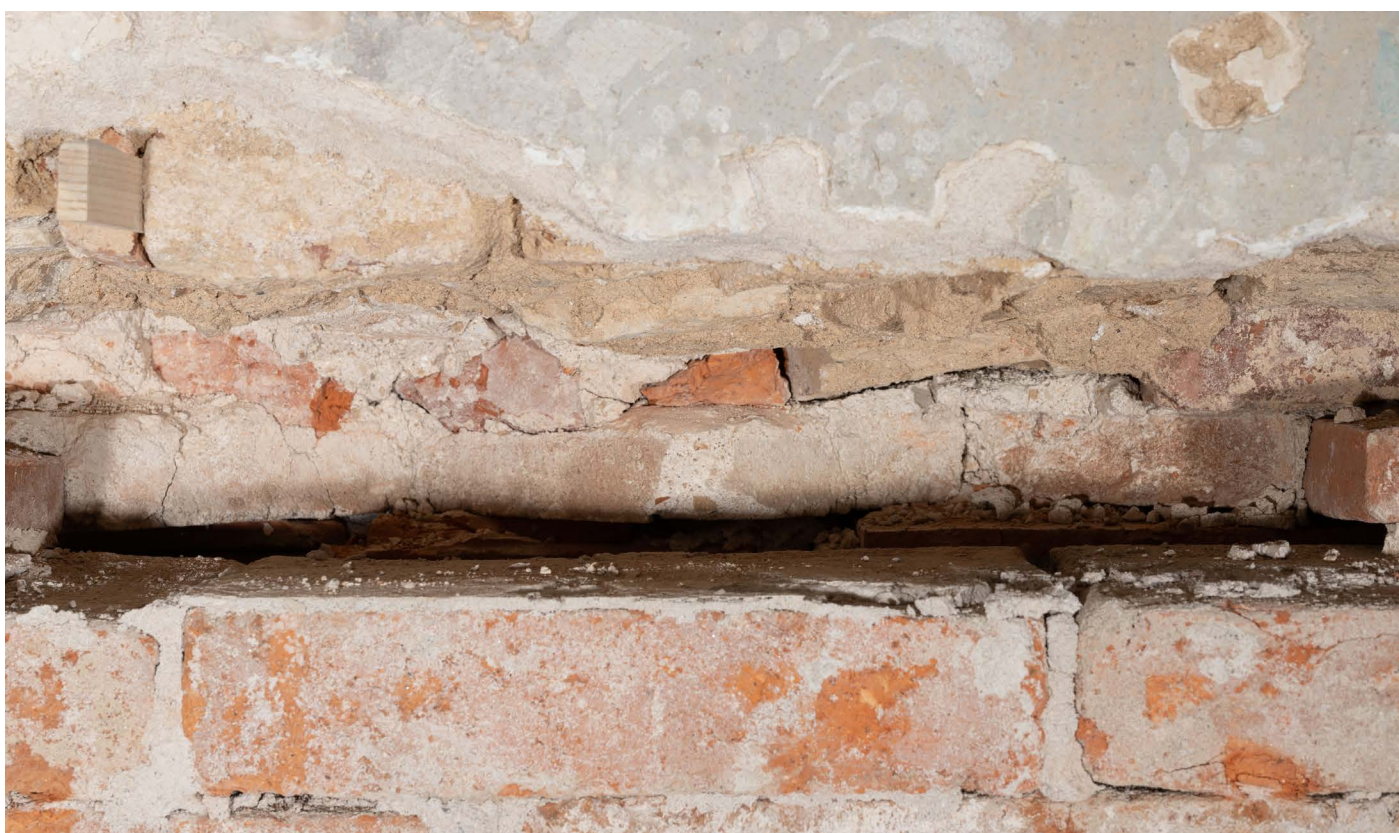
condition after the removal of modern plaster covering the walled door and traverse  
details of the deepness of the hole between the walled door and original plaster  
photographs in day light

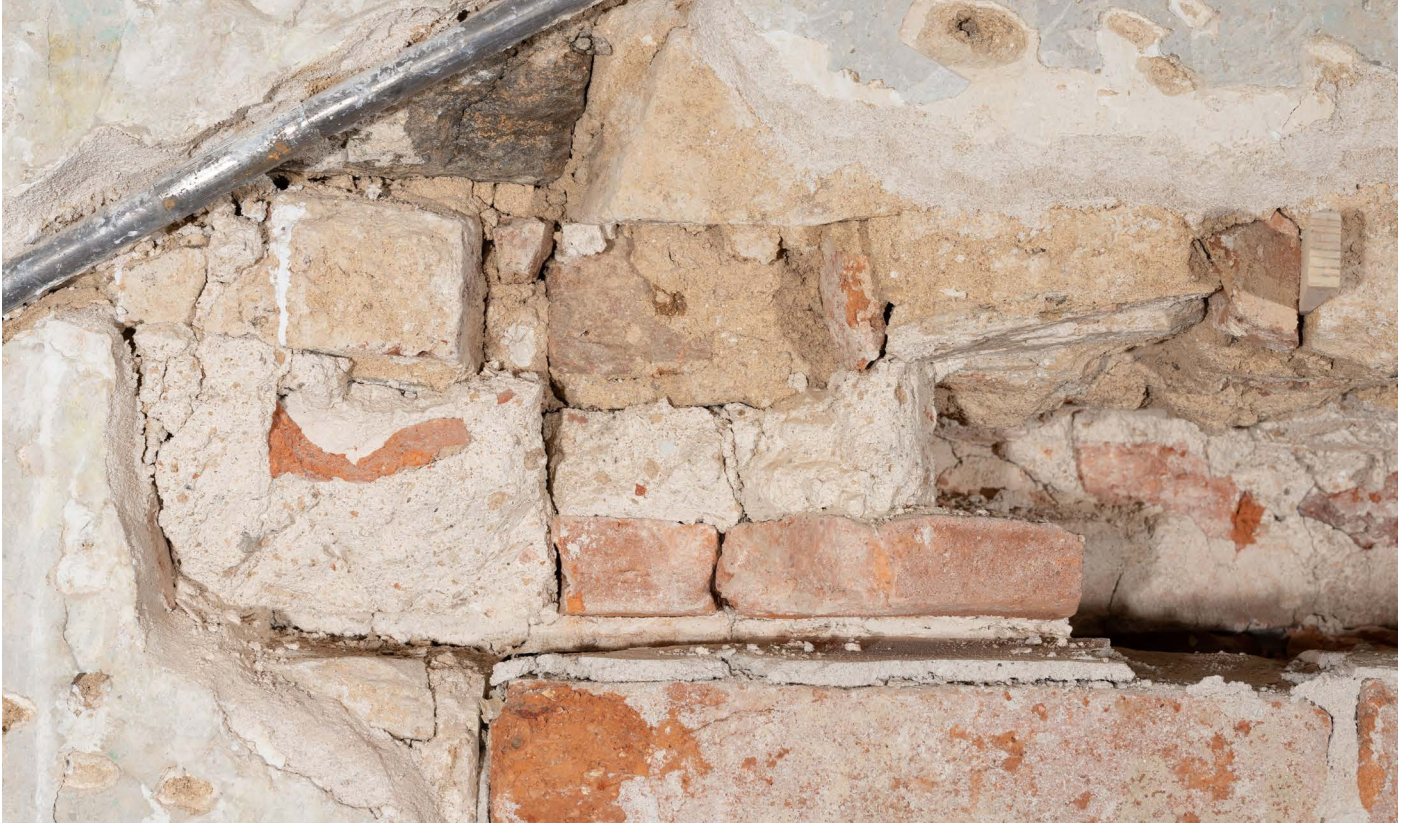
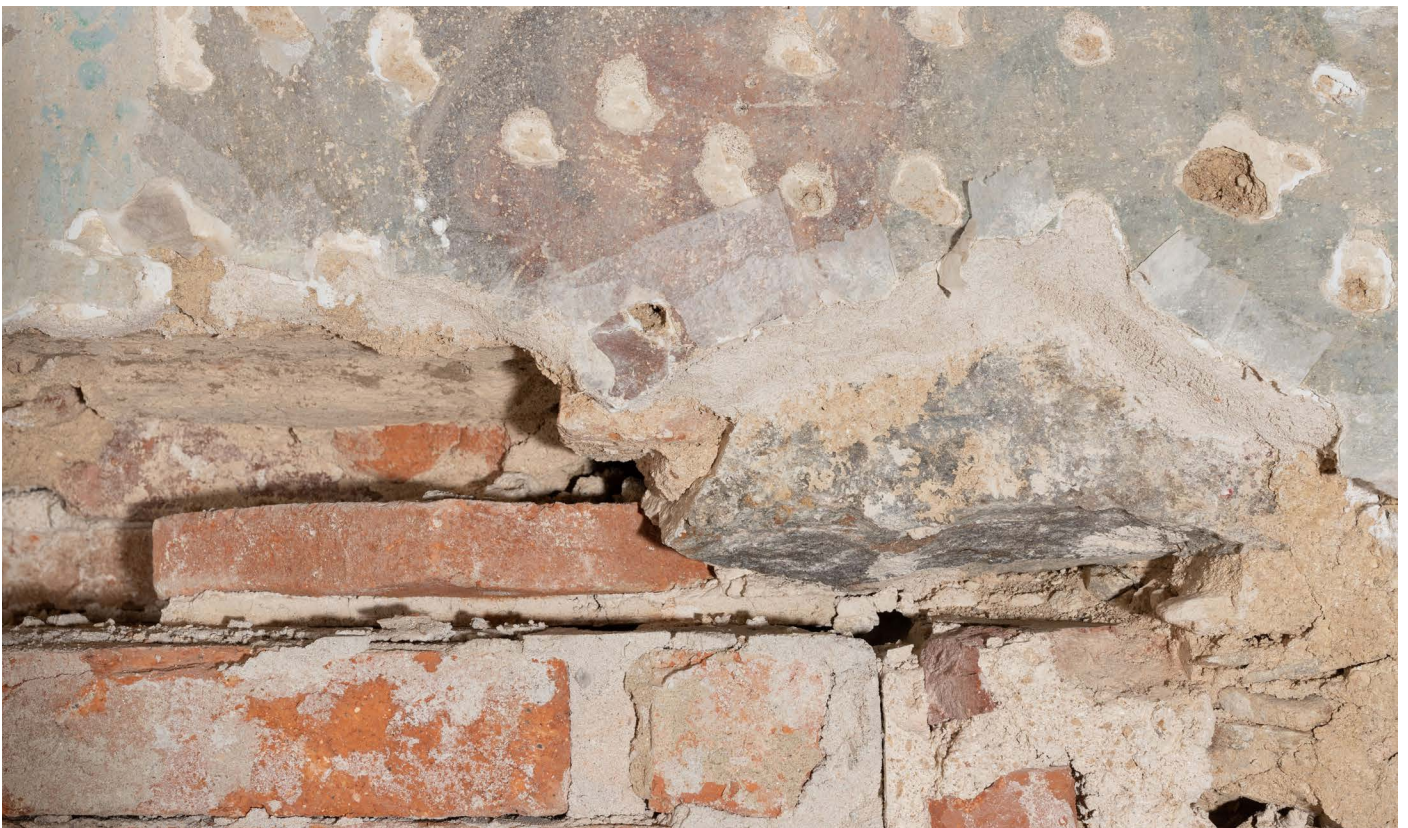
condition after the removal of modern plaster covering the walled door and traverse  
details of the deepness of the hole between the walled door and original plaster  
photographs in day light

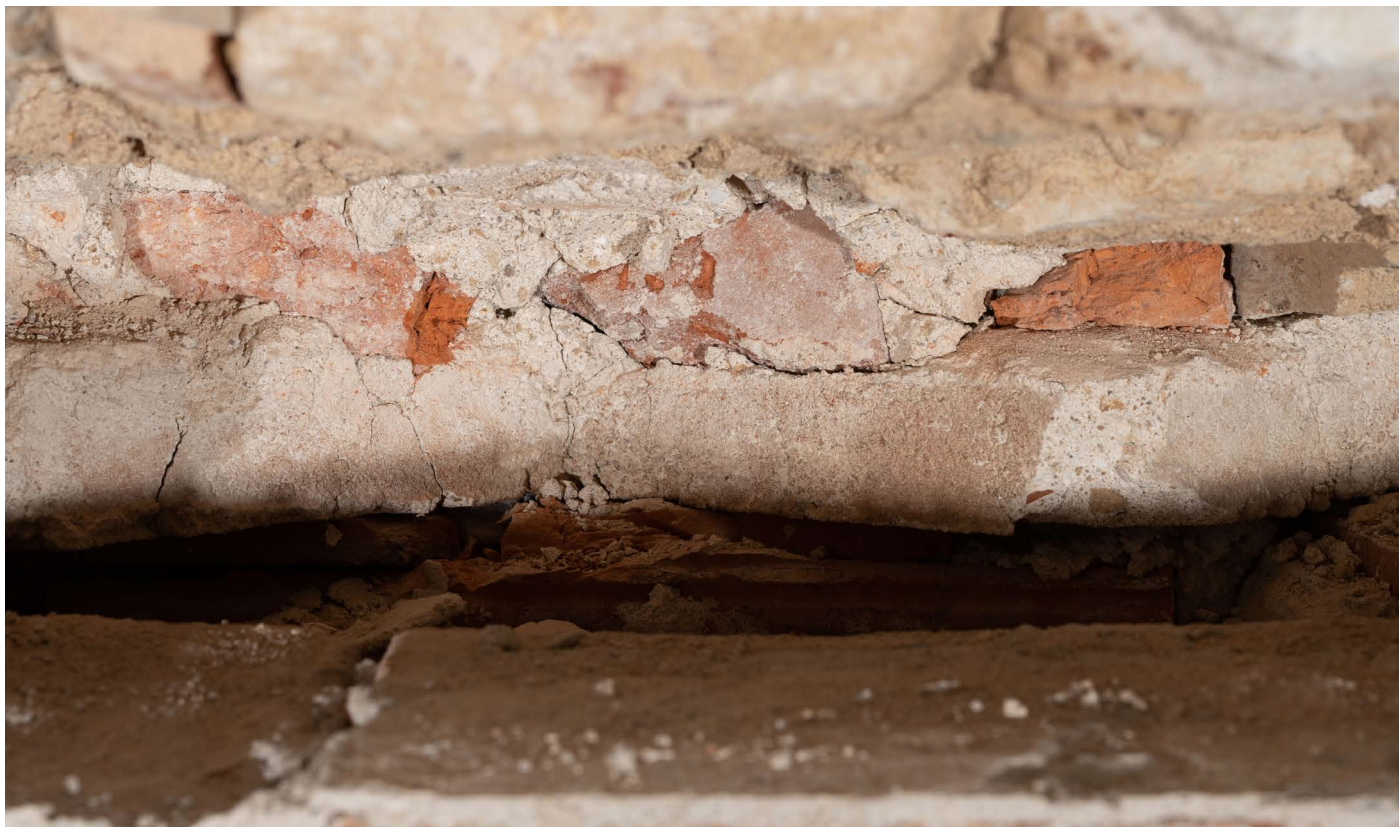
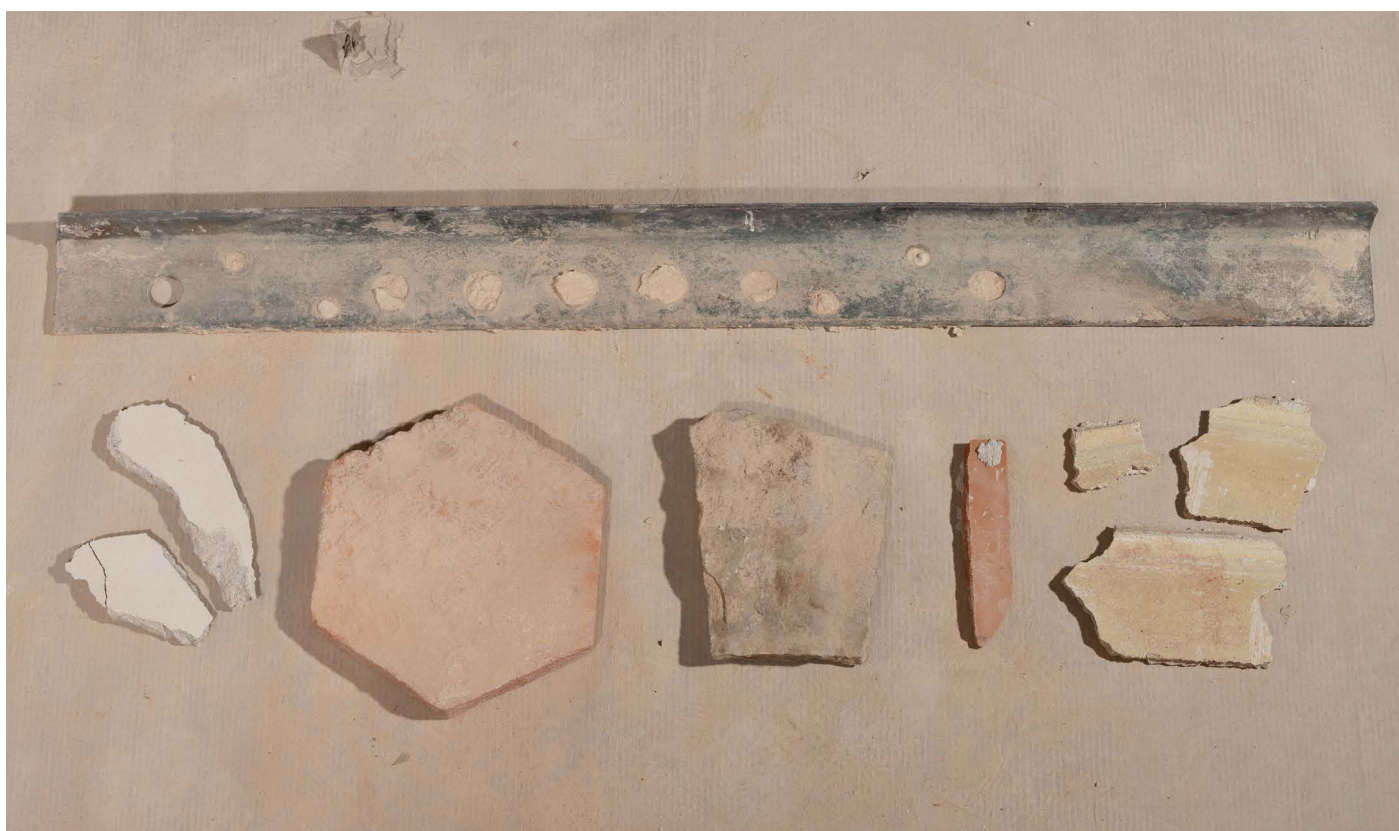
condition after the removal of traverse  
details of the deepness of the hole between the walled door and original plaster and picture of materials inserted to hole within the metal traverse  
photographs in day light

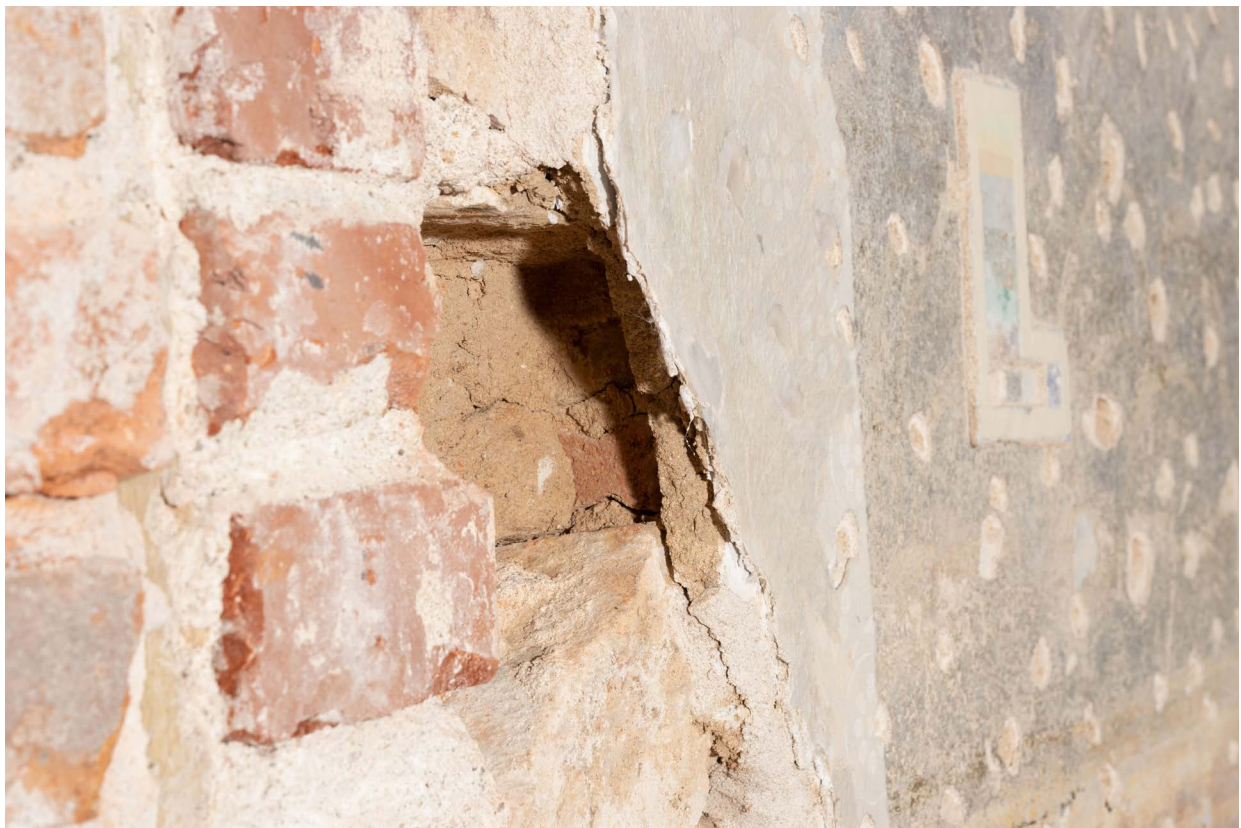
condition before the brickworking and reinforcement of the masonry of the wall  
details of the deepness of the defect  
photographs in day light
