# RESTORATION TREATMENT REPORT

## WATER FAIRY

EMIL JOHANN LAUFFER

NATIONAL GALLERY IN PRAGUE

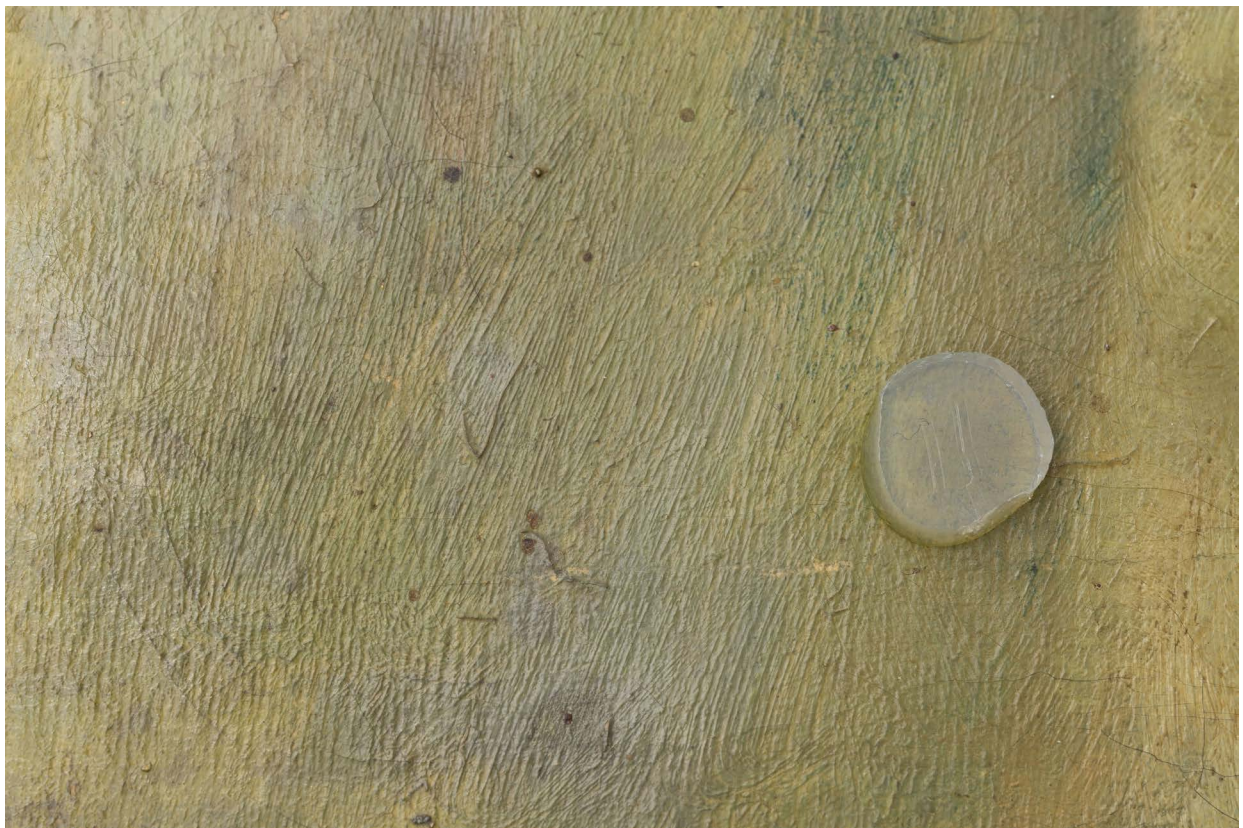
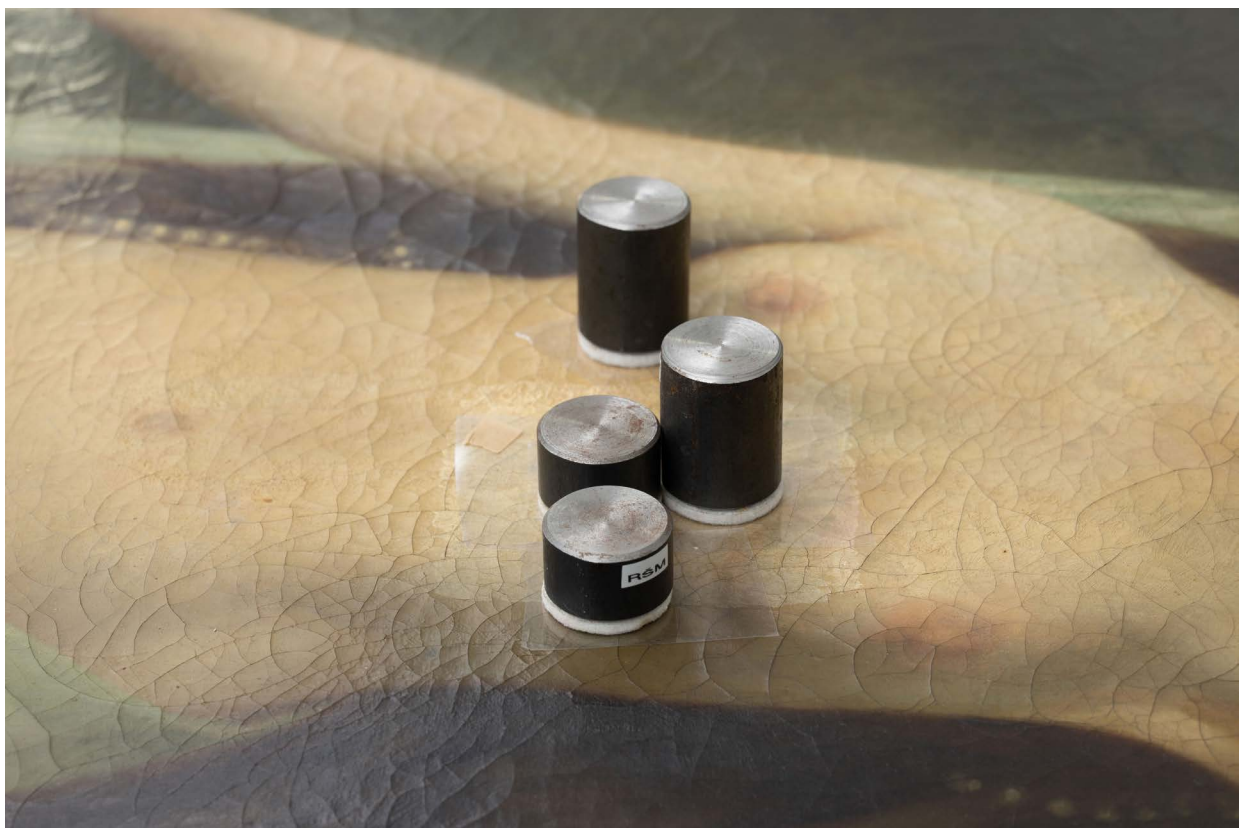
local consolidation of loosened and flaking paint and ground layer after application of adhesive and wheighthen photographs in day light

- There were multiple defects on the painting with loosened or missing paint layers. These areas were consolidated using a 5% gelatin solution in distilled water. Local facing was then removed using White Spirit after preconsolidation.

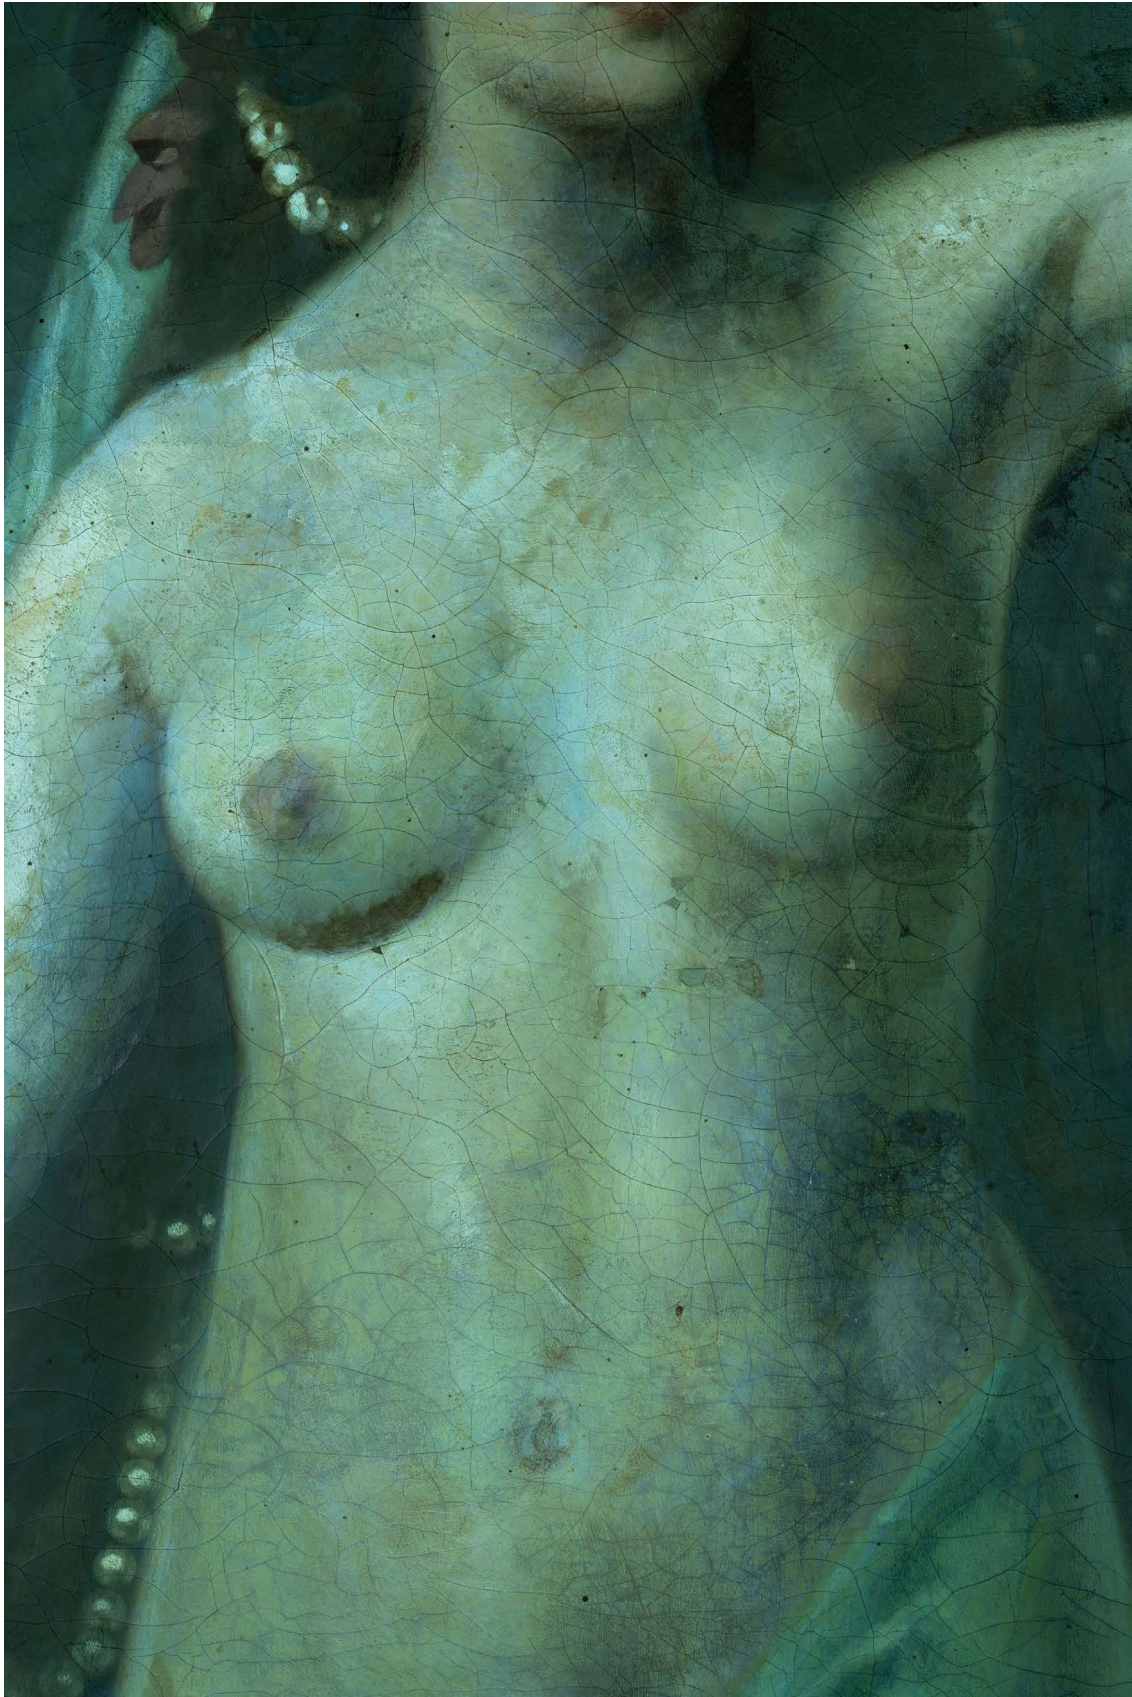
condition after thinning of varnish layer  
photography in day light, detail

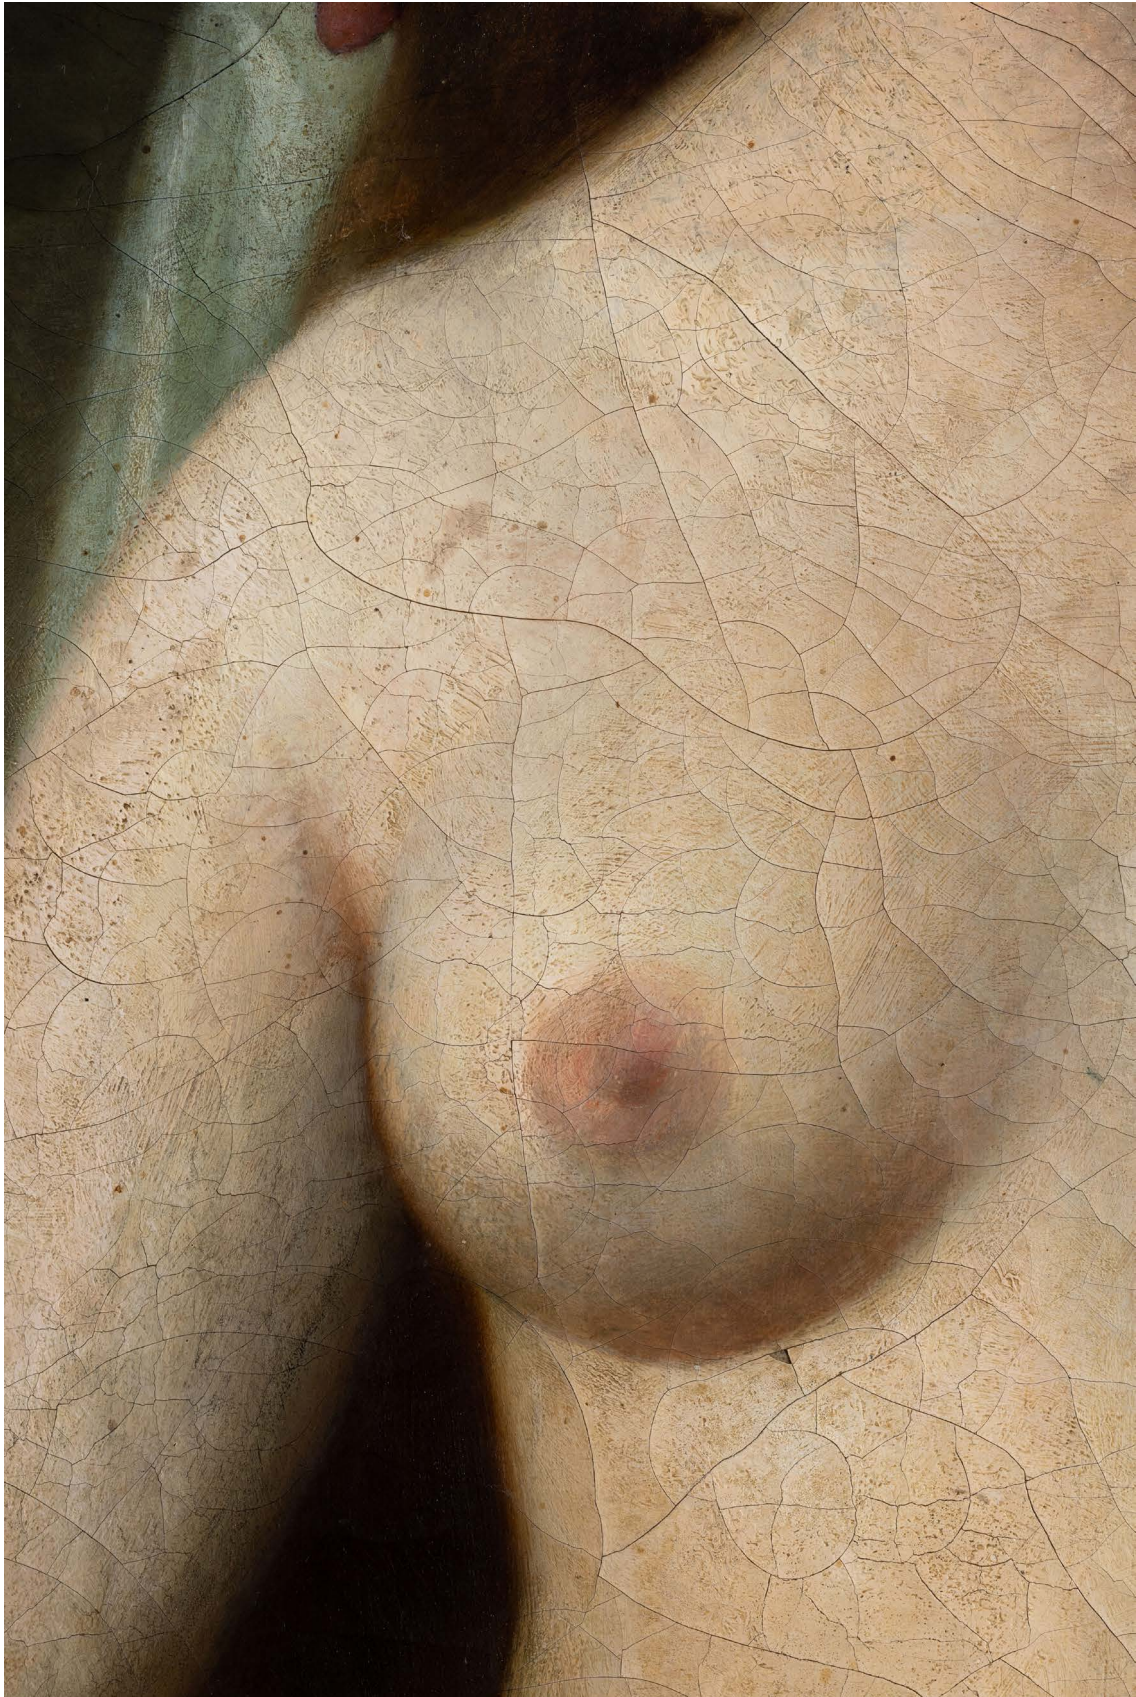
condition after thinning of varnish layer  
photography in UV luminescence, detail

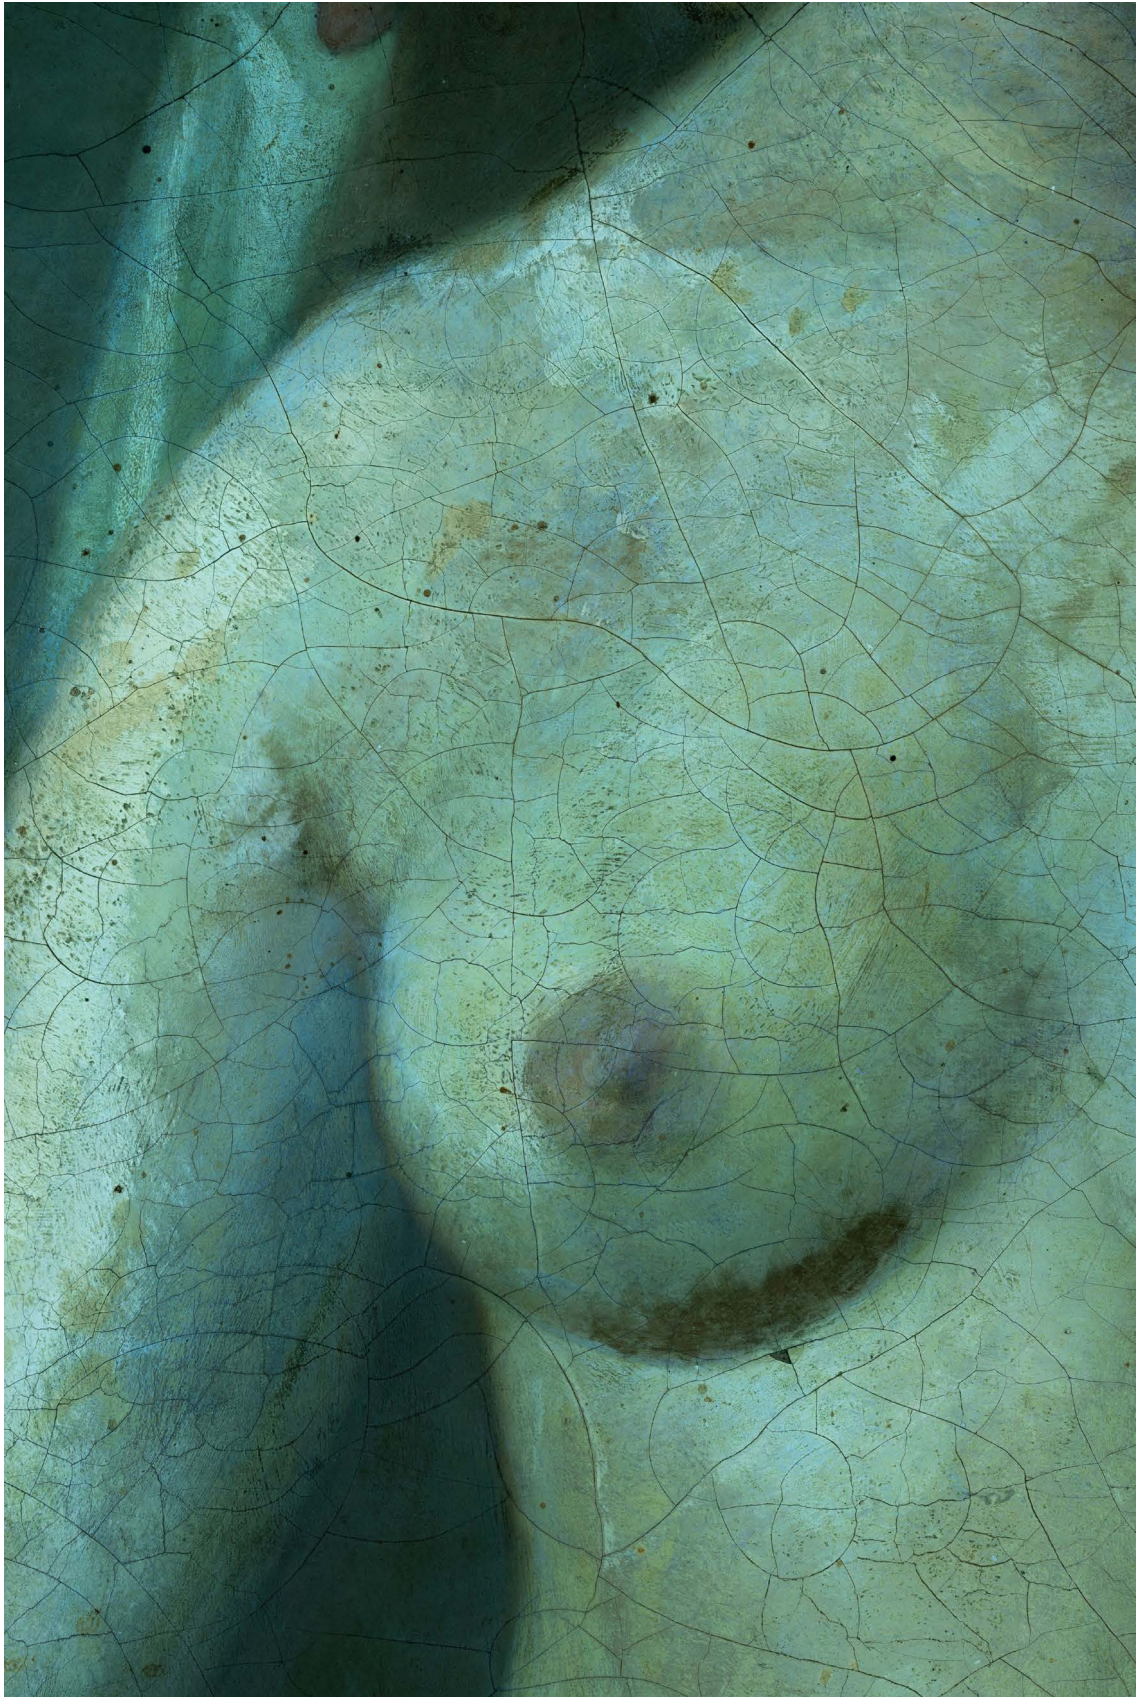
condition after thinning of varnish layer  
photography in day light, detail

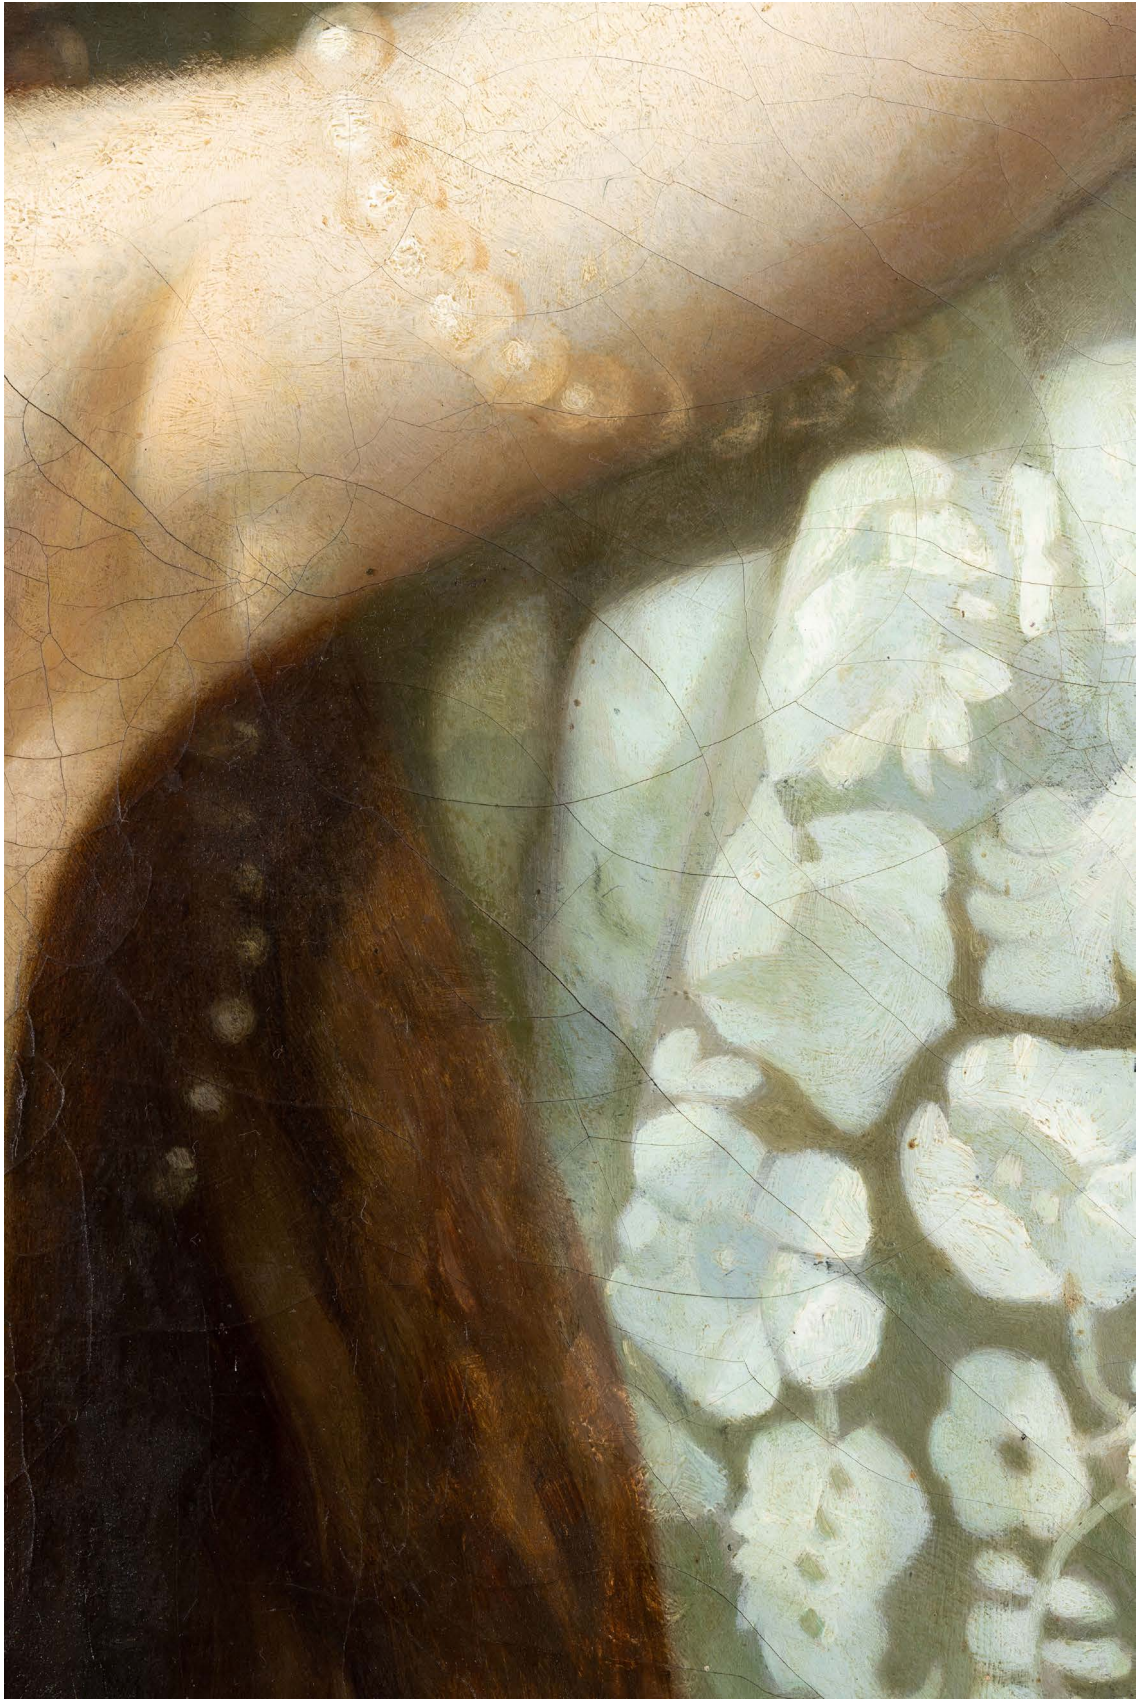
condition after thinning of varnish layer  
photography in UV luminescence, detail

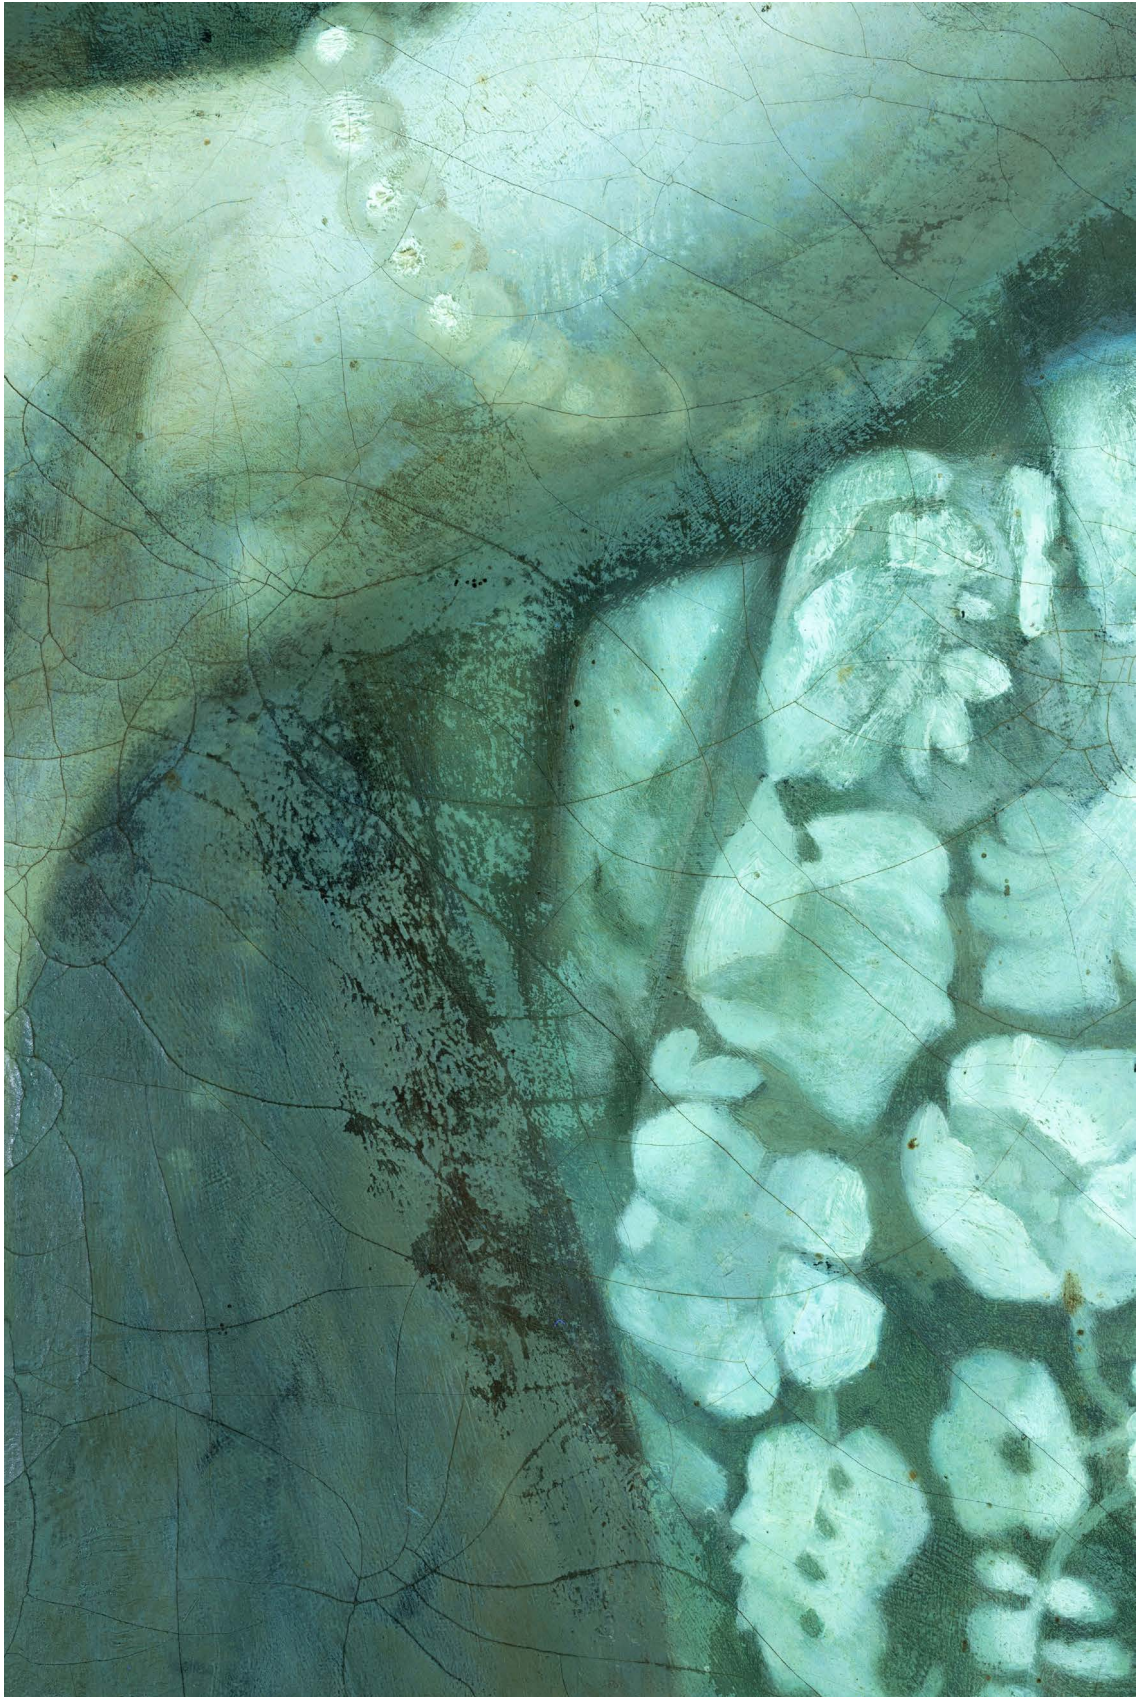
condition after thinning of varnish layer  
photography in day light, detail

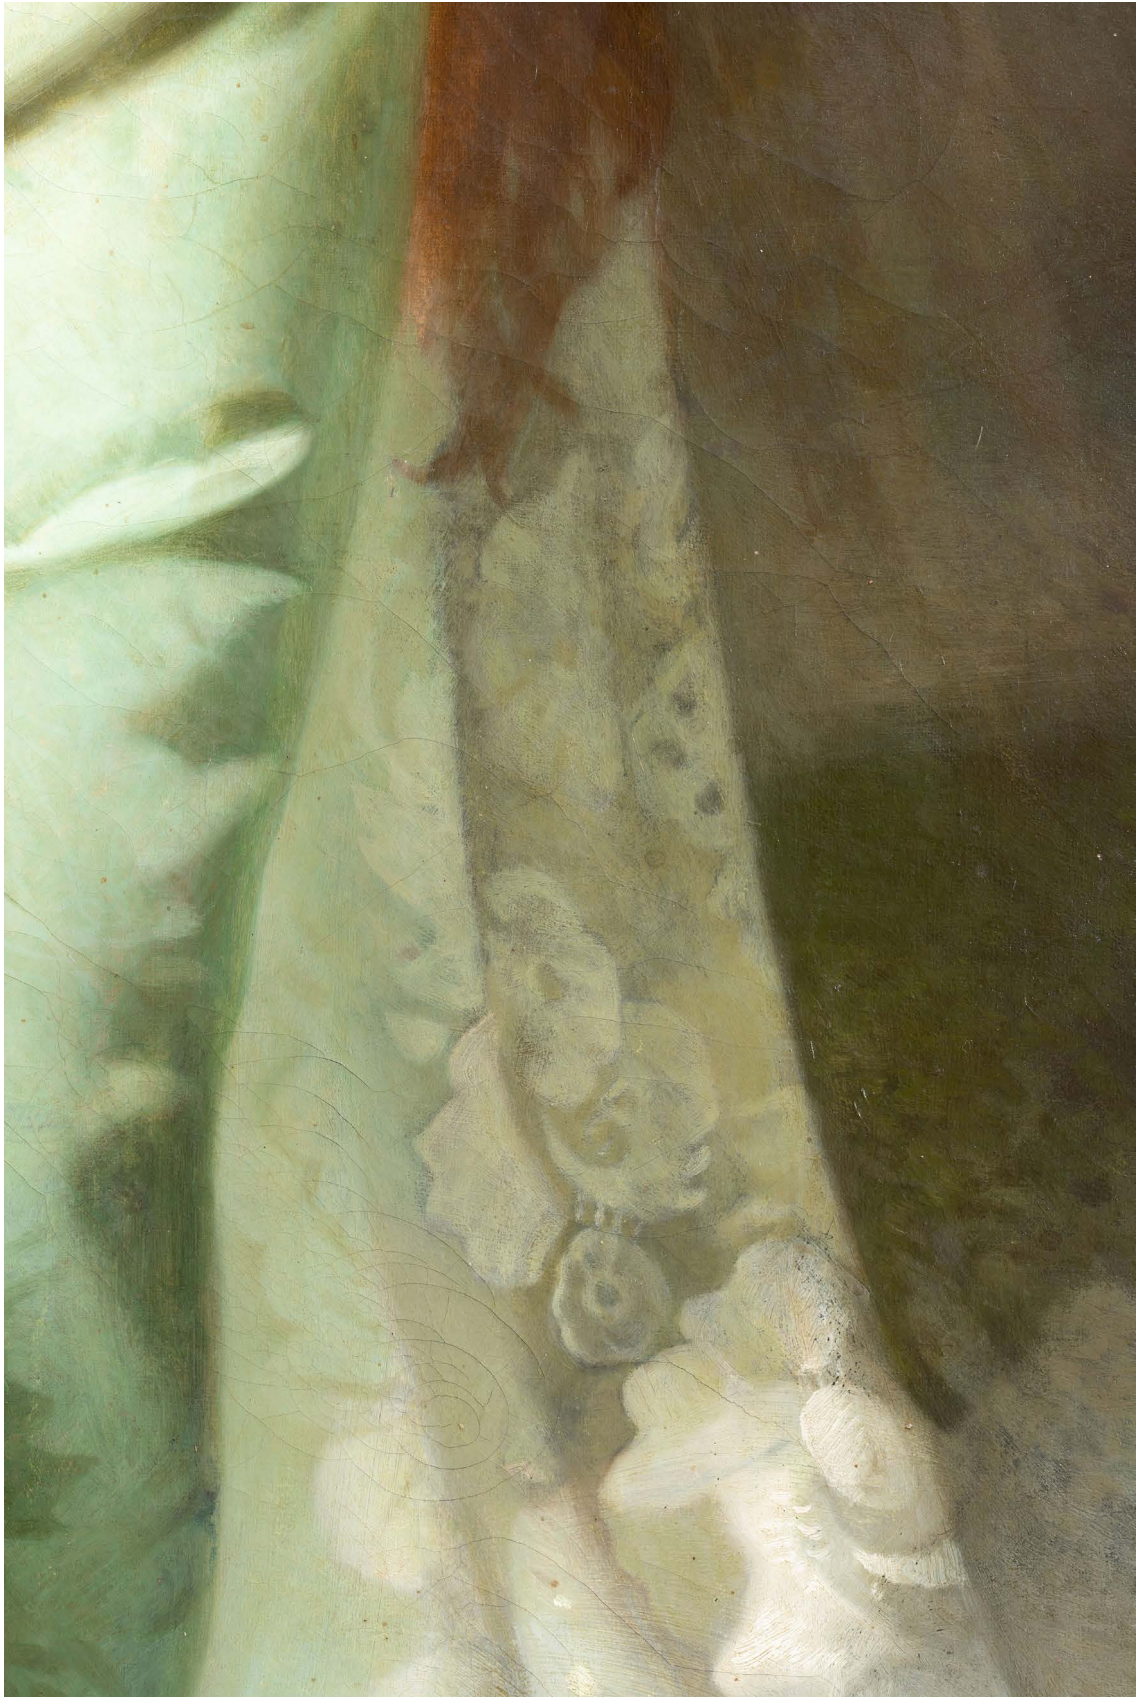
condition after thinning of varnish layer  
photographs in day light and UV luminescence, detail

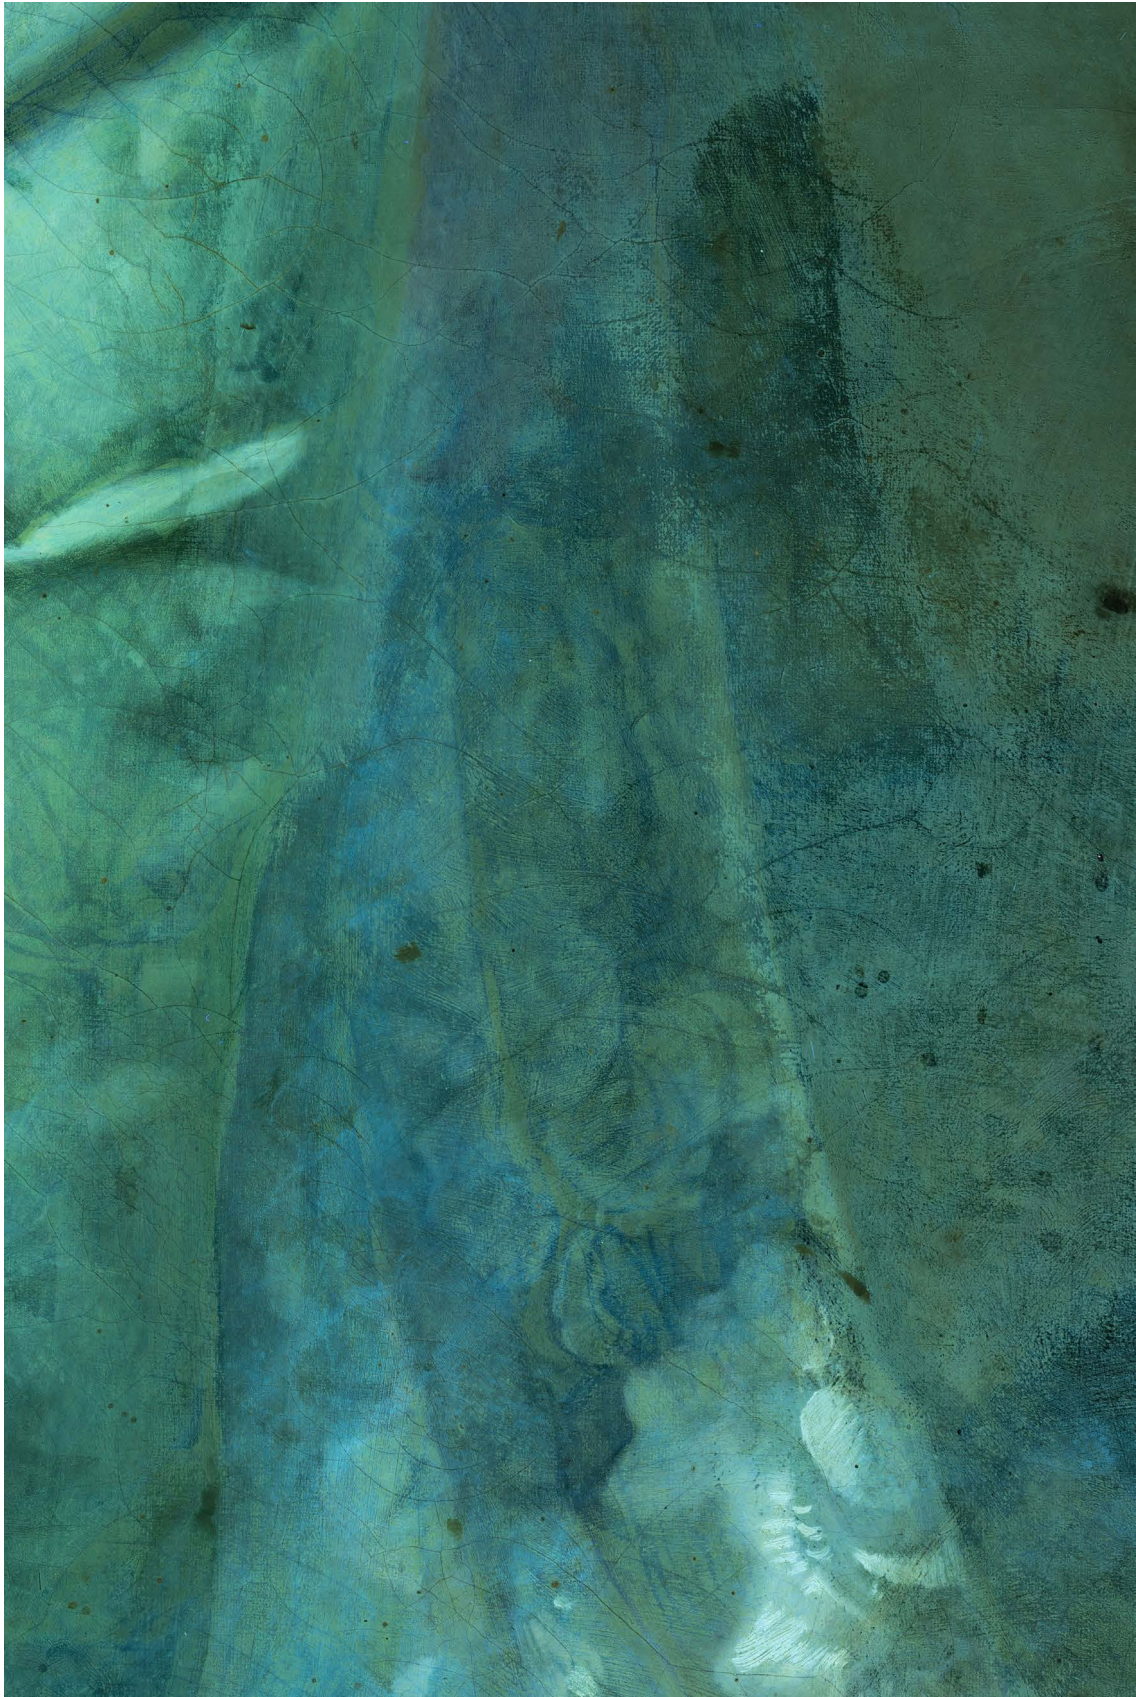
condition after thinning of varnish layer  
photography in day light, detail

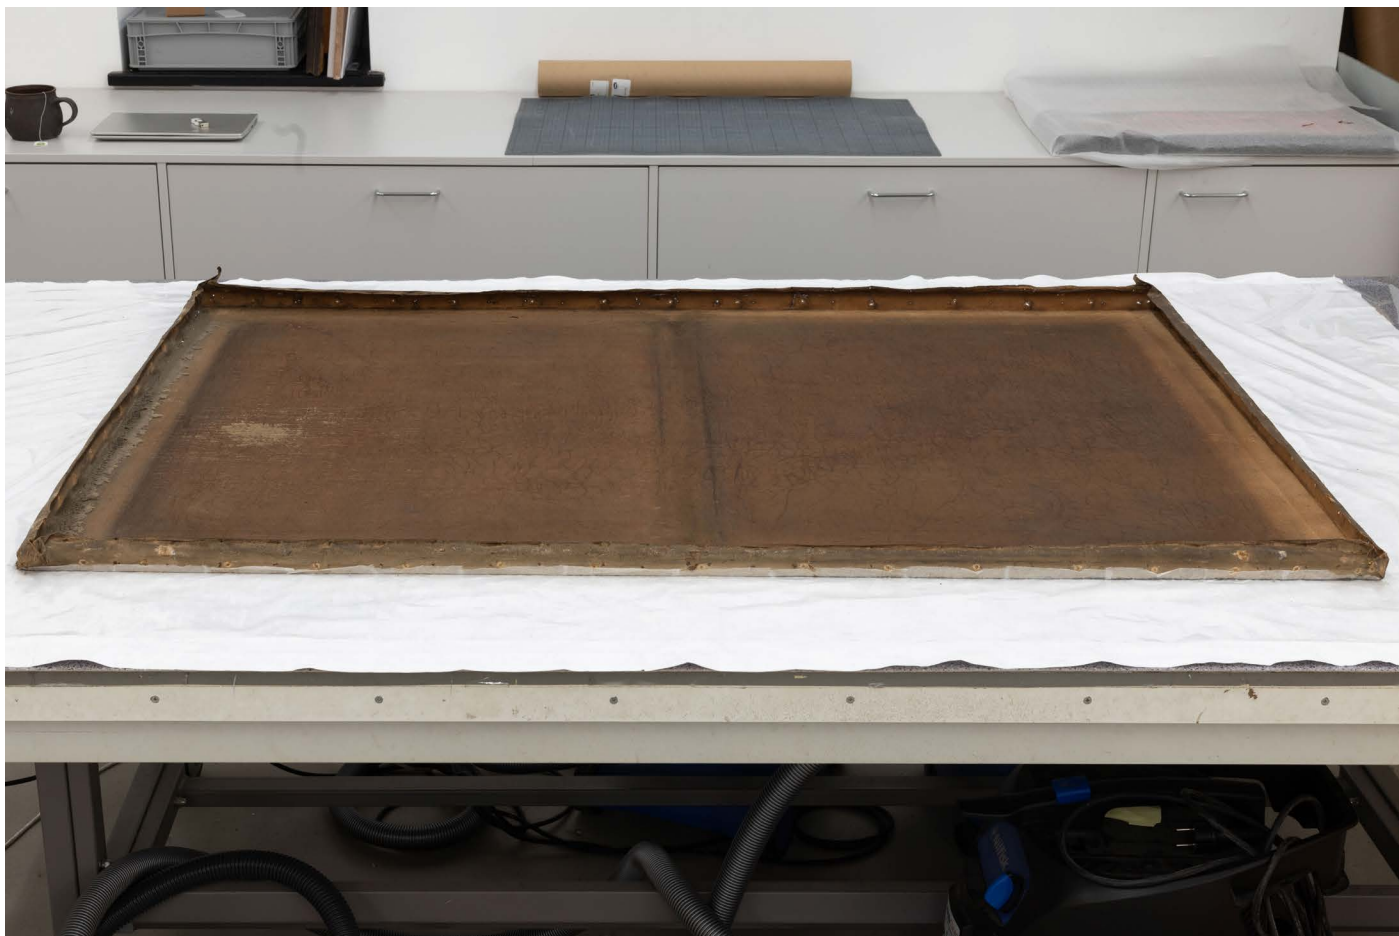
condition after removal from the stretcher  
photography in day light

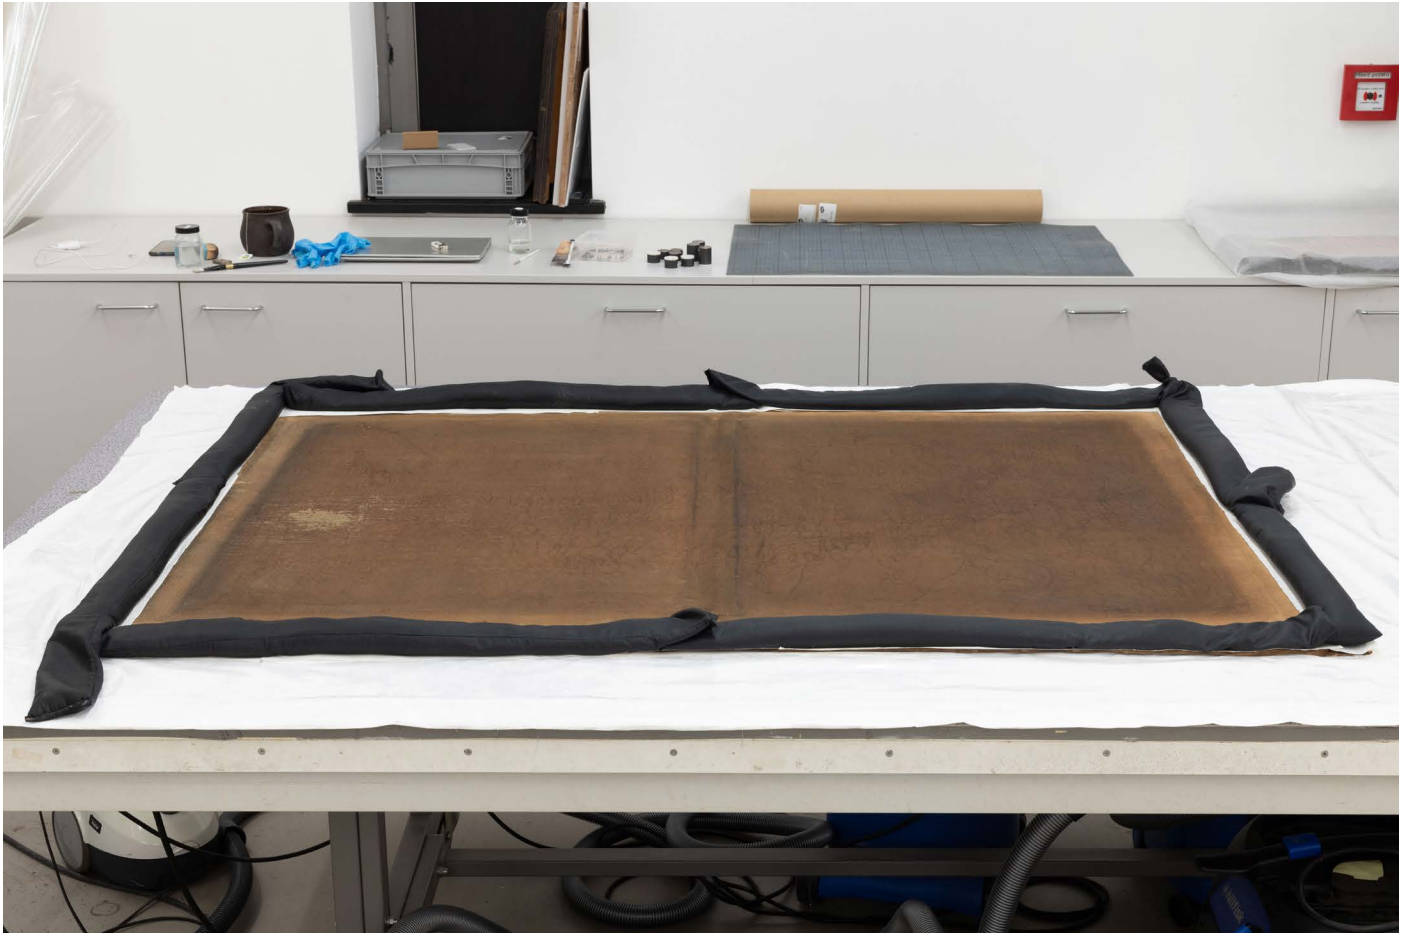
condition after flattening of the edges by local influence of humidity and application of weight  
photography in day light

- The back side of the canvas was cleaned using dry methods (vacuum cleaner, brushes, and sponges) to remove dust residues. The edges of the canvas, which were on the sides of the stretcher bars, were flattened by the application of distilled water to the grooves on the back side of the painting.

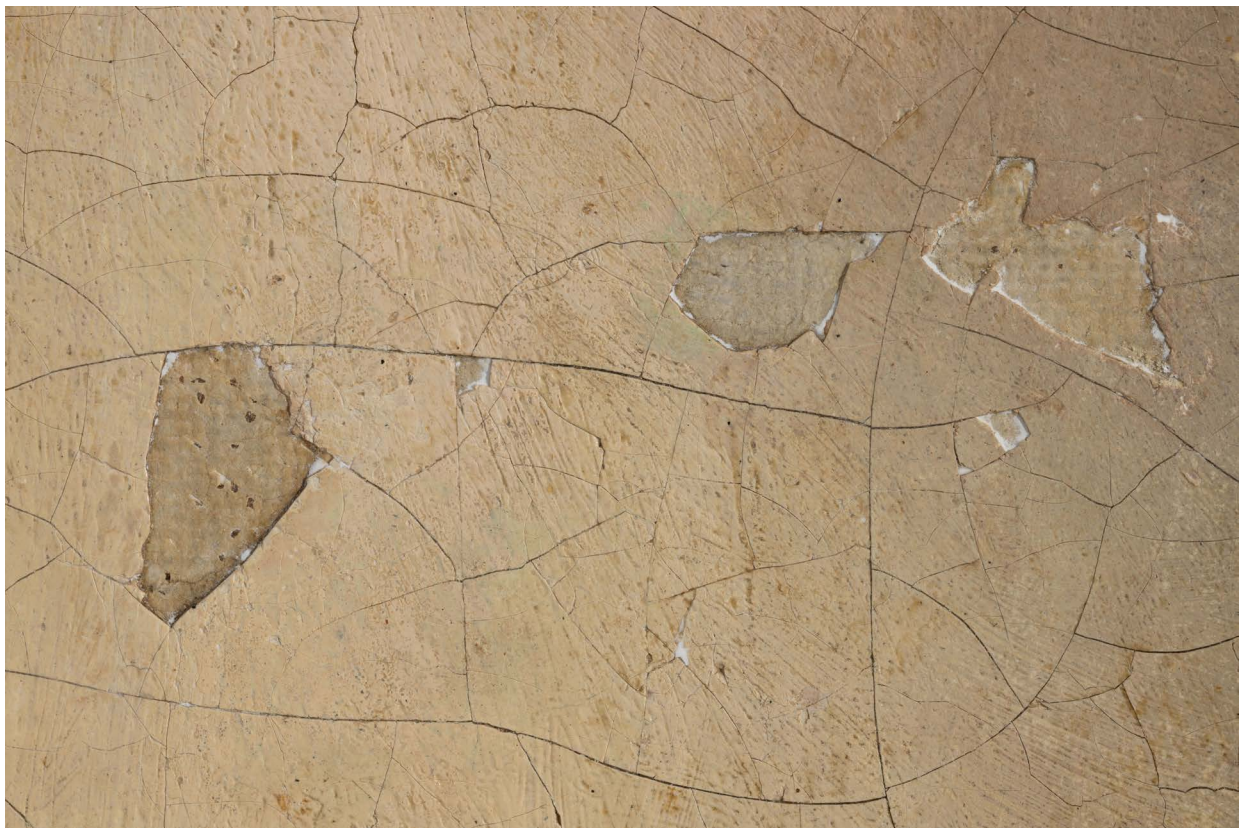
condition after removal of degraded retouching and unsuitable fillers  
details of losses in paint and ground layer of the painting  
photographs in day light

- Several areas of the painting with overpainting and fillers were discovered during the varnish removal. These areas were removed due to color changes and inadequate surface quality. The removal was conducted using isooctane-methyl ethyl ketone-ethanol (proportion 7:2:1) solvent surfactant gel with carbopol.

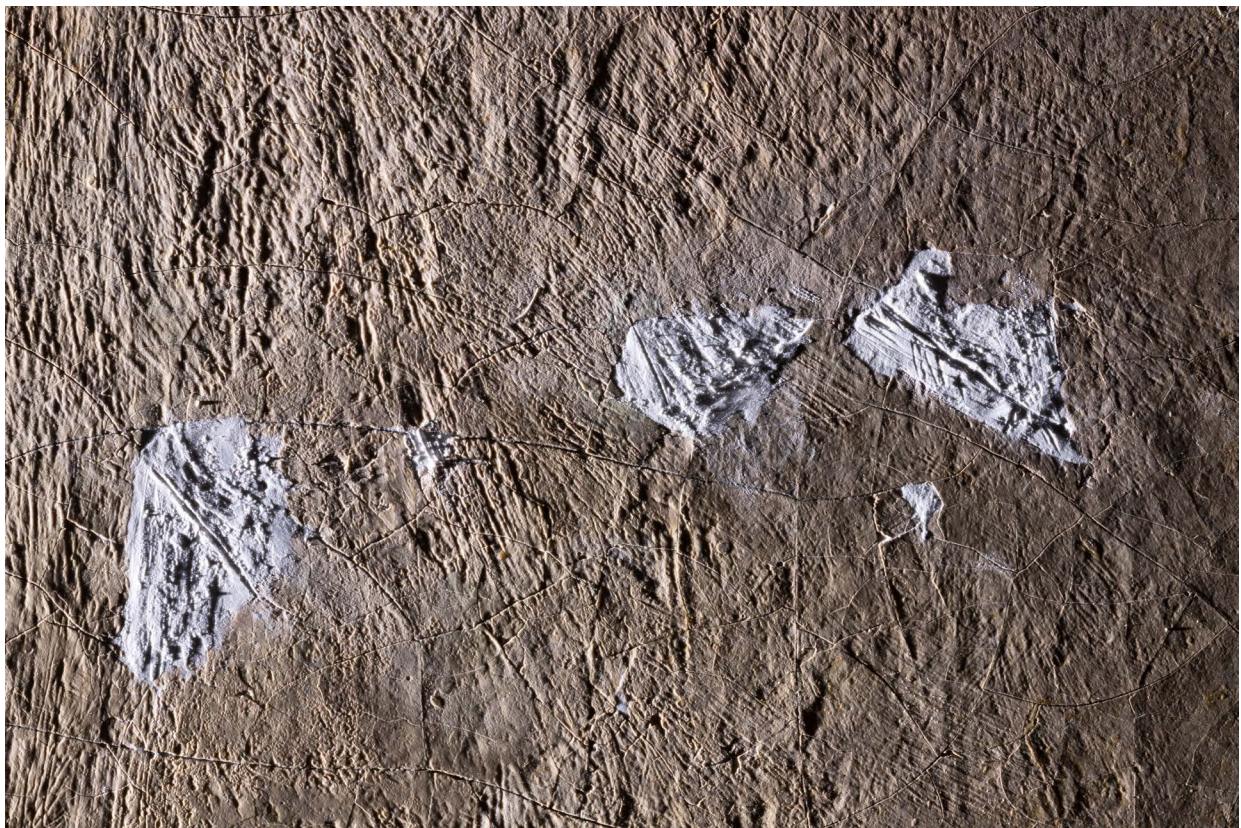
condition after application of fillers inside the defects  
macrophotographs in day and raking light, details

- The temporary fillers were removed, and all the losses were infilled by a filler consisting of Evacon R, tylose, and calcium carbonate with Bolognese chalk (1:1). The surface of the fills was adjusted to imitate the surrounding painting surface by incision and application of fluid filler to achieve an impression of impasto character.
