# RESTORATION TREATMENT REPORT

## THE STORY OF MOSES KAREL JOSEF MORAVINI

wall painting in the interior of chamber in a ground floor of southwest part of castle Kácov  
1730s  
private owner

Alžběta Mirjam Procházková  
Academy of Fine Arts in Prague  
Studio of Restoration of Painted Artworks and Polychrome Sculpture  
akademic years 2022/2023 - 2022/2024

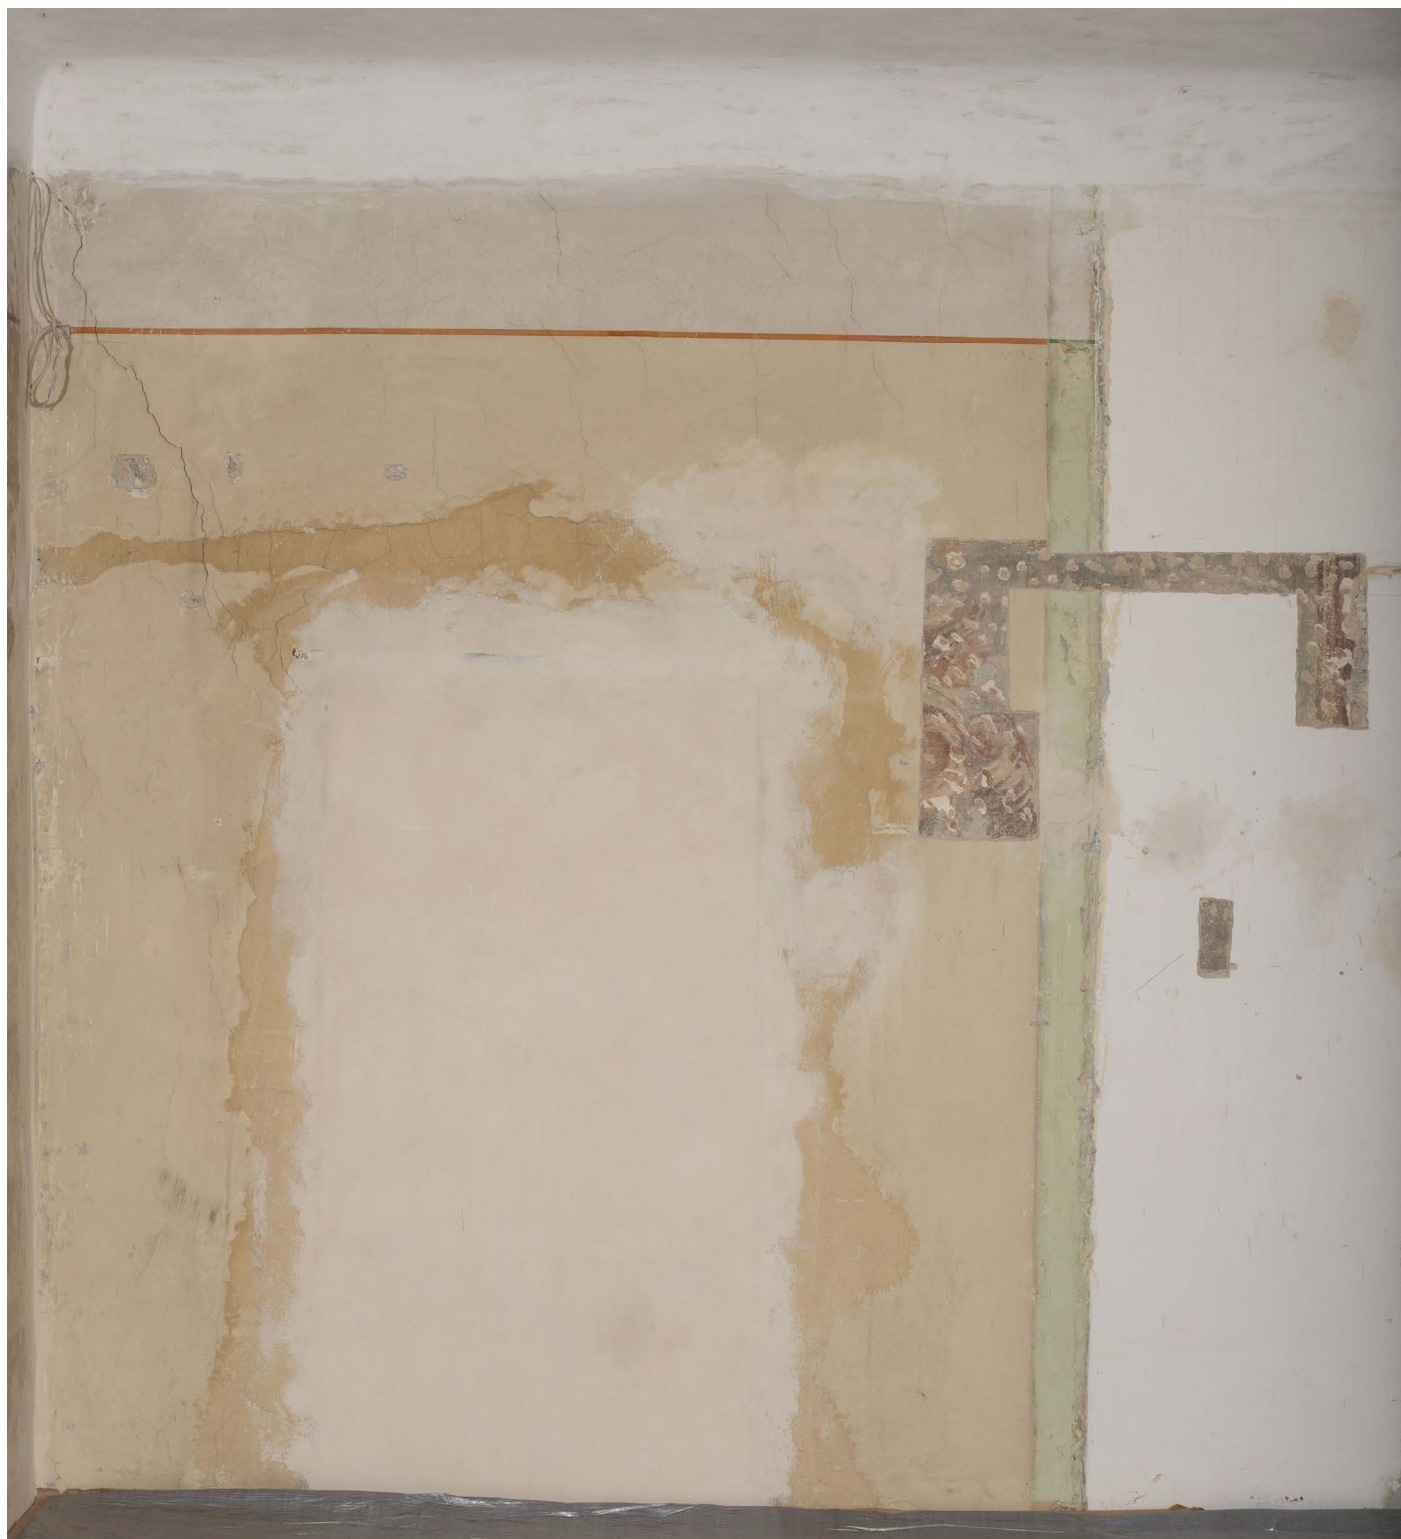
restorated section, north part of south wall of the chamber  
photography in daylight

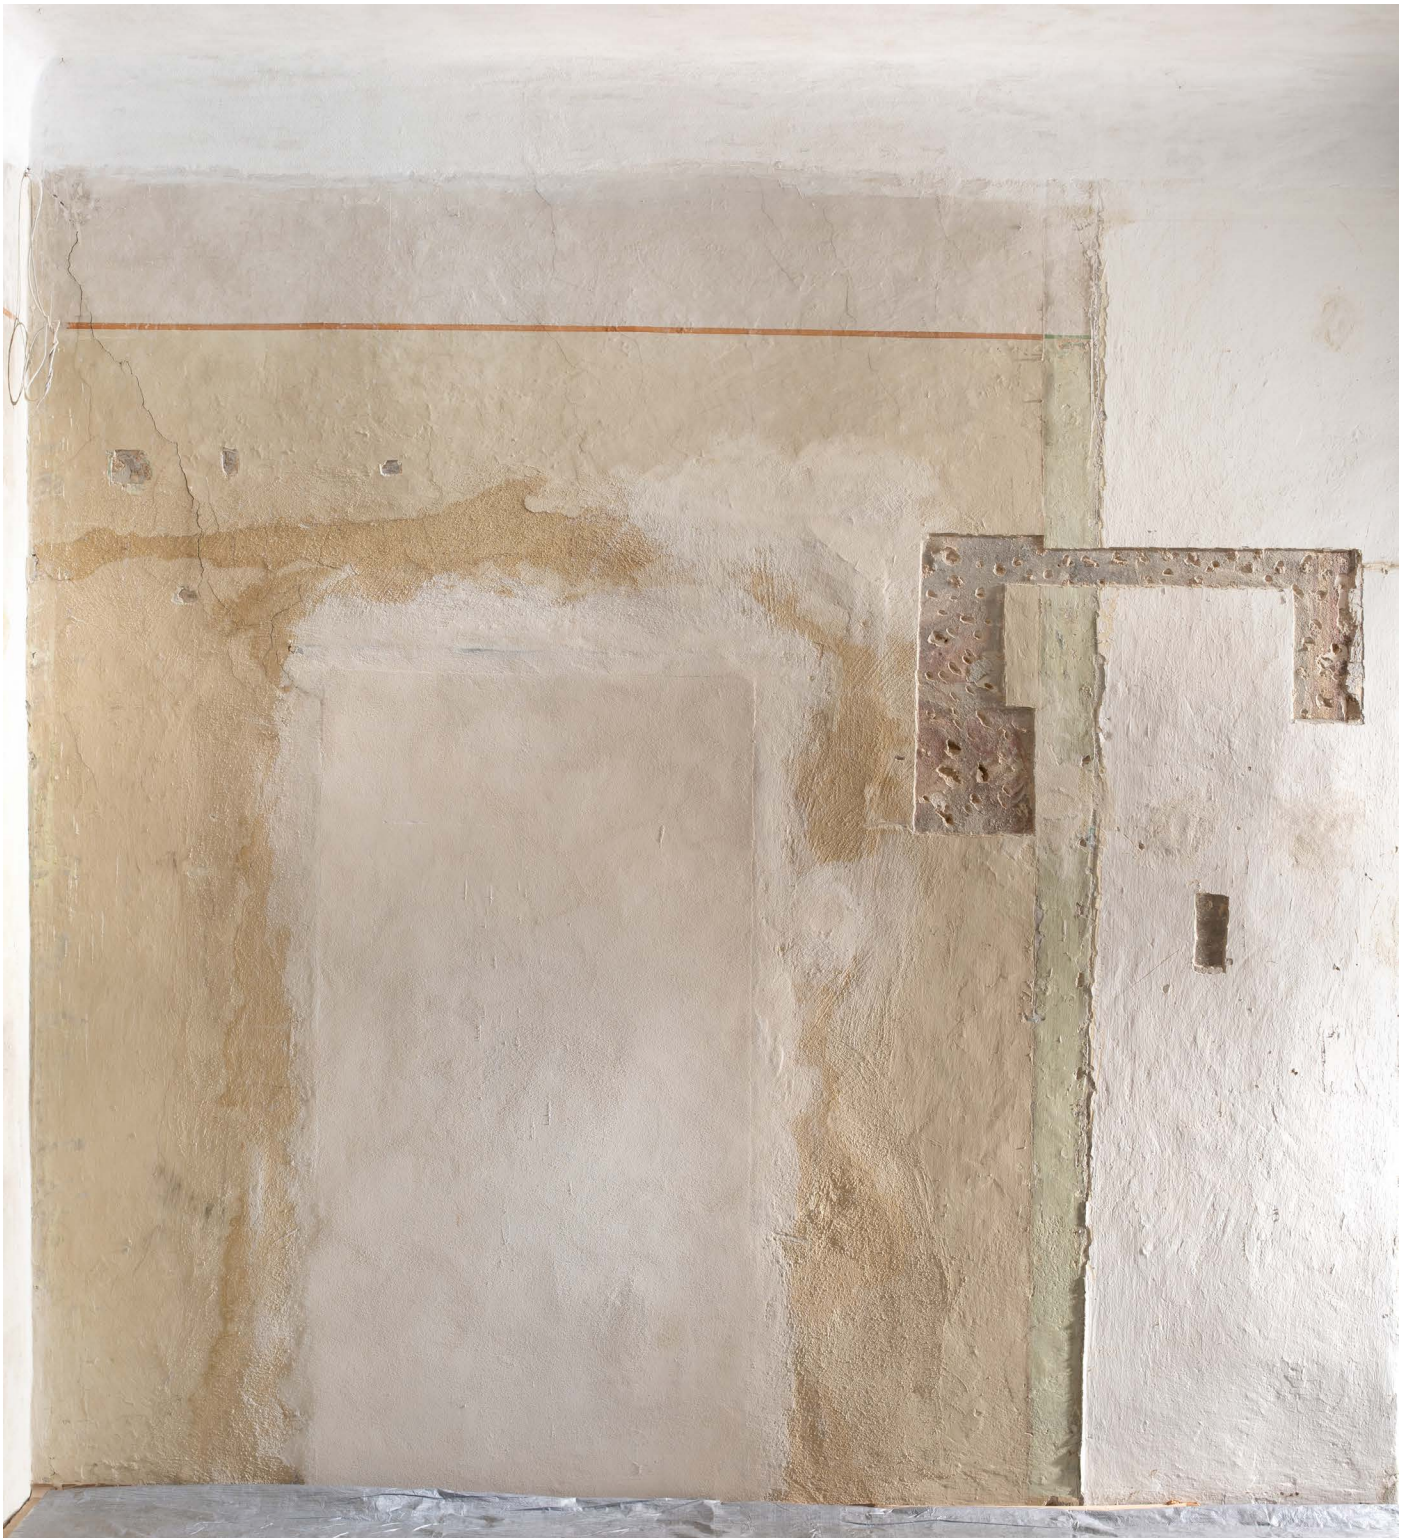
restorated section, north part of south wall of the chamber  
photography in raking light

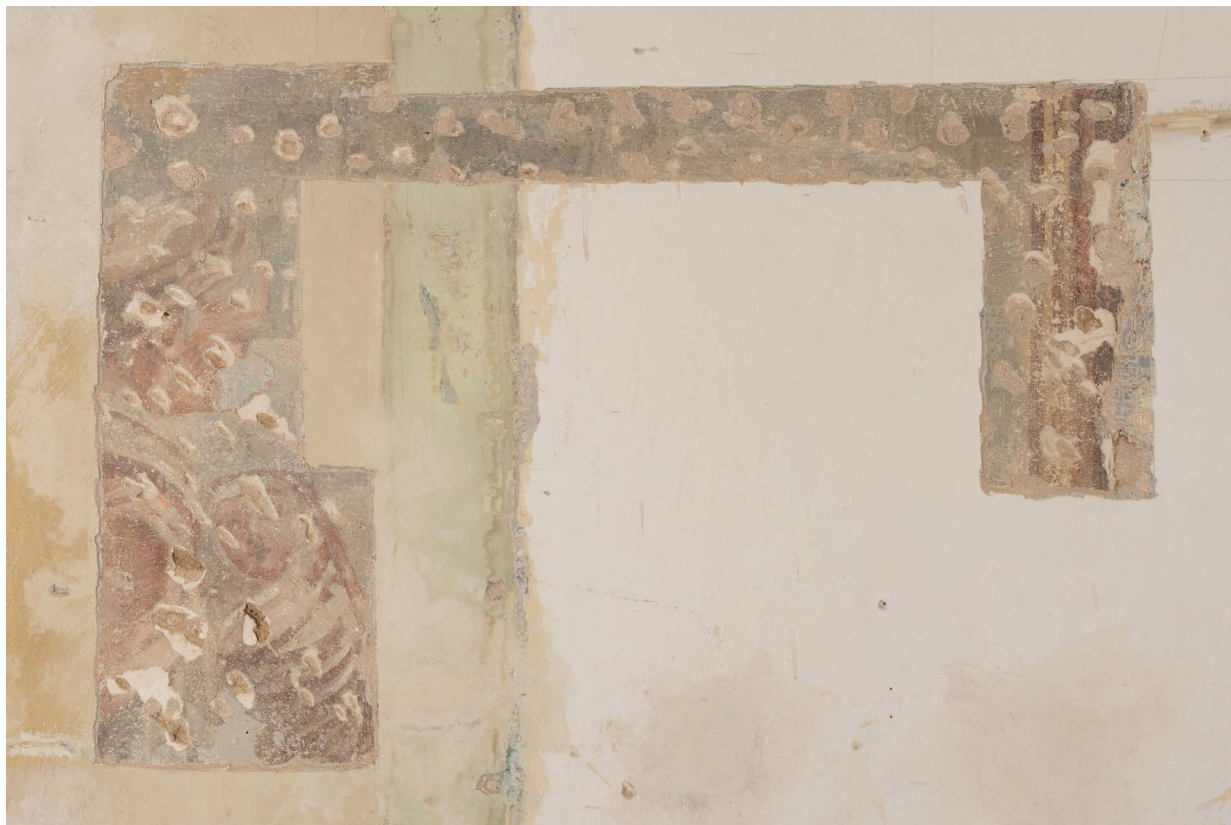
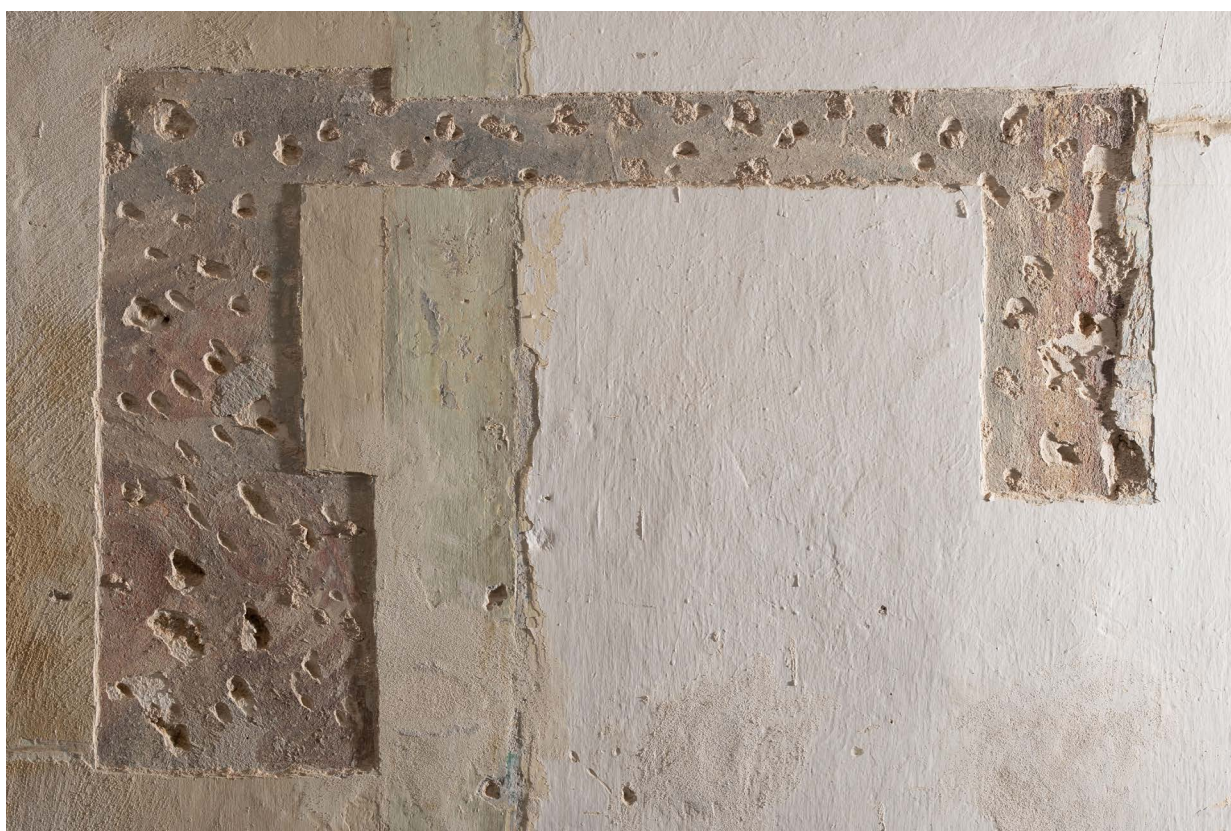
detail of the probe exposing the original painted plaster layer made during technological building survey by different restorer  
photographs in day and raking light

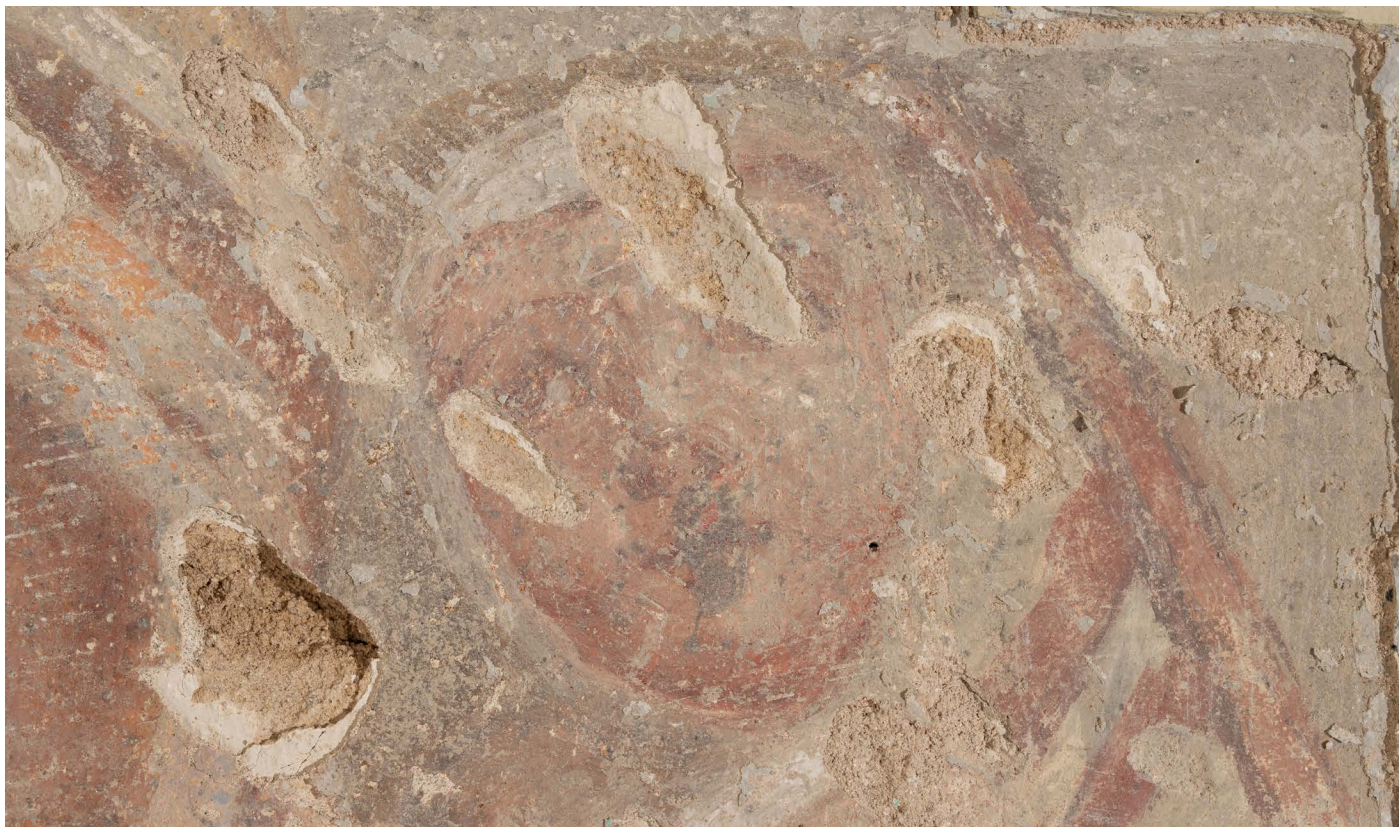
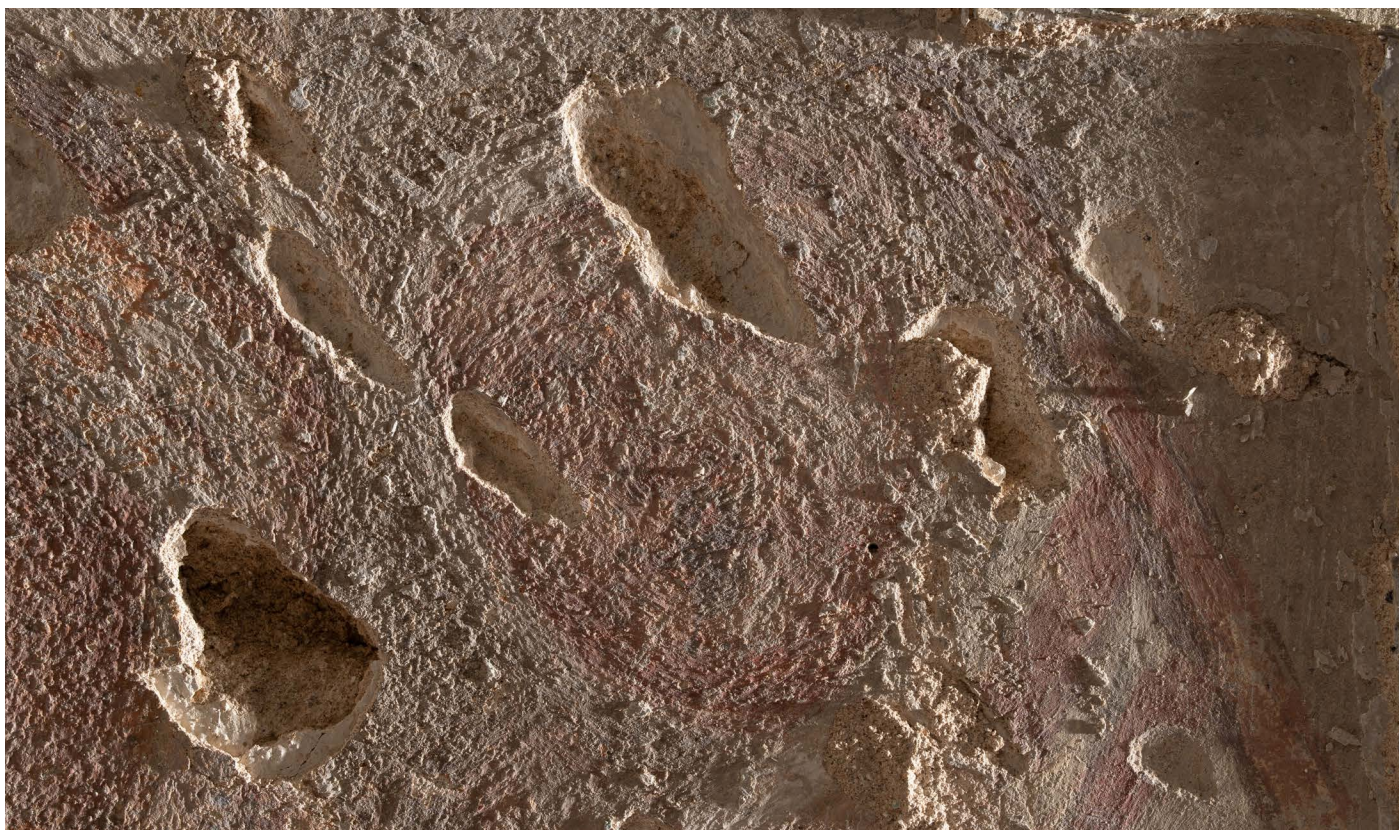
detail of the original painting inside the probe made during technological building survey by different restorer  
macrophotographs in day and raking light

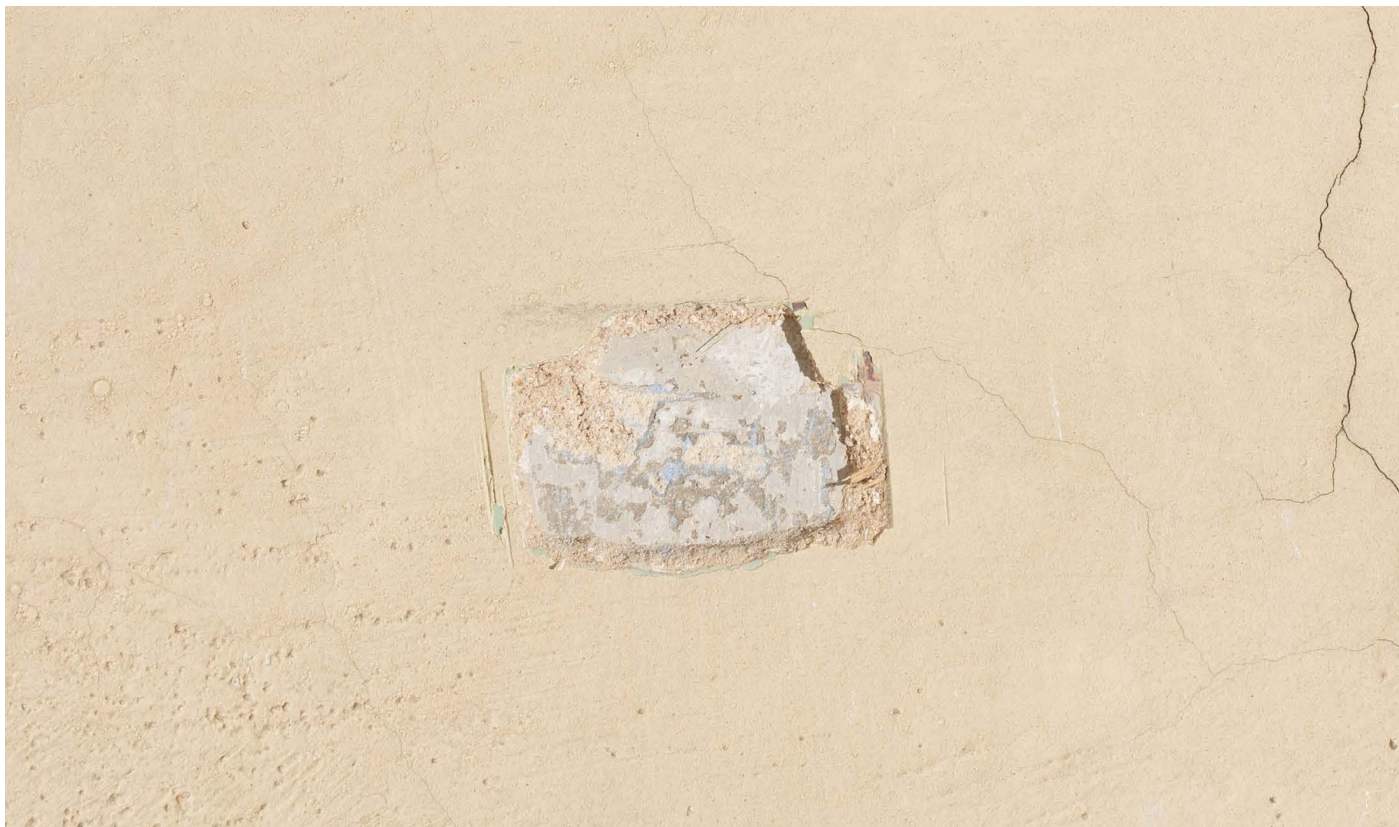
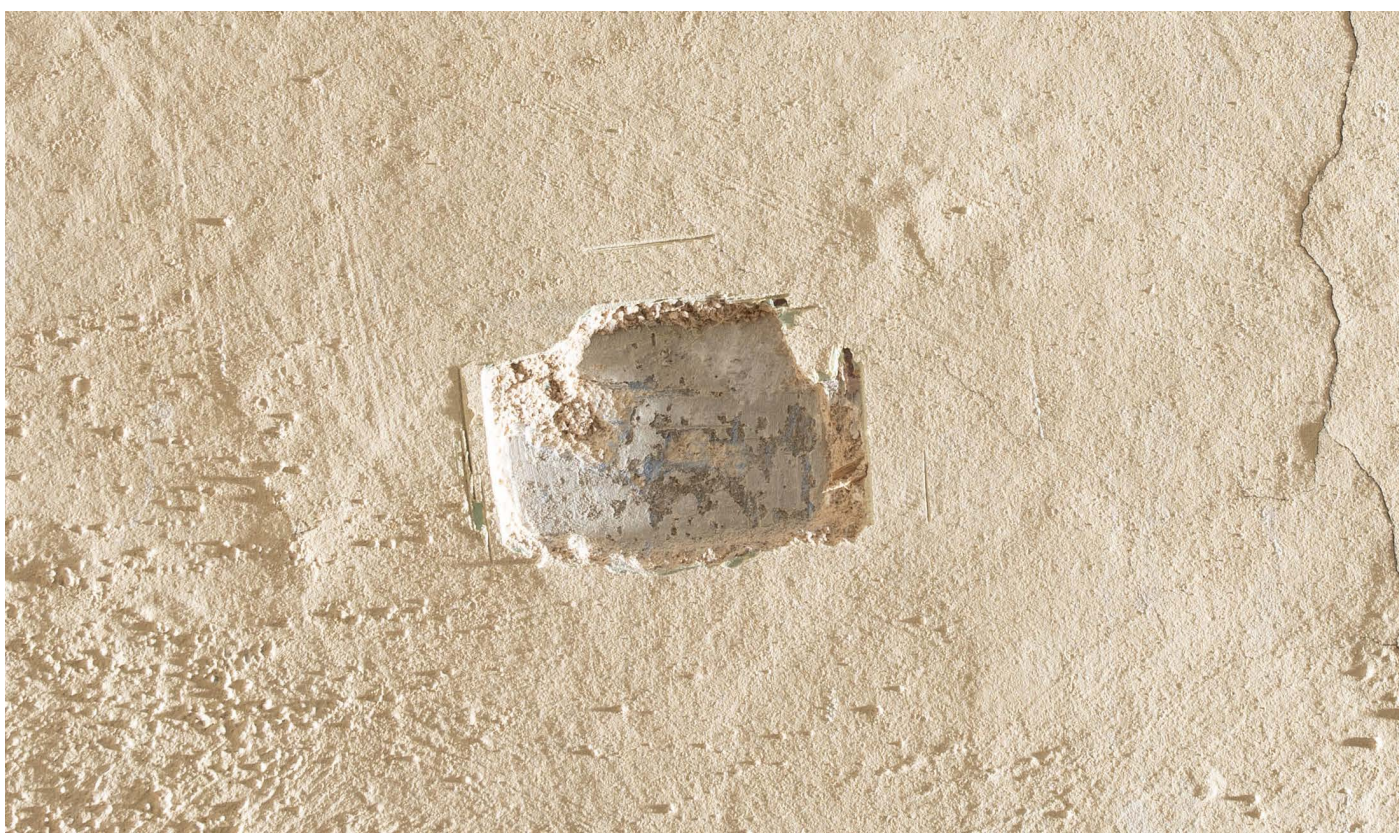
details of probe exposing the original painted plaster layer partially covered by the second oldest layer made during technological building survey by different restorer  
macrophotographs in day and raking light

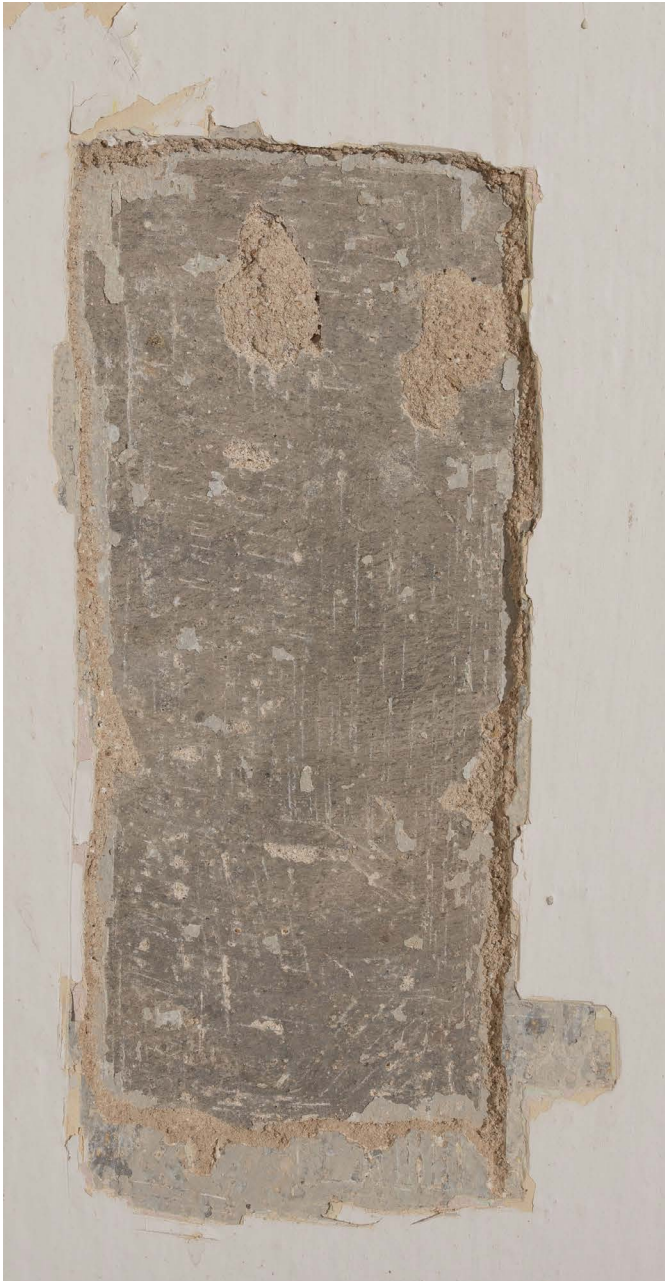
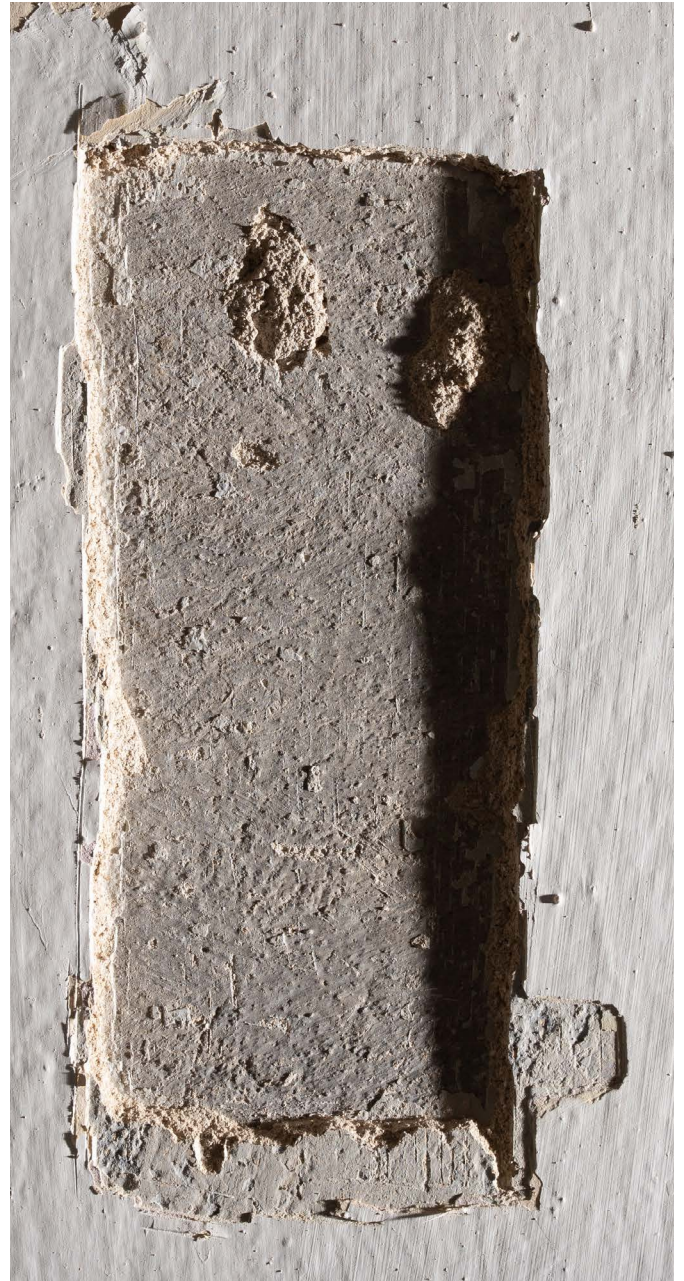
detail of the probe exposing the original painted plaster layer made during technological building survey by different restorer  
macrophotographs in day and raking light

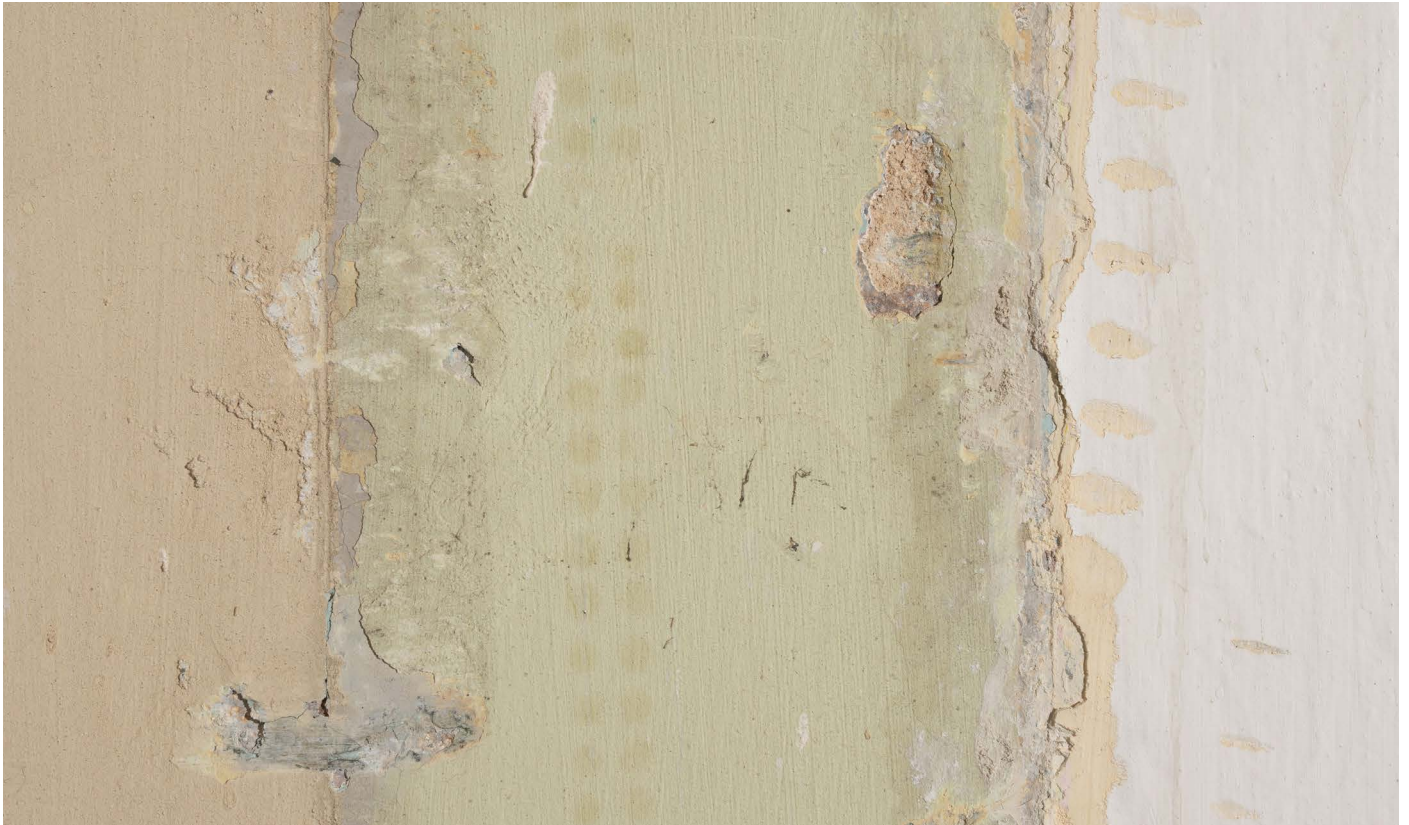
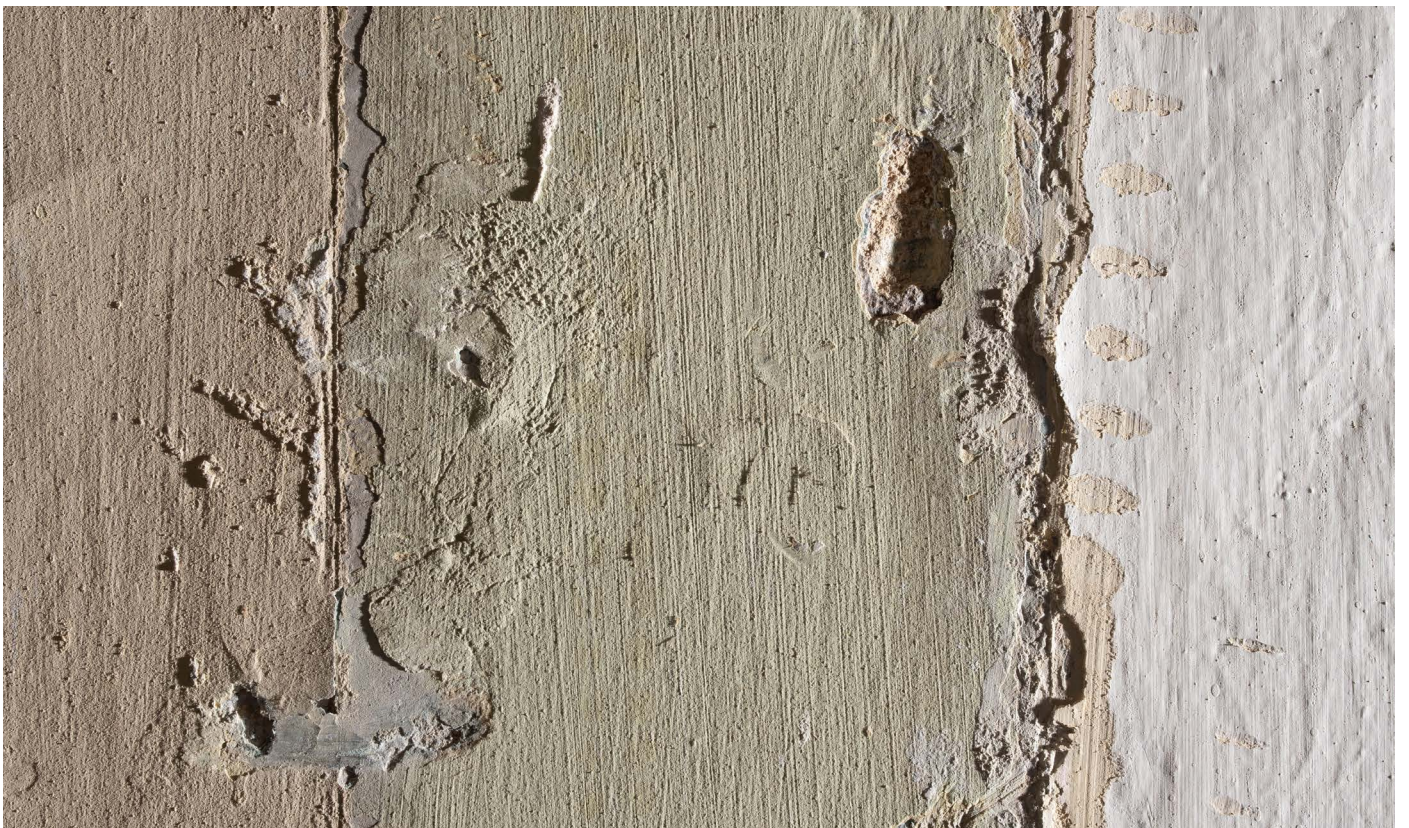
detail of the modern clay plaster layers  
macrophotographs in day and raking light

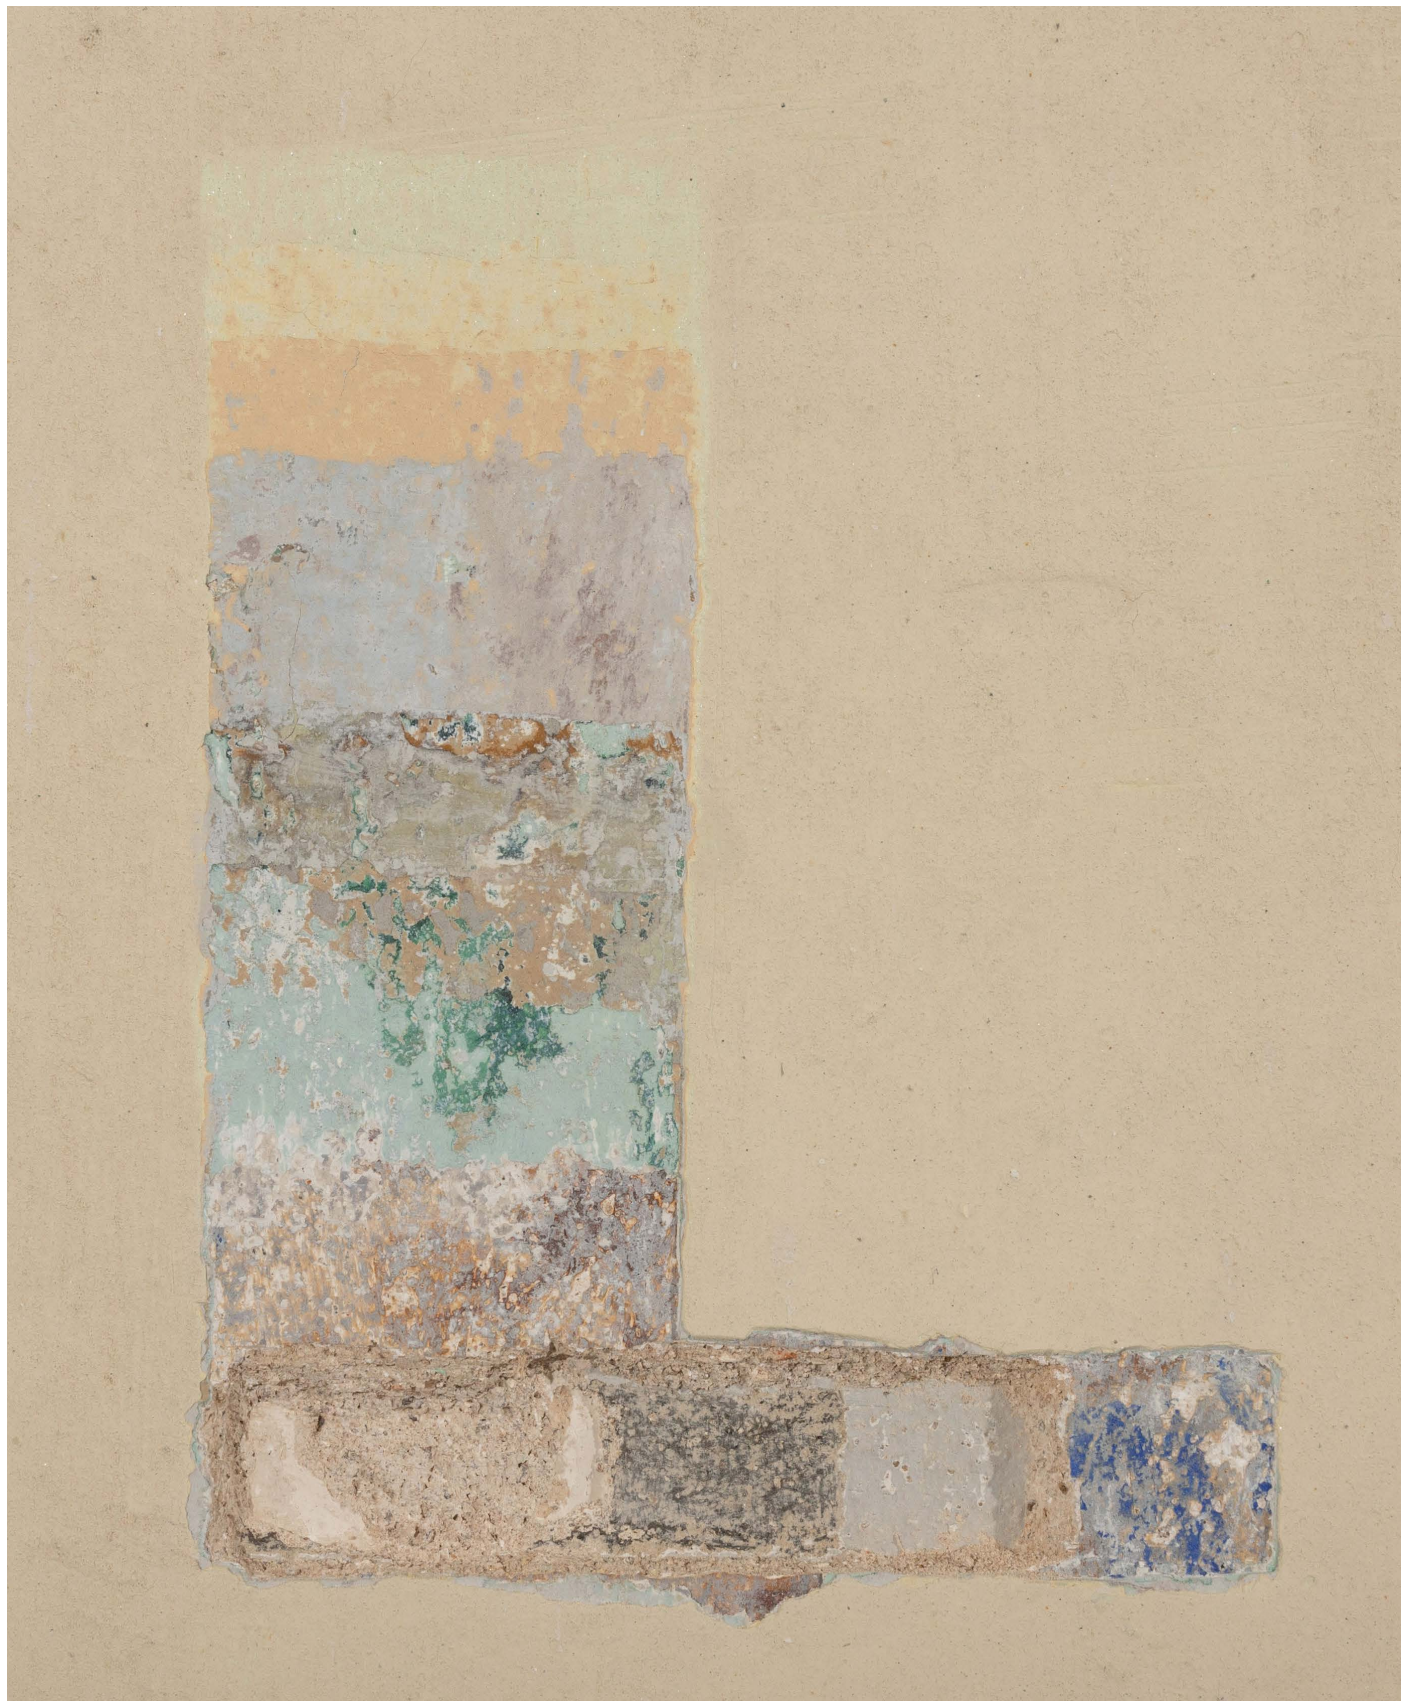
stratigraphic probe exposing all layers of plaster on the particular part of the wall  
macrophotography in day light

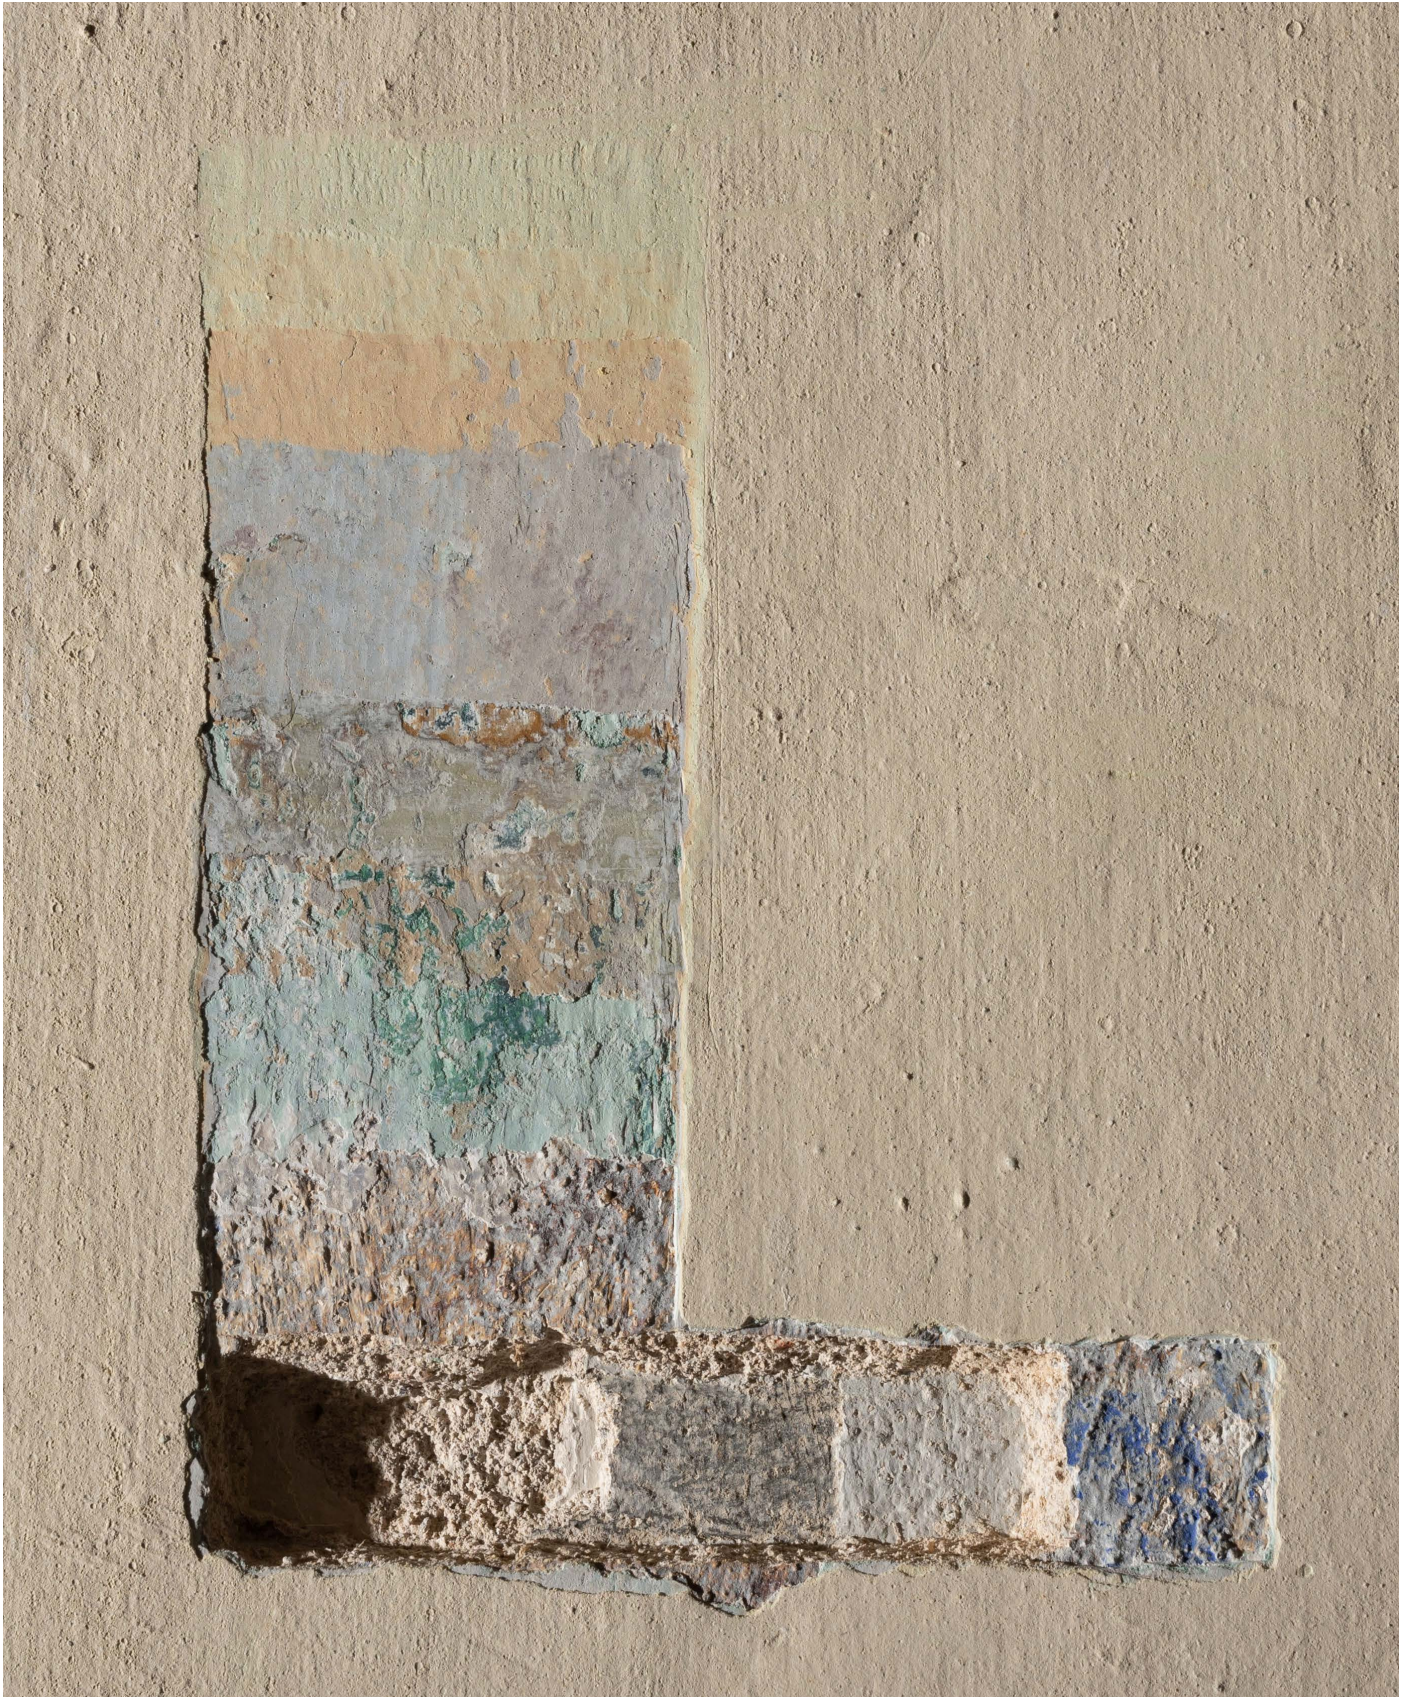
stratigraphic probe exposing all layers of plaster on the particular part of the wall  
macrophotography in raking light

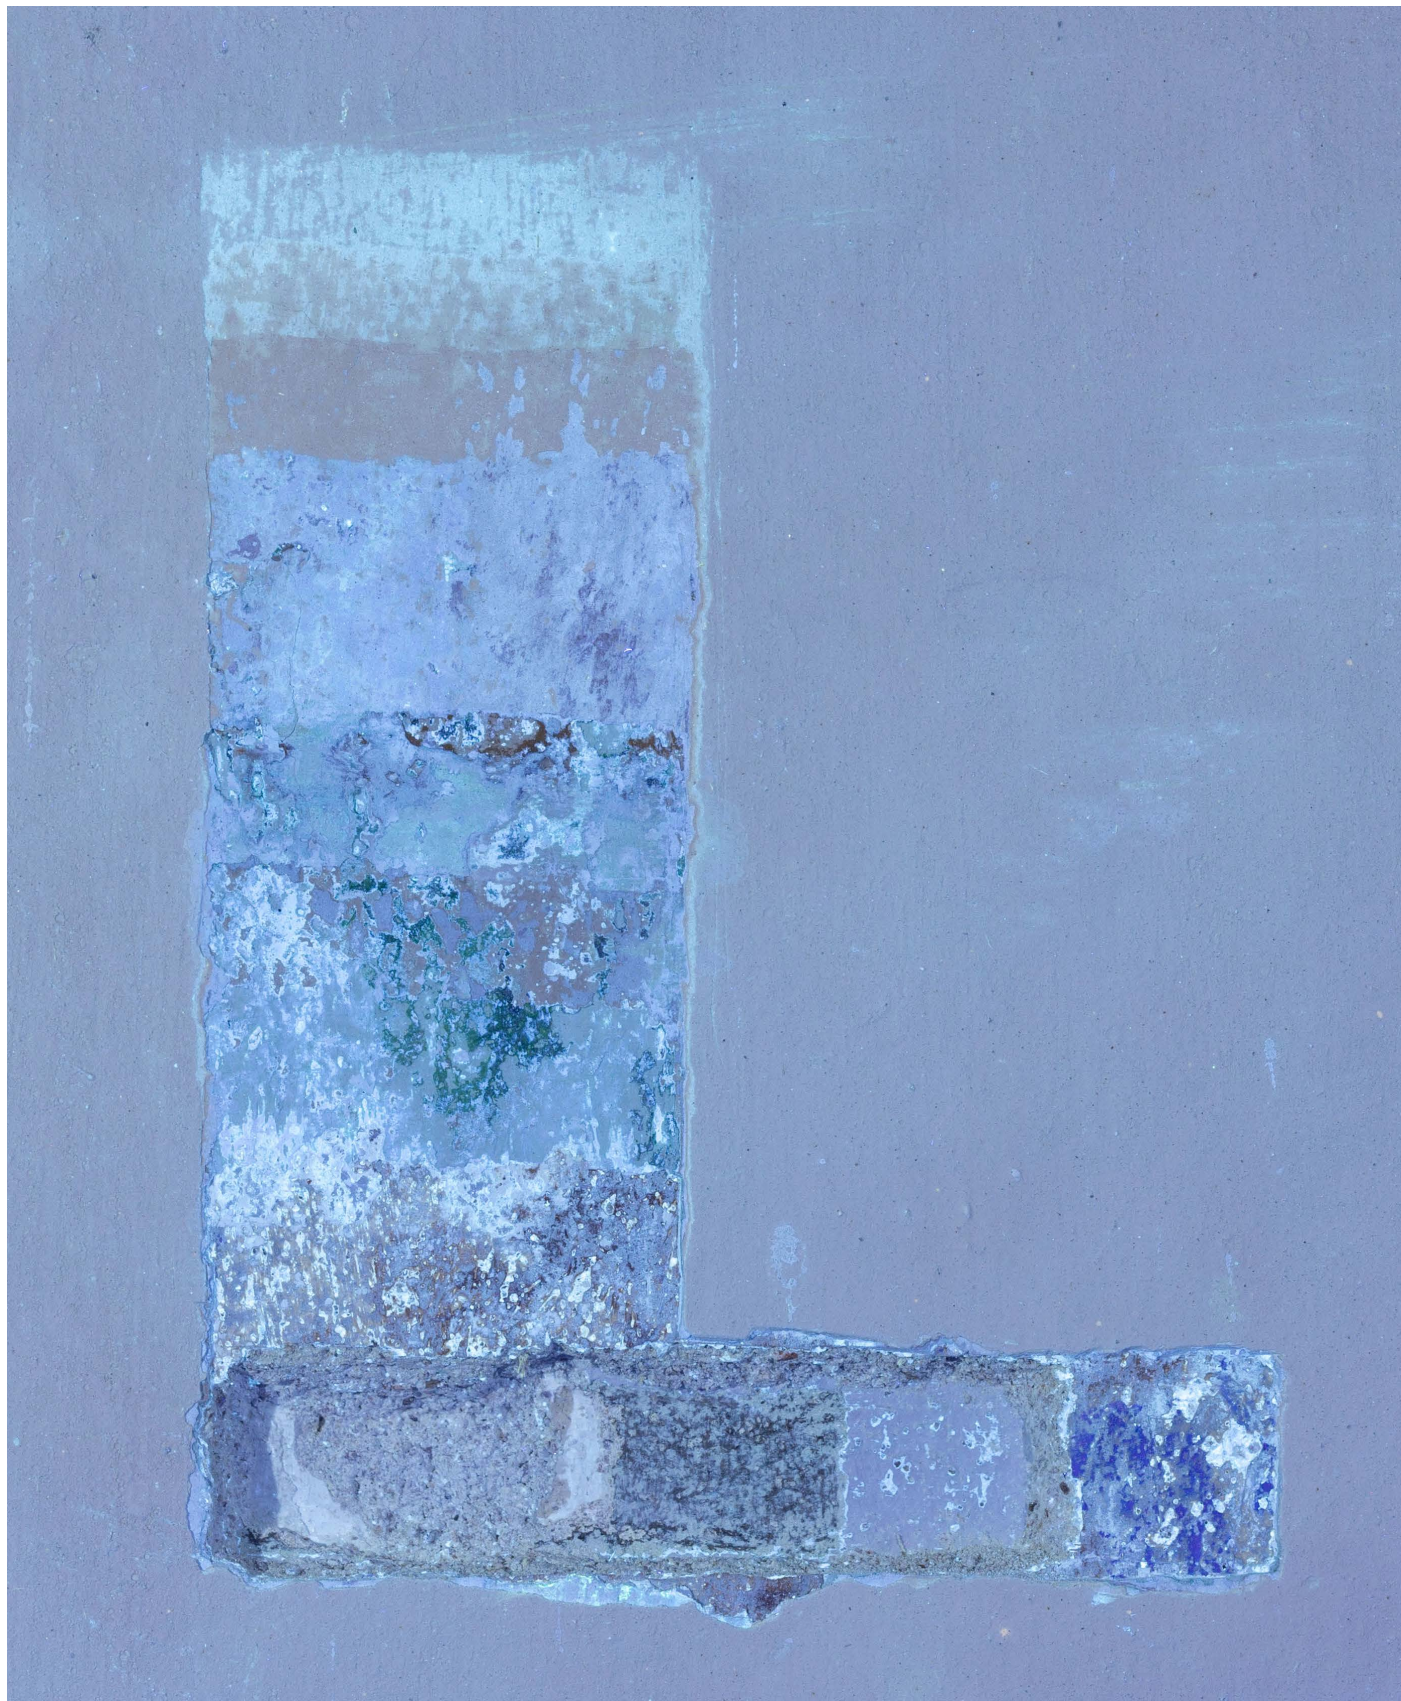
stratigraphic probe exposing all layers of plaster on the particular part of the wall  
macrophotography in UV luminescence
