# RESTORATION TREATMENT REPORT

## THE STORY OF MOSES KAREL JOSEF MORAVINI

wall painting in the interior of chamber in a ground floor of southwest part of castle Kácov  
1730s  
private owner

Alžběta Mirjam Procházková  
Academy of Fine Arts in Prague  
Studio of Restoration of Painted Artworks and Polychrome Sculpture  
akademic years 2022/2023 - 2022/2024

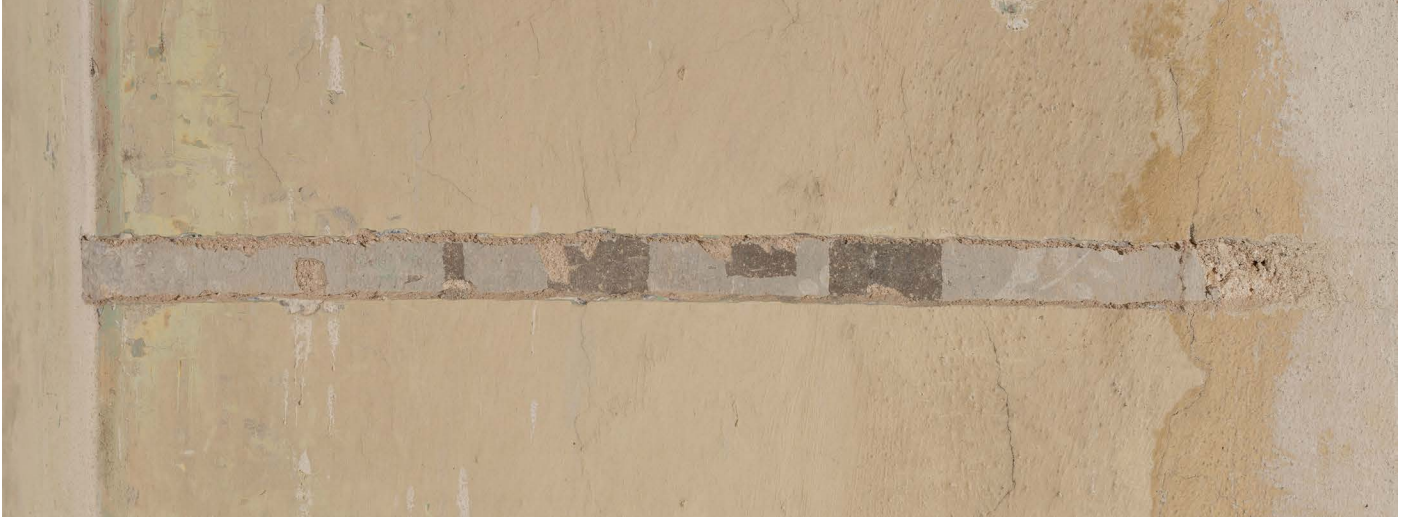
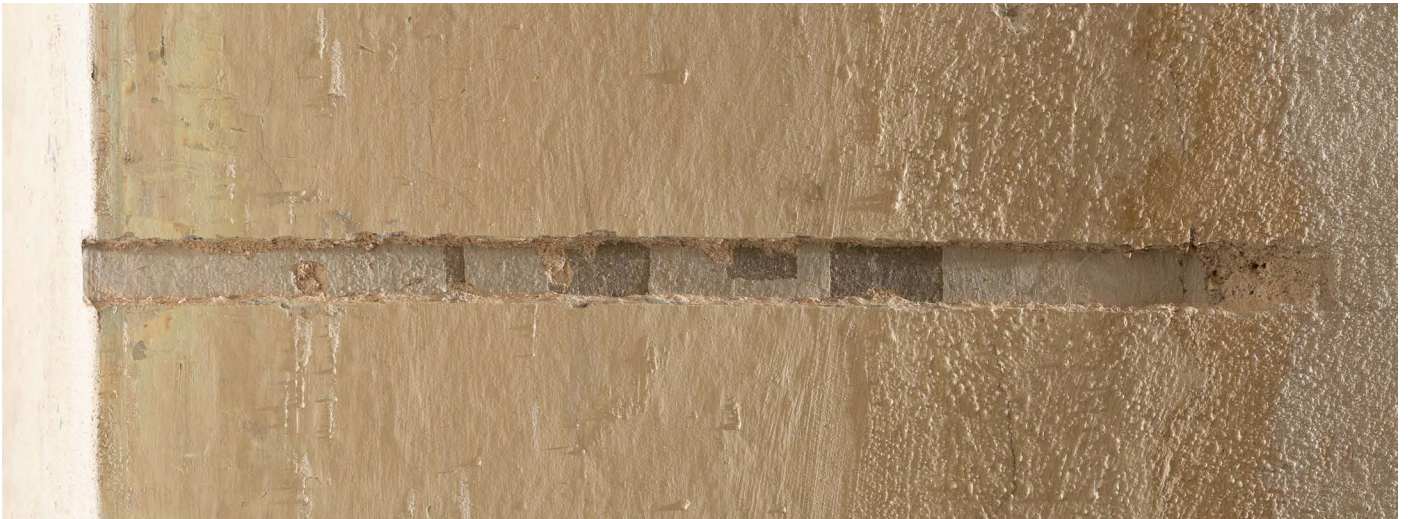
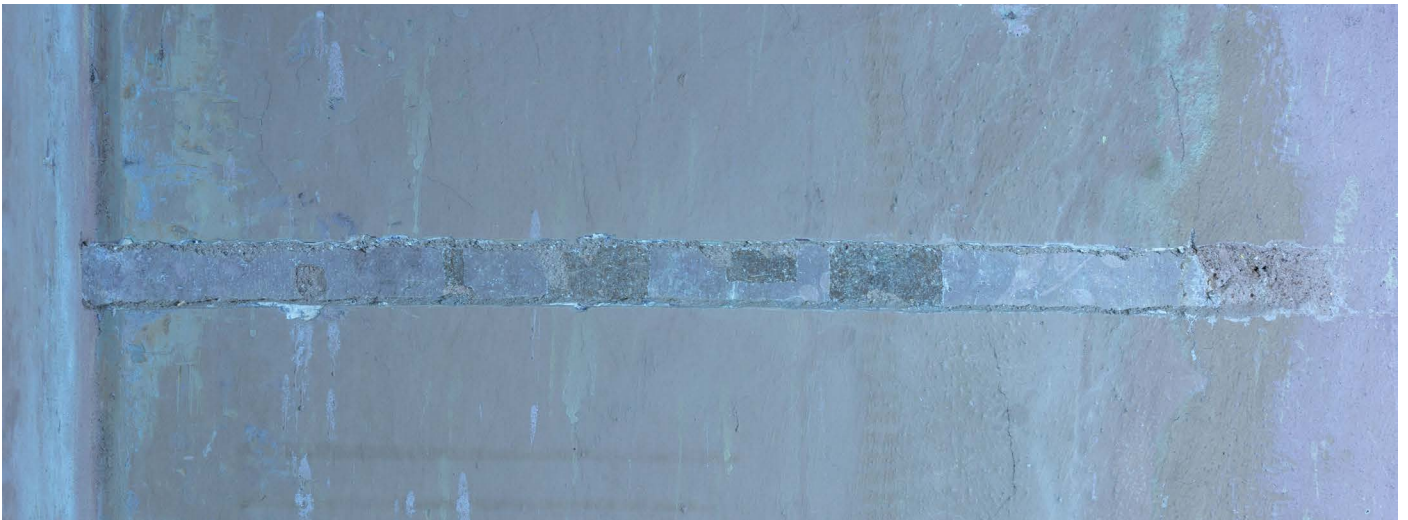
strip probe exposing the original painted plaster layer partially covered by second oldest plaster layer indicating the dimensions of the walled door  
macrophotographs in day and raking light and in UV luminescence

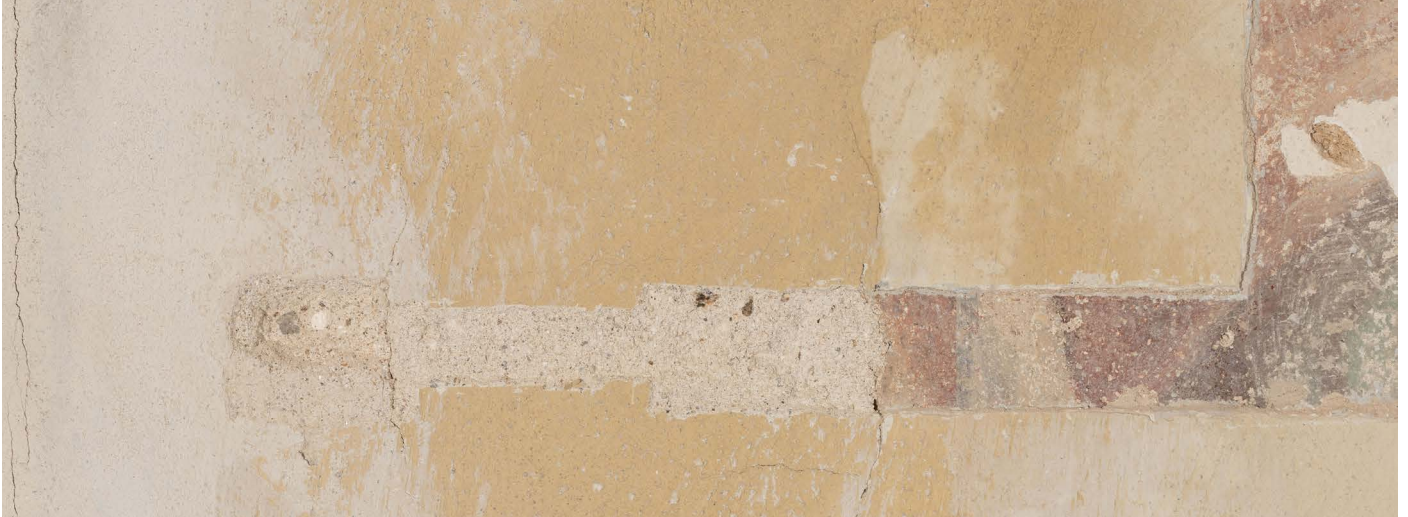
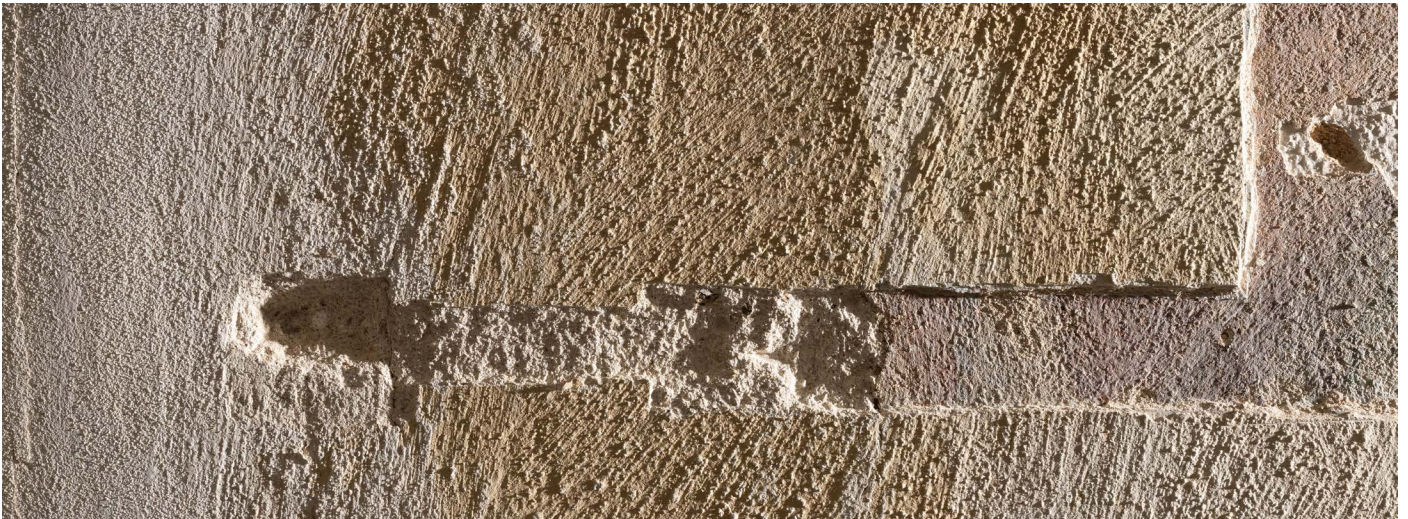
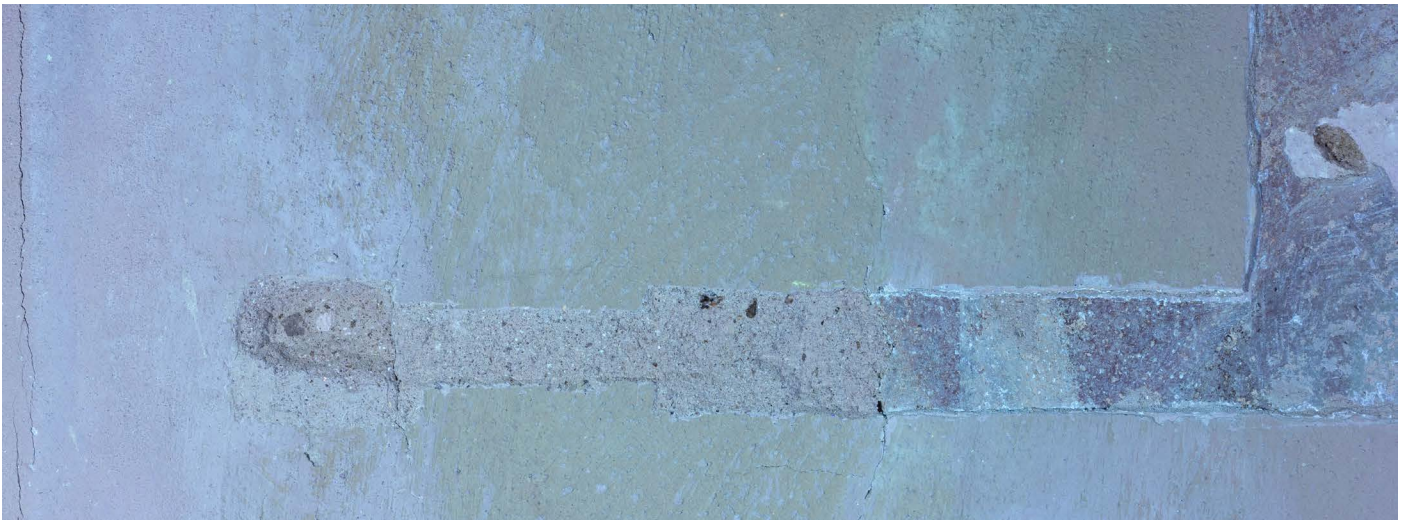
strip probe exposing the original painted plaster layer partially covered by second oldest plaster layer indicating the dimensions of the walled door  
macrophotographs in day and raking light and in UV luminescence

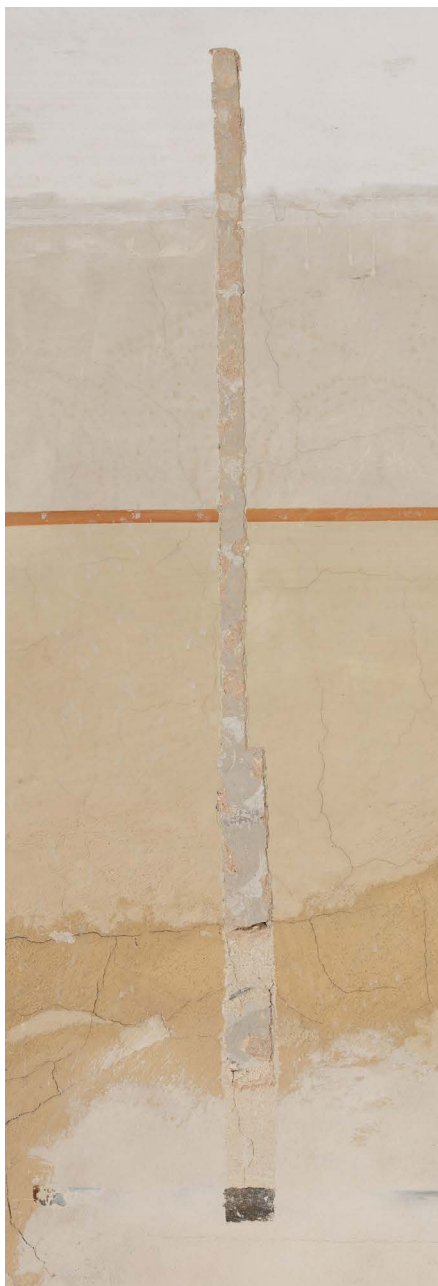
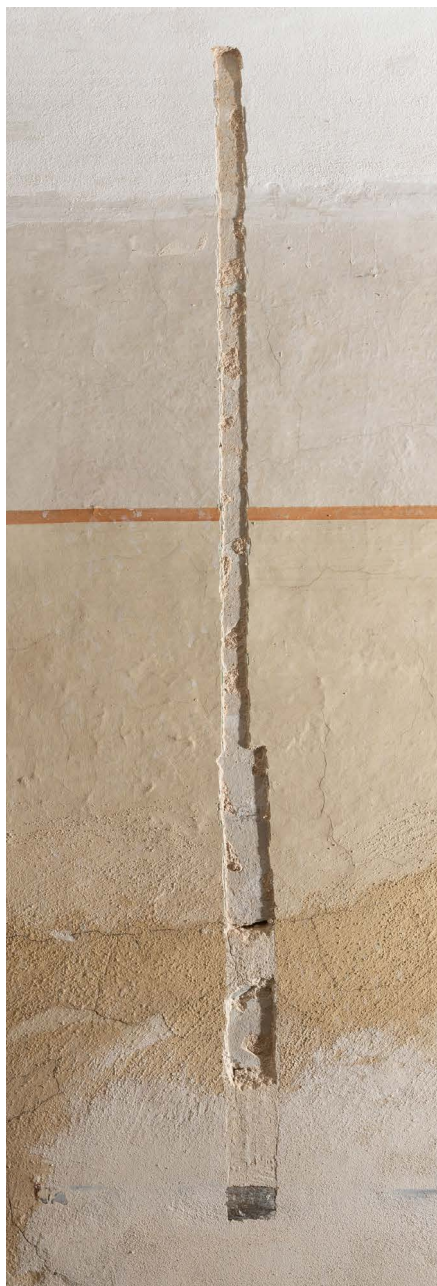
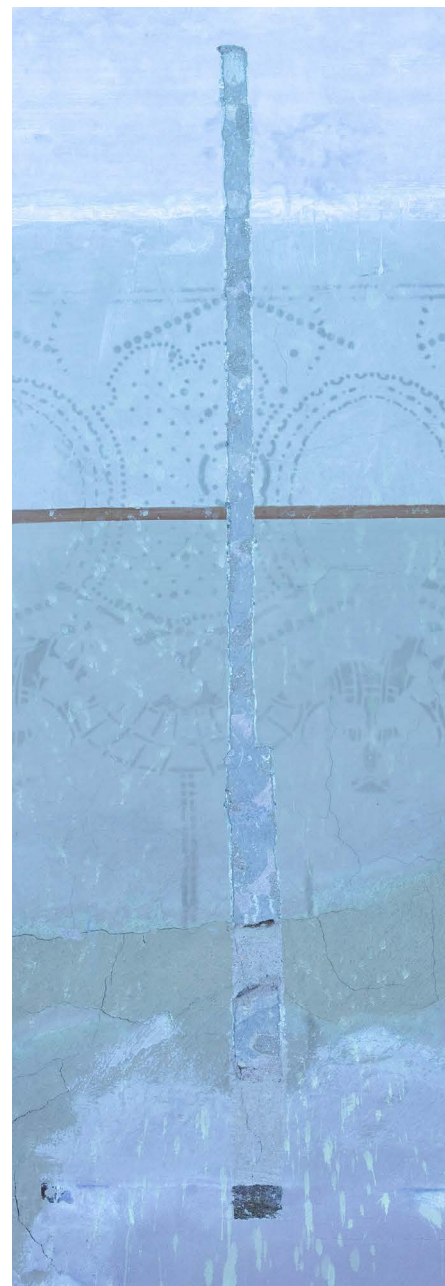
strip probe exposing the original painted plaster layer partially covered by second oldest plaster layer indicating the dimensions of the walled door  
macrophotographs in day and raking light and in UV luminescence

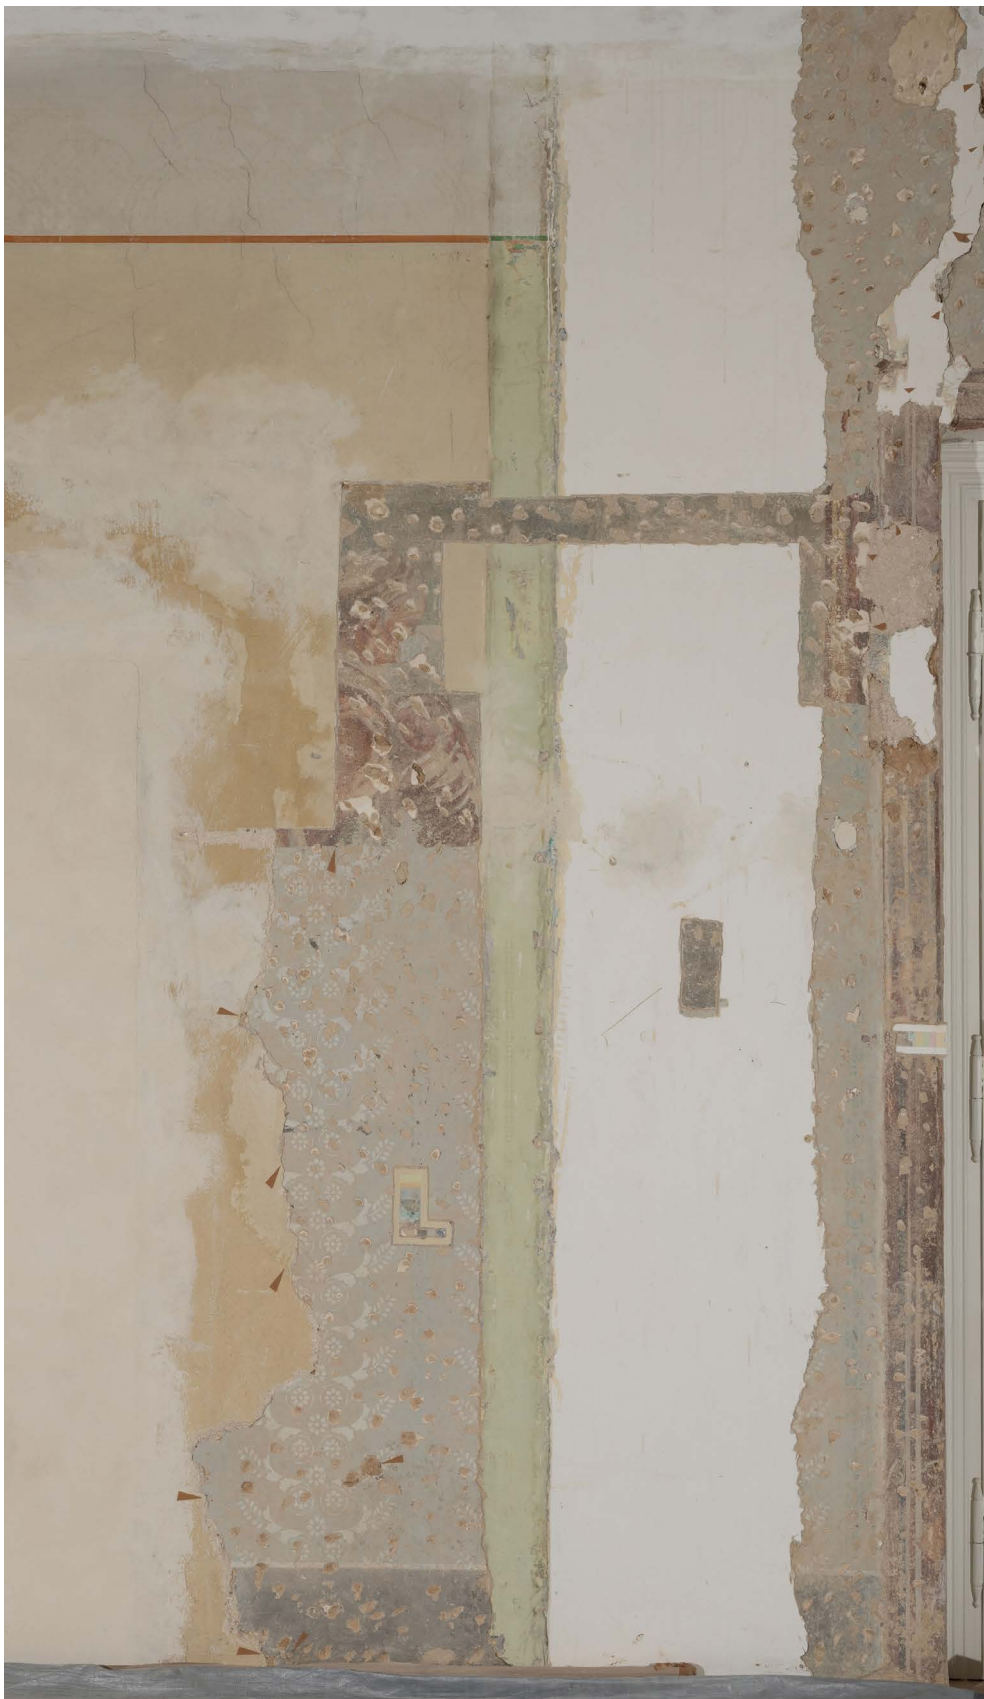
condition during the removal of the modern plaster layers on the second oldest plaster layer  
photography in day light, detail

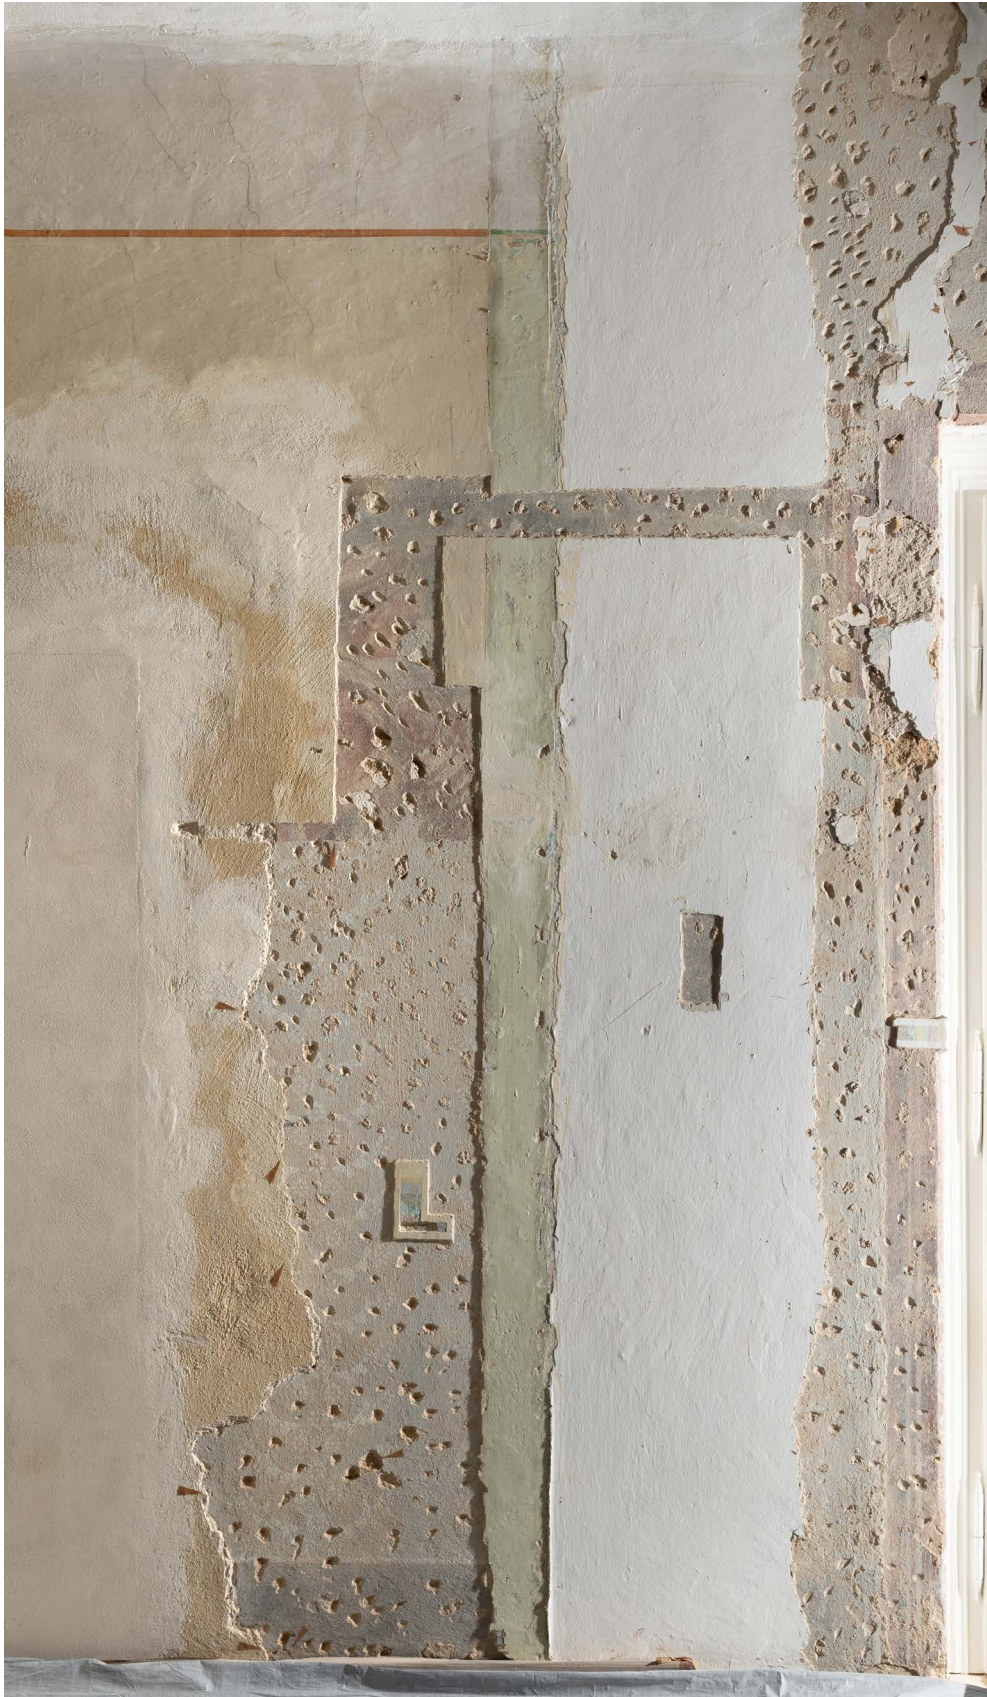
condition during the removal of the modern plaster layers on the second oldest plaster layer  
photography in raking light, detail

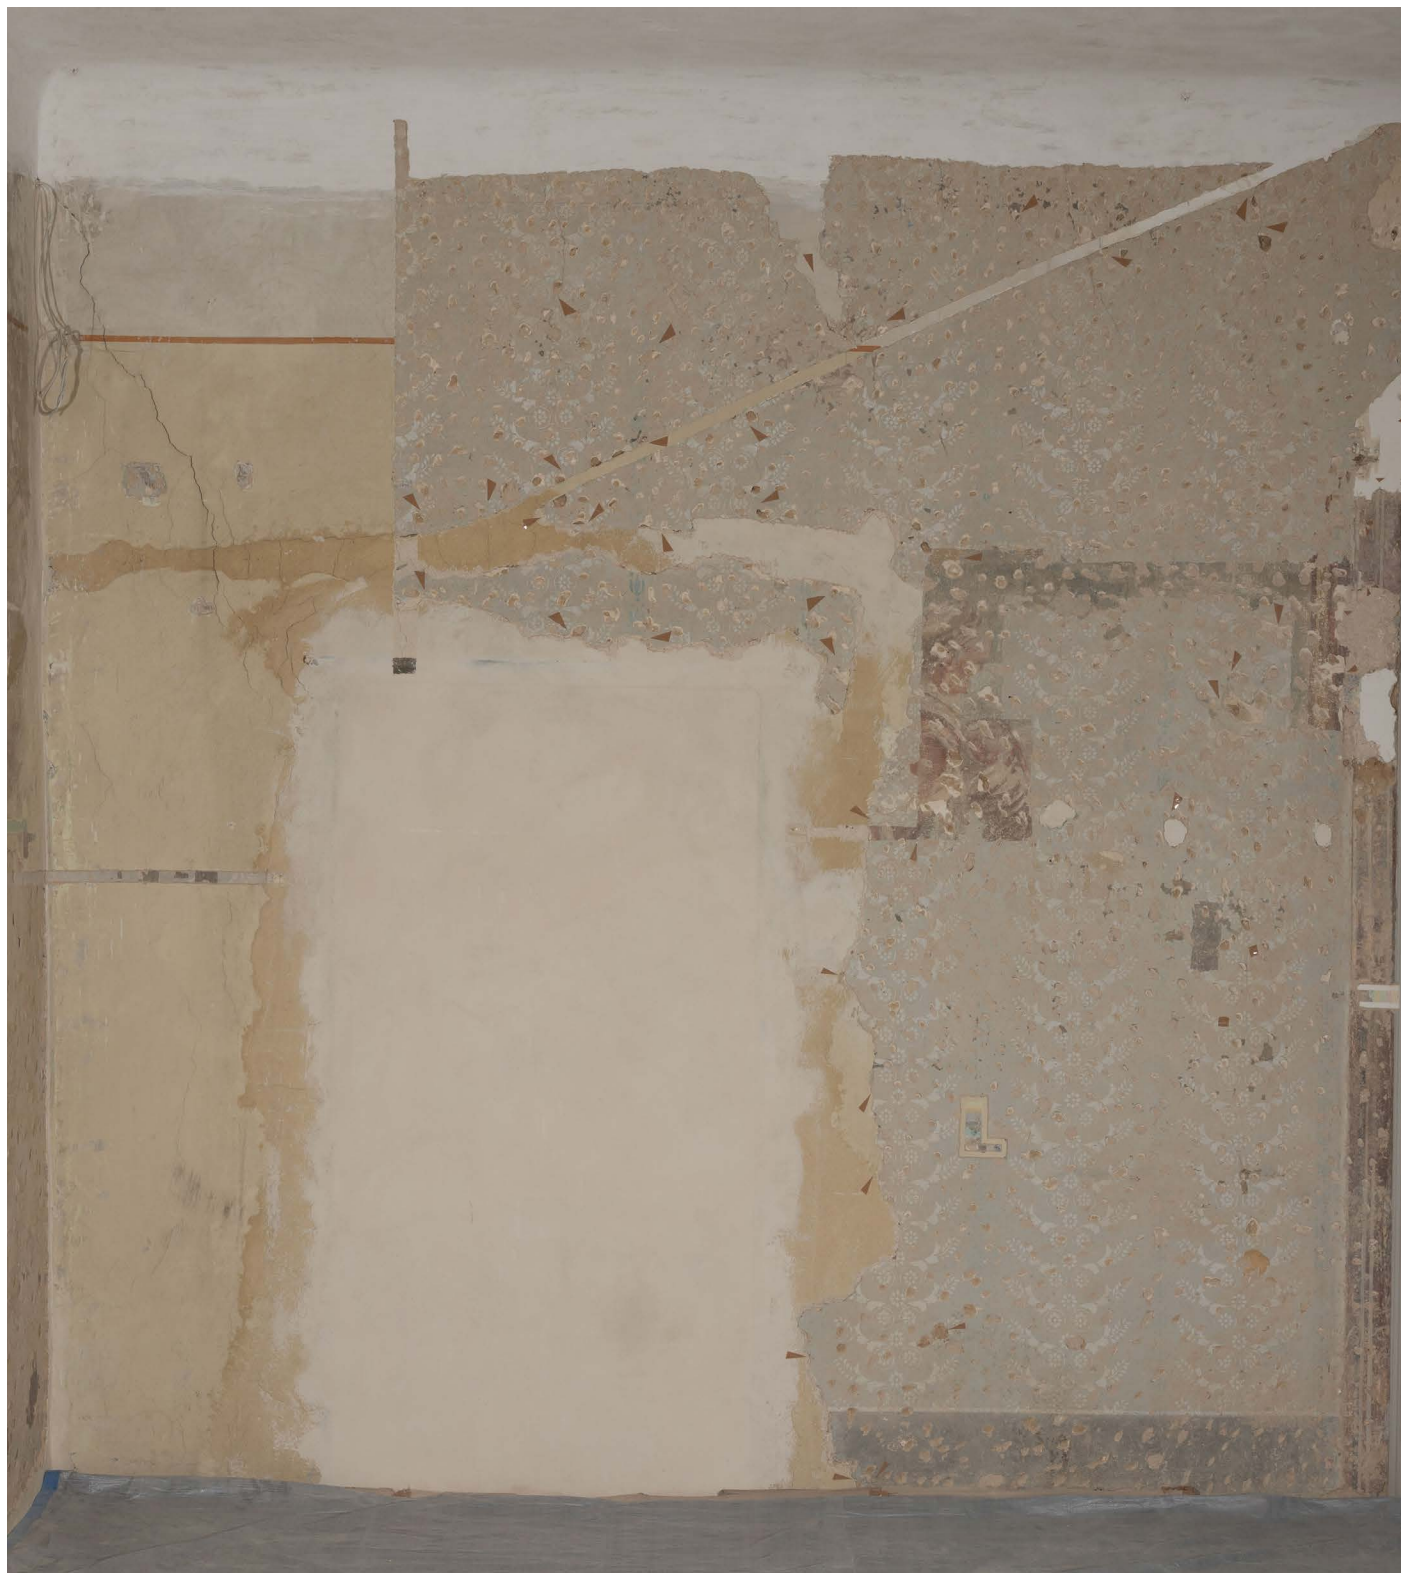
condition during the removal of the modern plaster layers on the second oldest plaster layer  
photography in day light

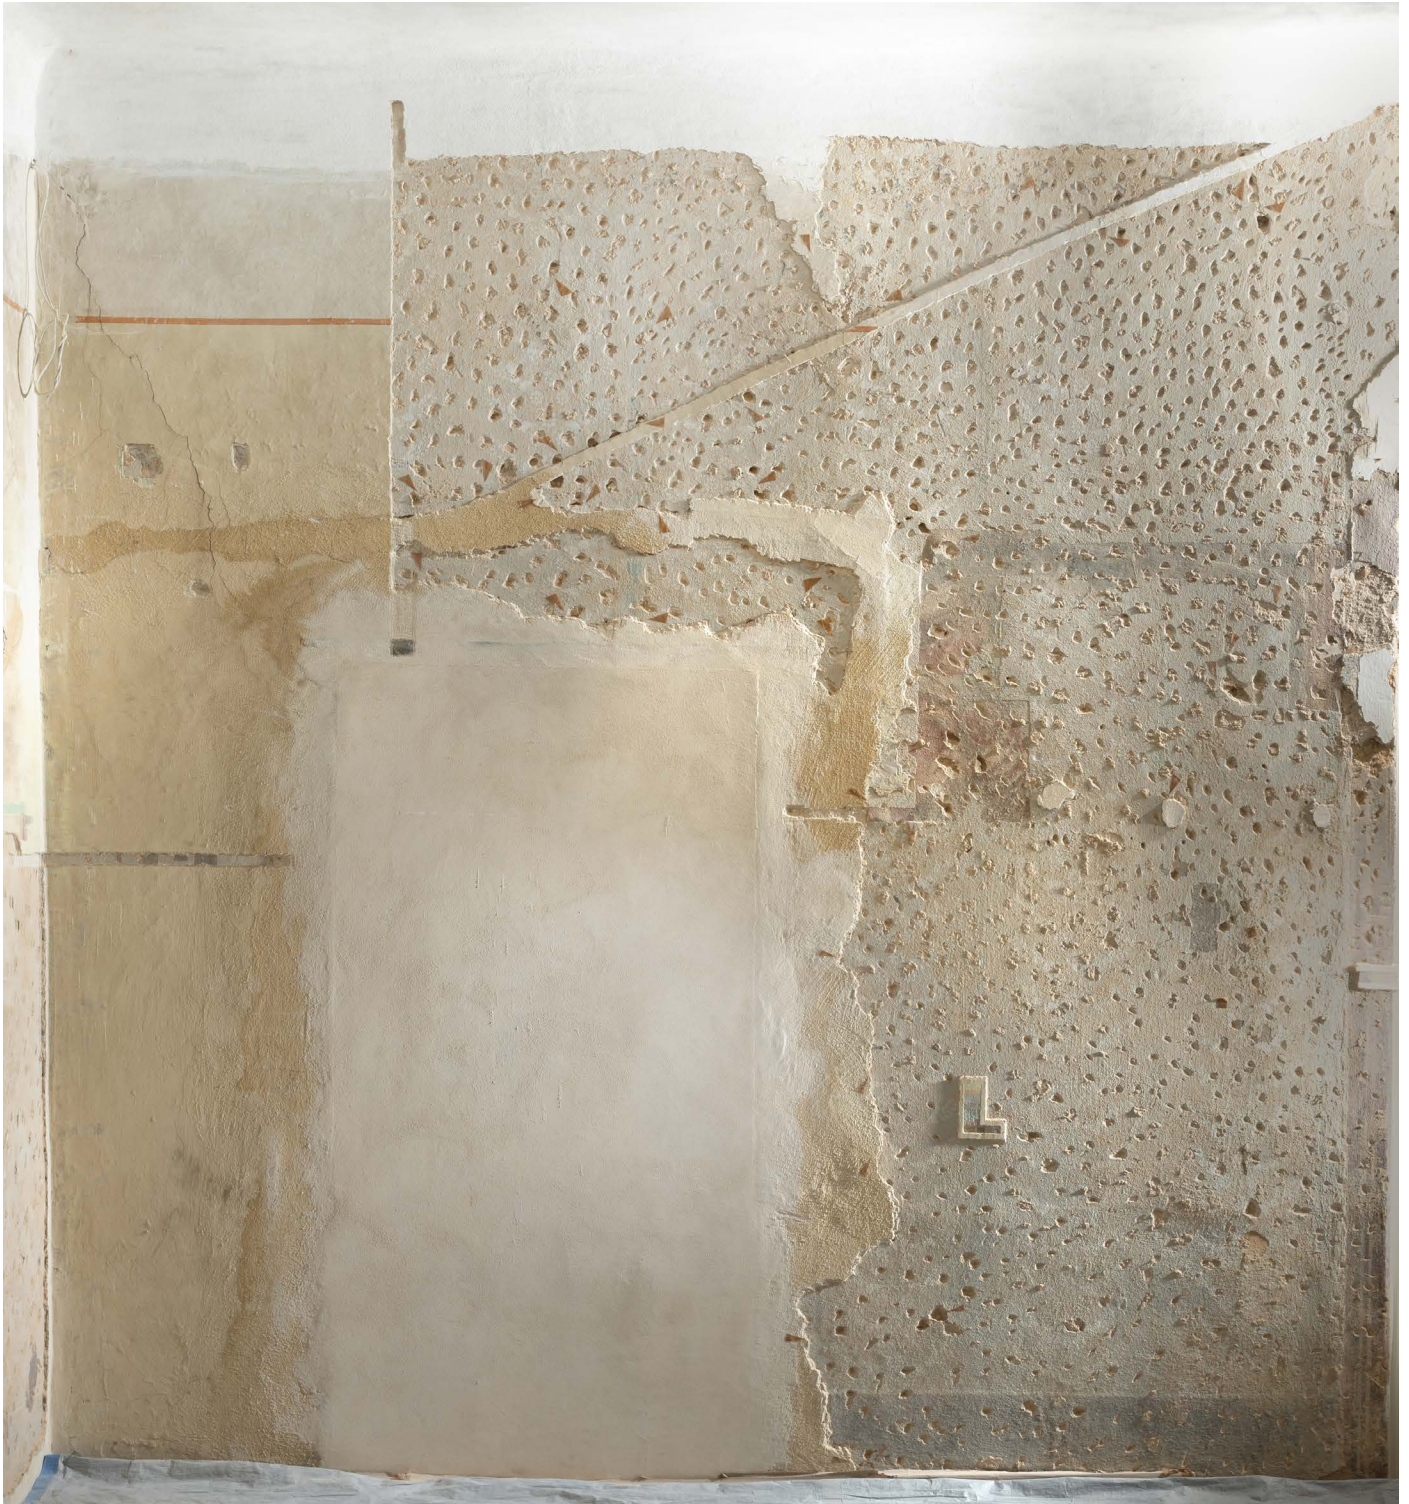
condition during the removal of the modern plaster layers on the second oldest plaster layer  
photography in raking light

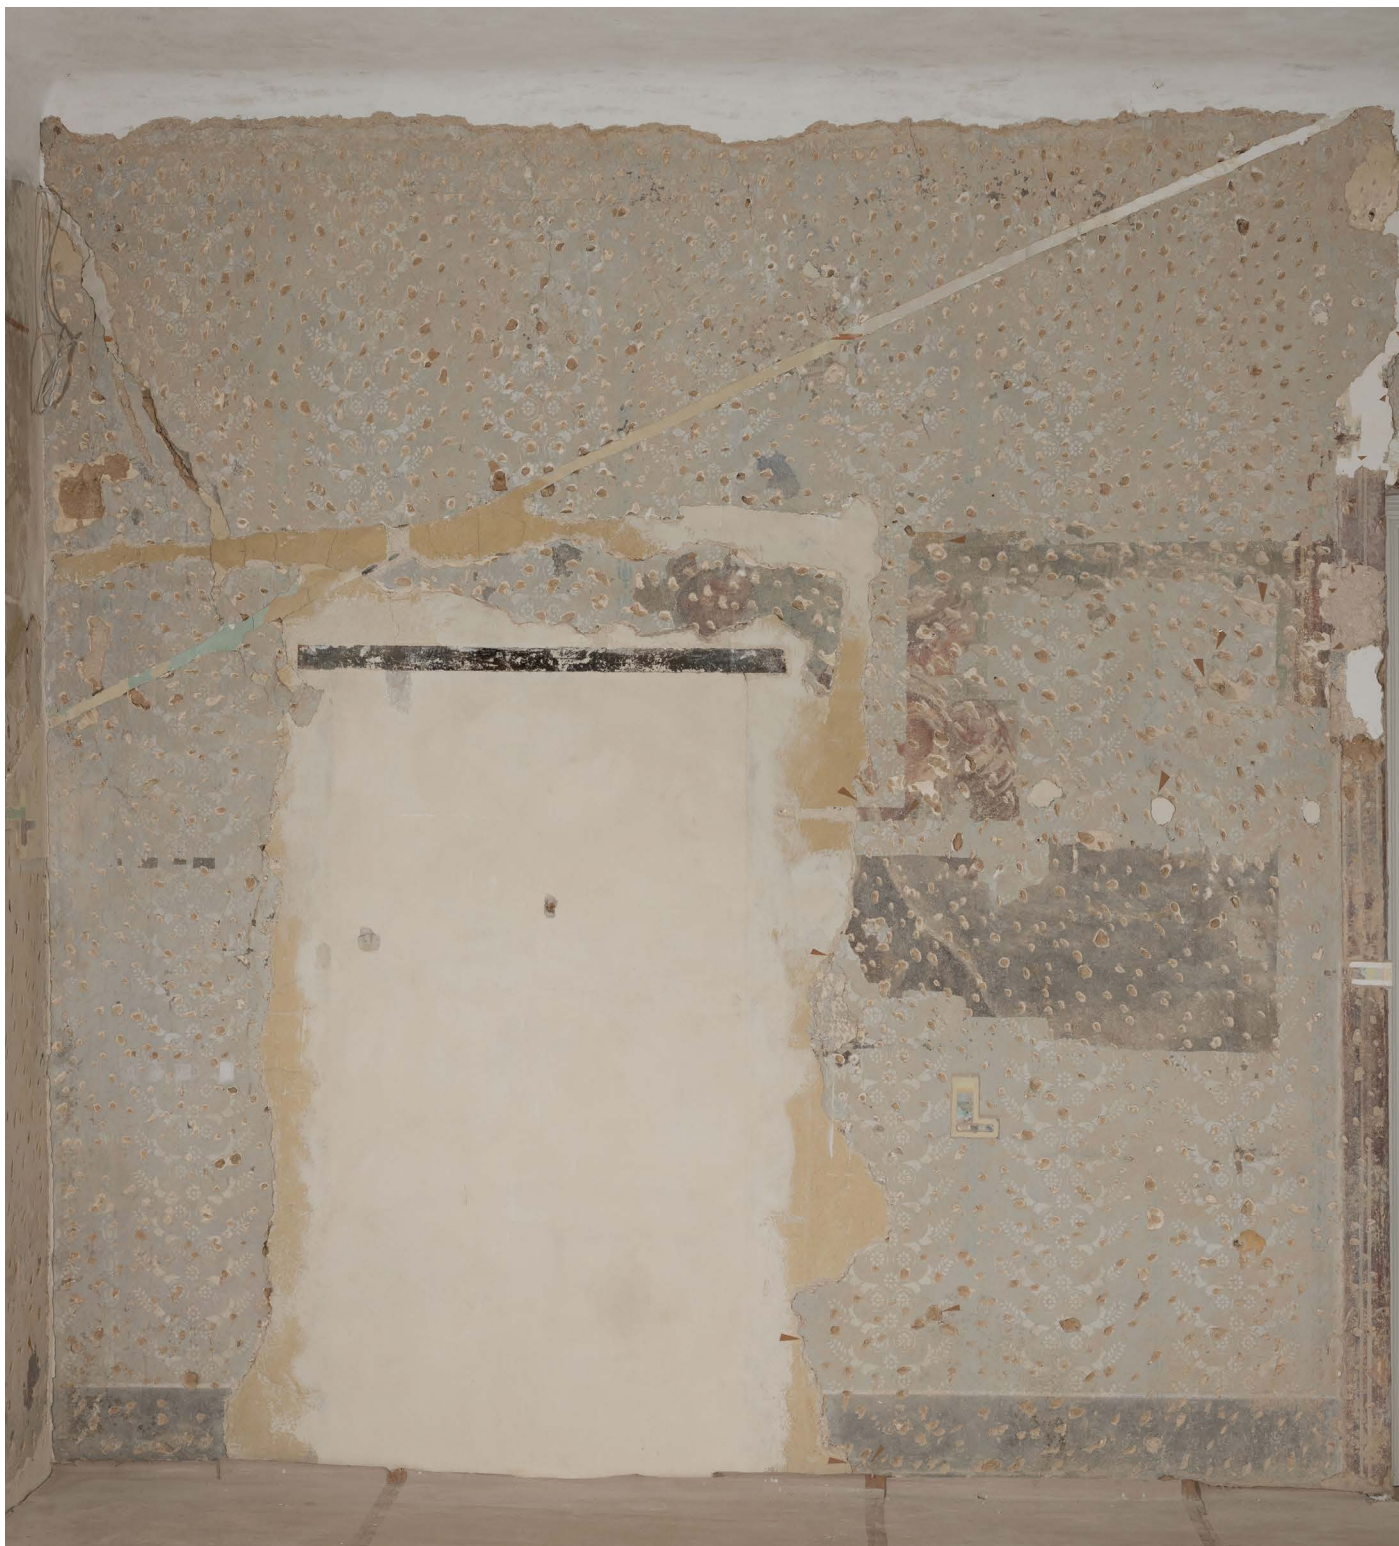
condition after the removal of the modern plaster layers on the second oldest plaster layer  
photography in day light

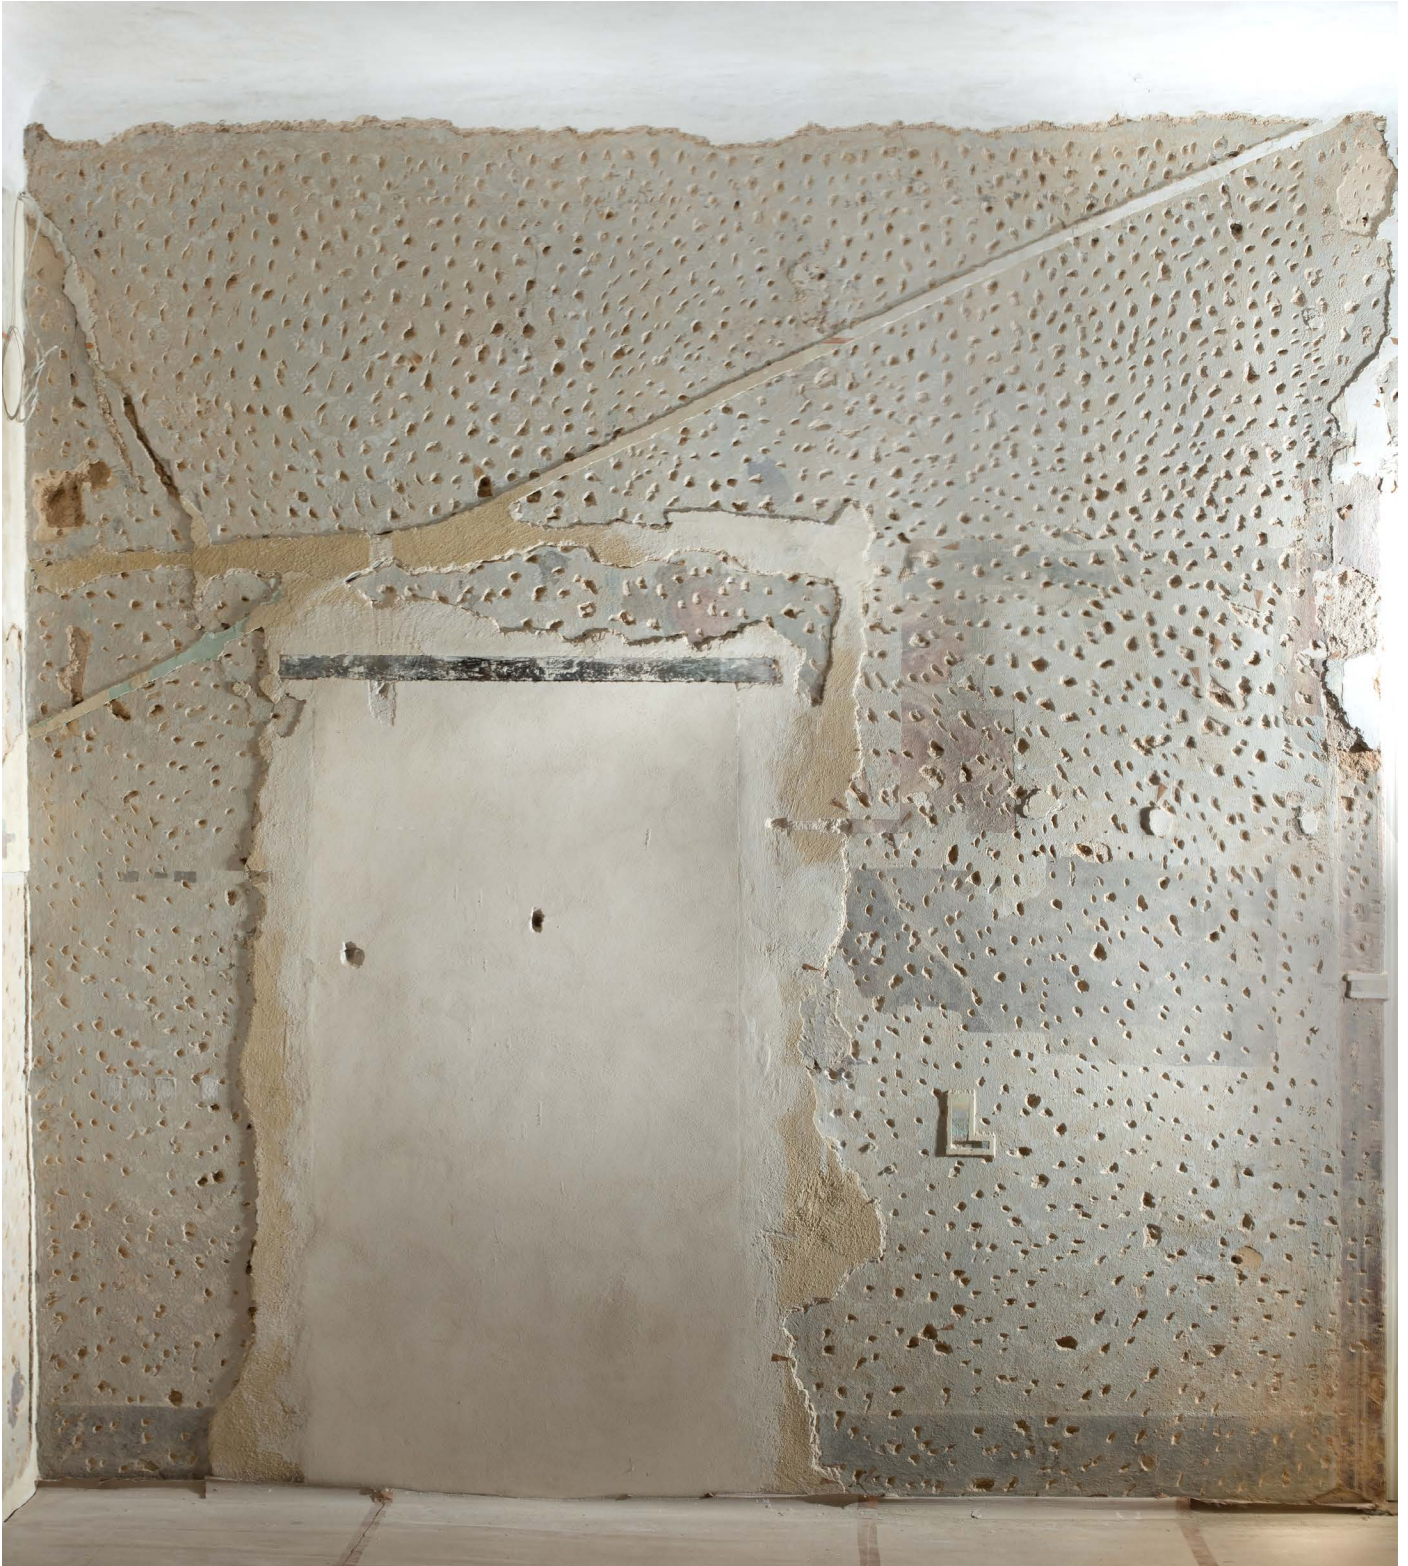
condition after the removal of the modern plaster layers on the second oldest plaster layer  
photography in raking light

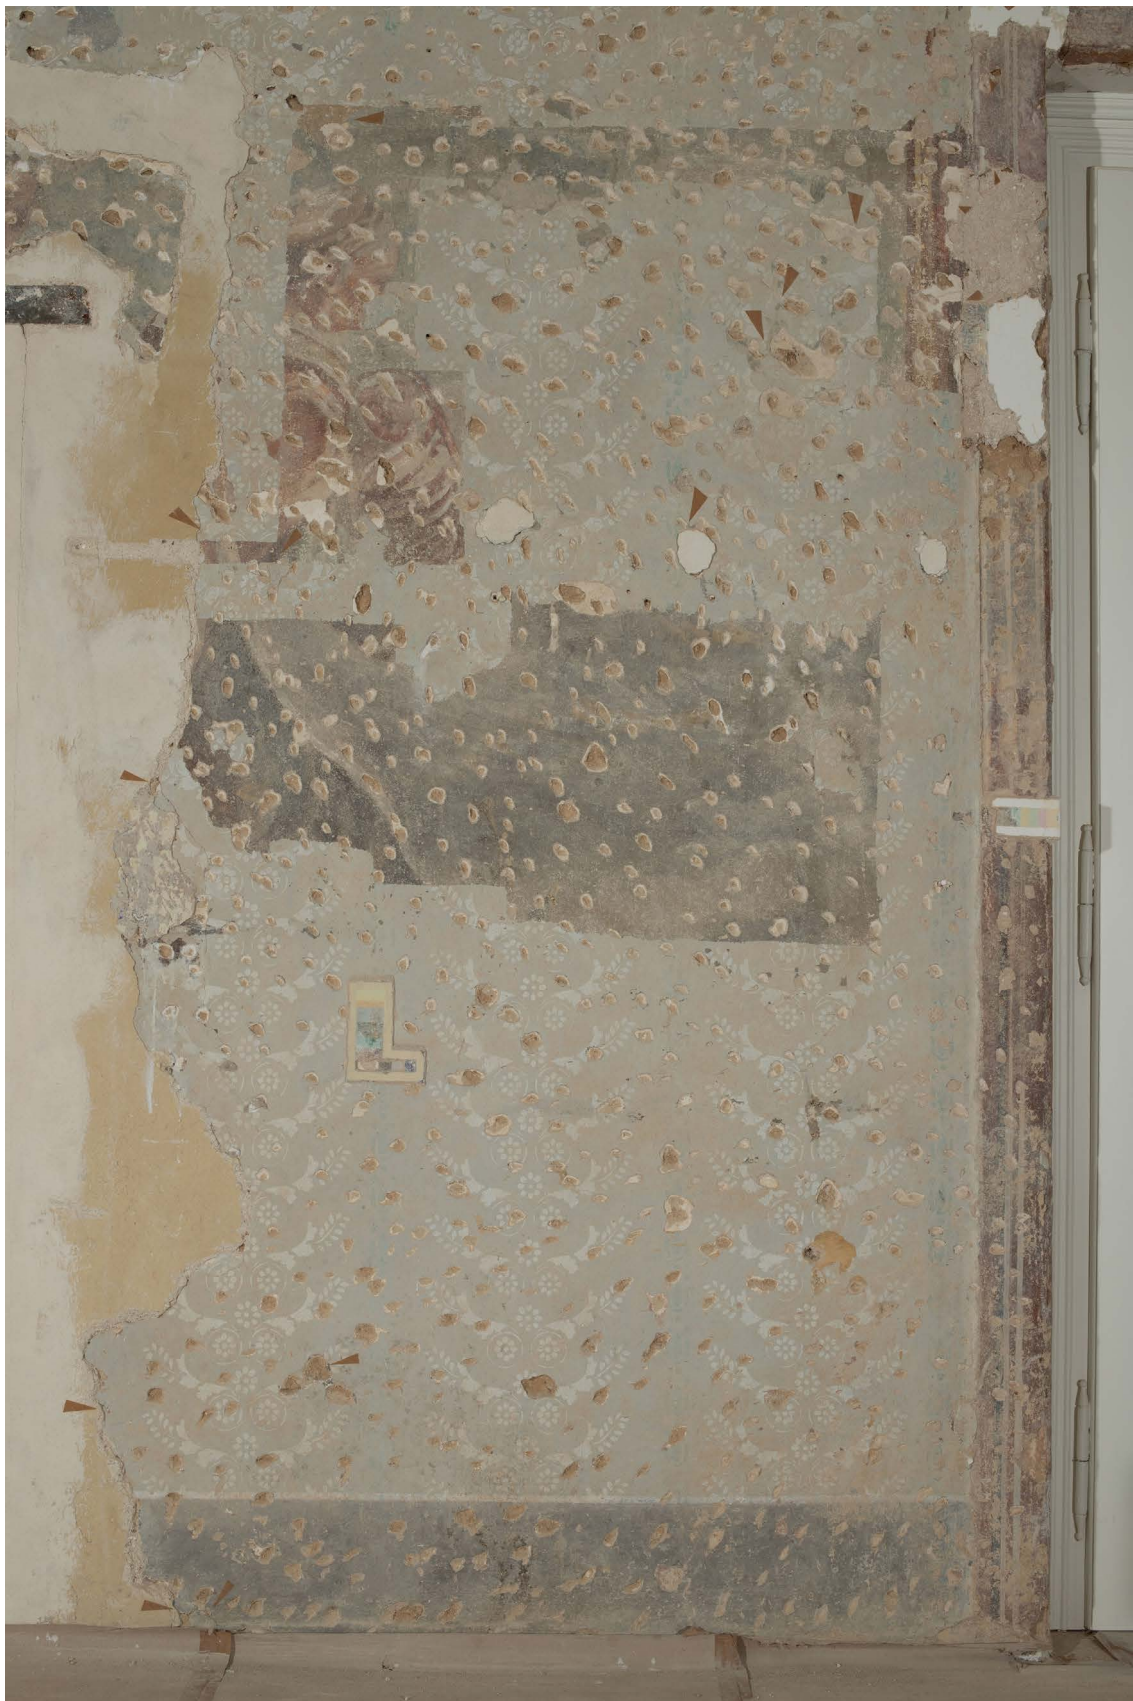
condition after the removal of the modern plaster layers on the second oldest plaster layer  
photography in day light, detail

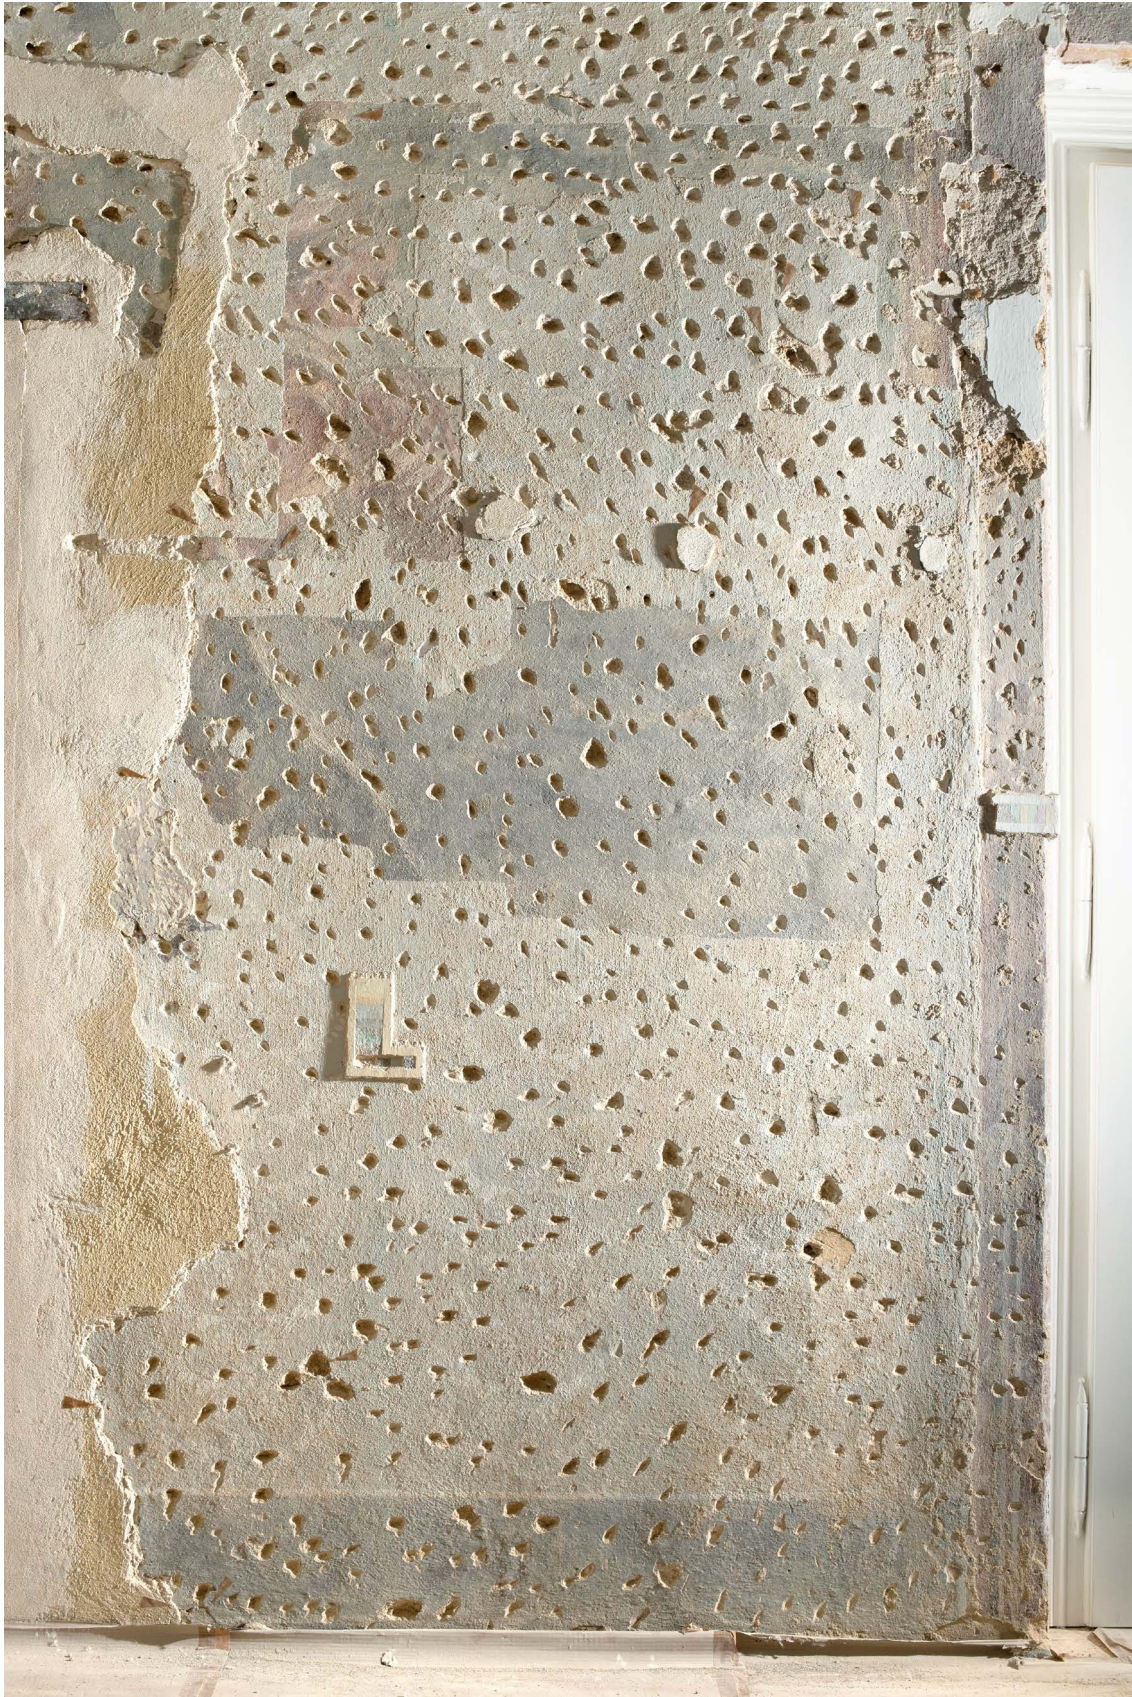
condition after the removal of the modern plaster layers on the second oldest plaster layer  
photography in raking light, detail
