# RESTORATION TREATMENT REPORT

## THE STORY OF MOSES KAREL JOSEF MORAVINI

wall painting in the interior of chamber in a ground floor of southwest part of castle Kácov  
1730s  
private owner

Alžběta Mirjam Procházková  
Academy of Fine Arts in Prague  
Studio of Restoration of Painted Artworks and Polychrome Sculpture  
akademic years 2022/2023 - 2022/2024

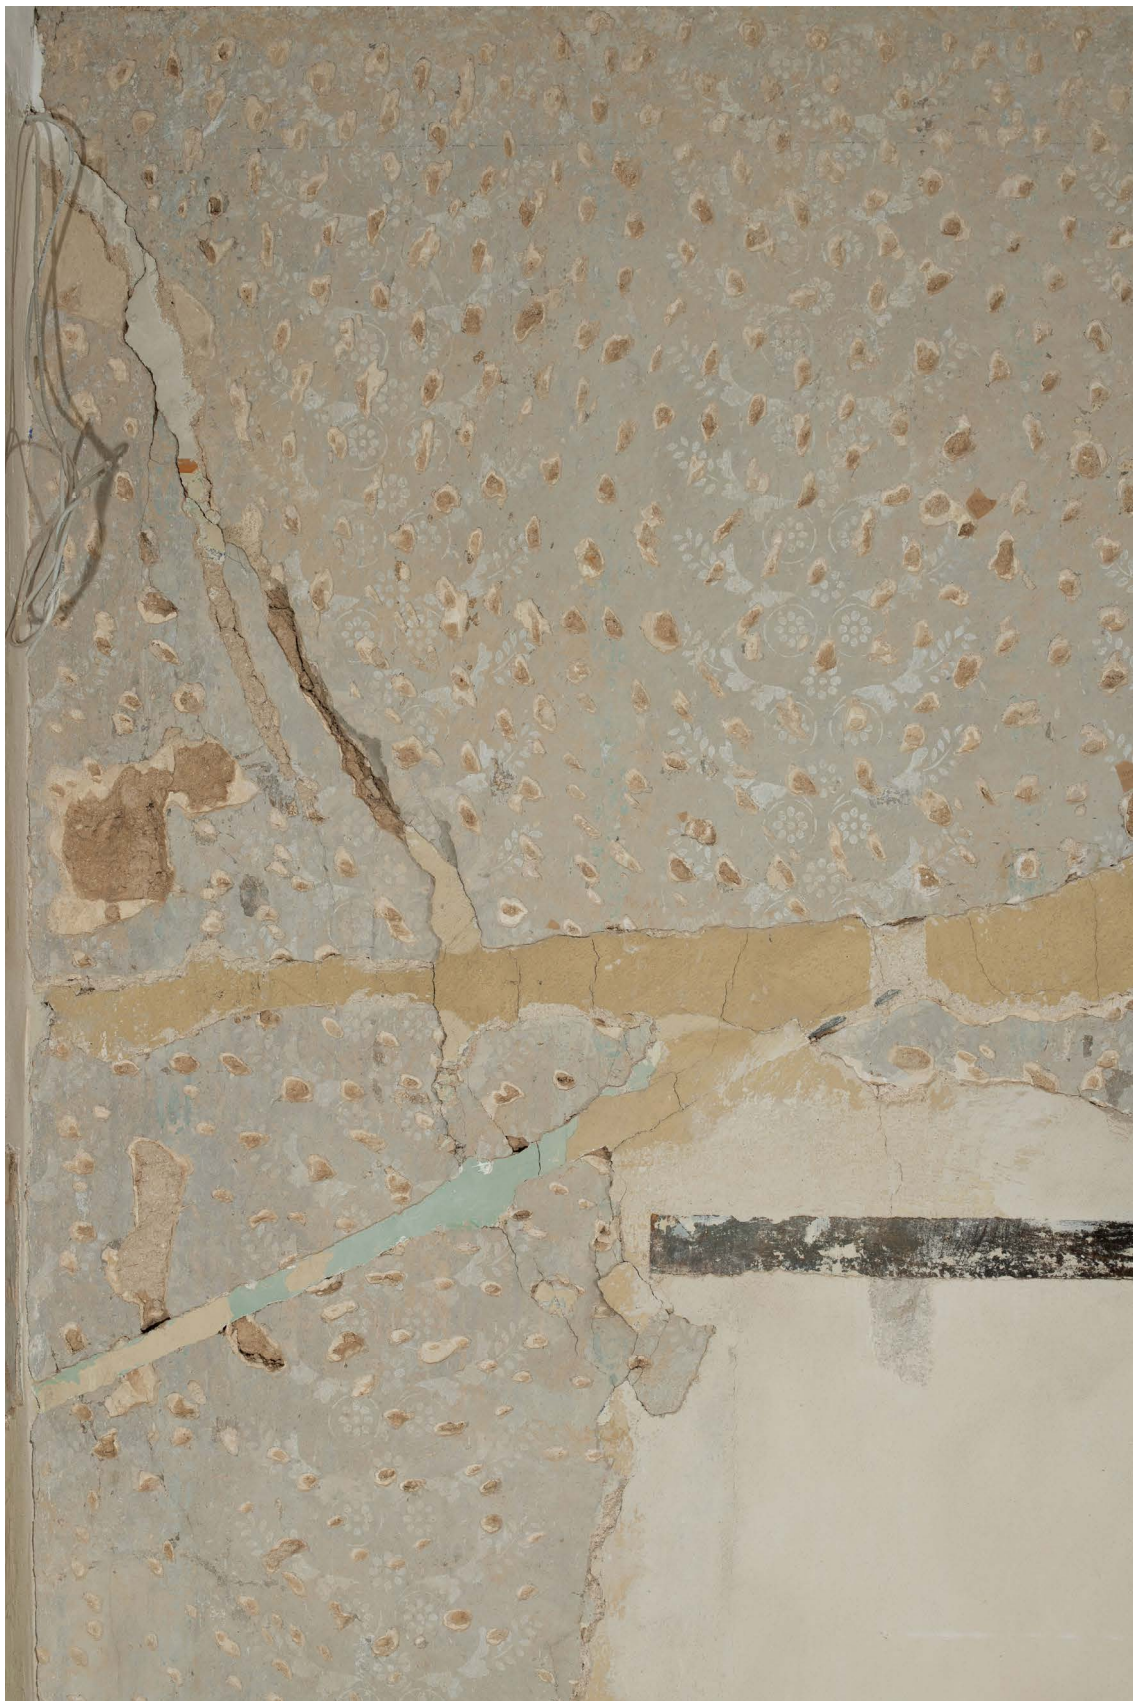
condition after the removal of the modern plaster layers on the second oldest plaster layer  
photography in day light, detail

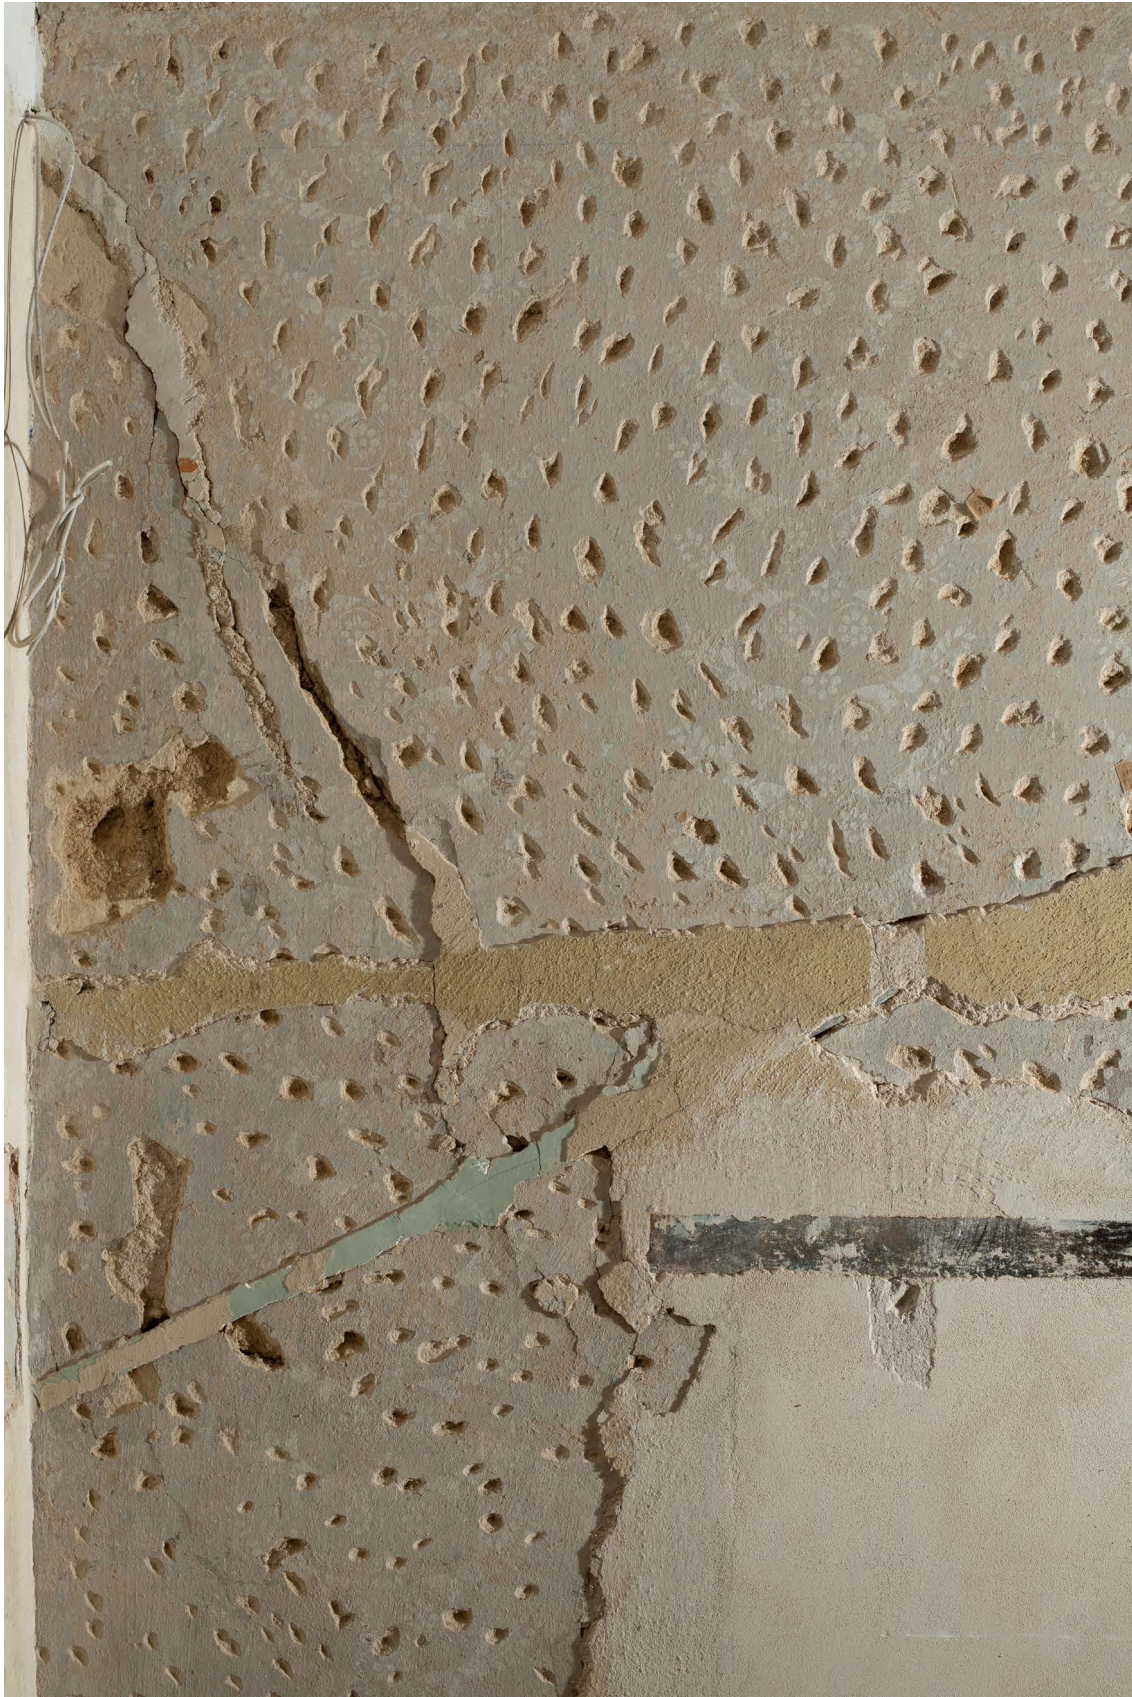
condition after the removal of the modern plaster layers on the second oldest plaster layer  
photography in raking light, detail

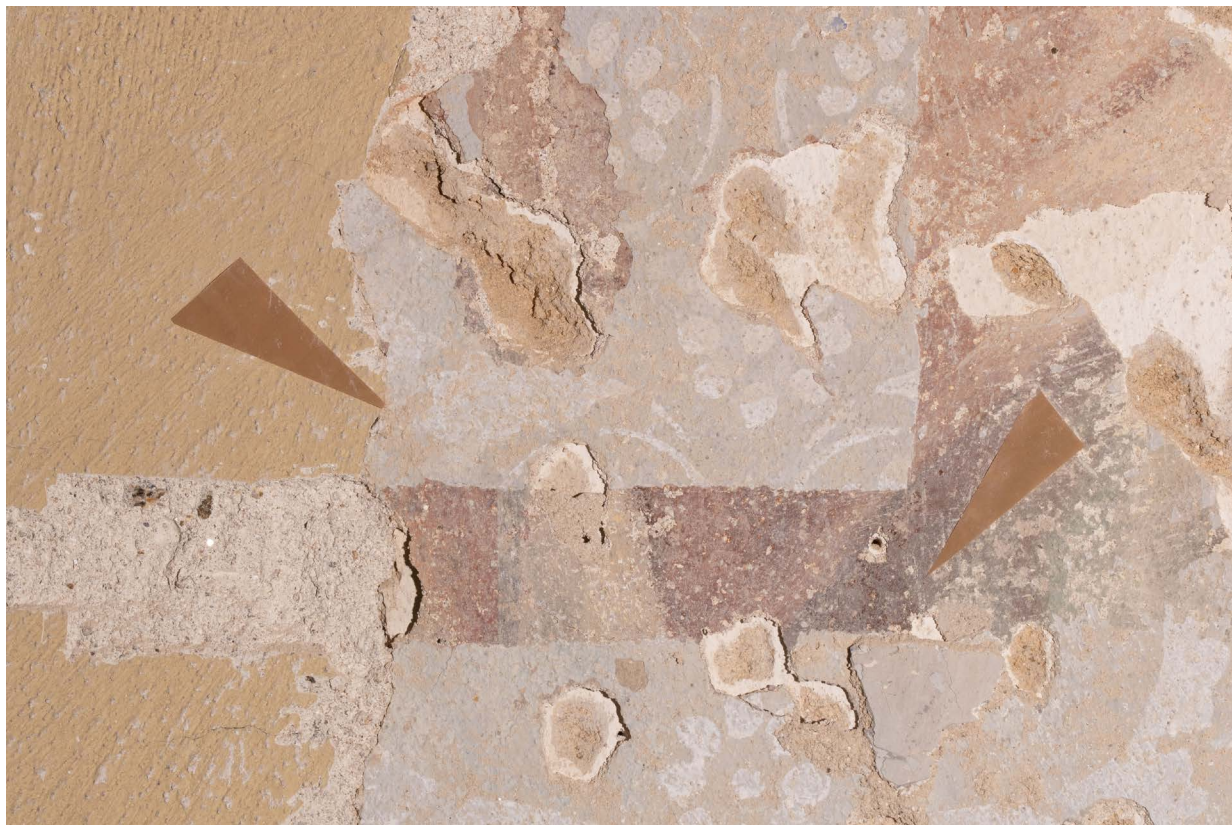
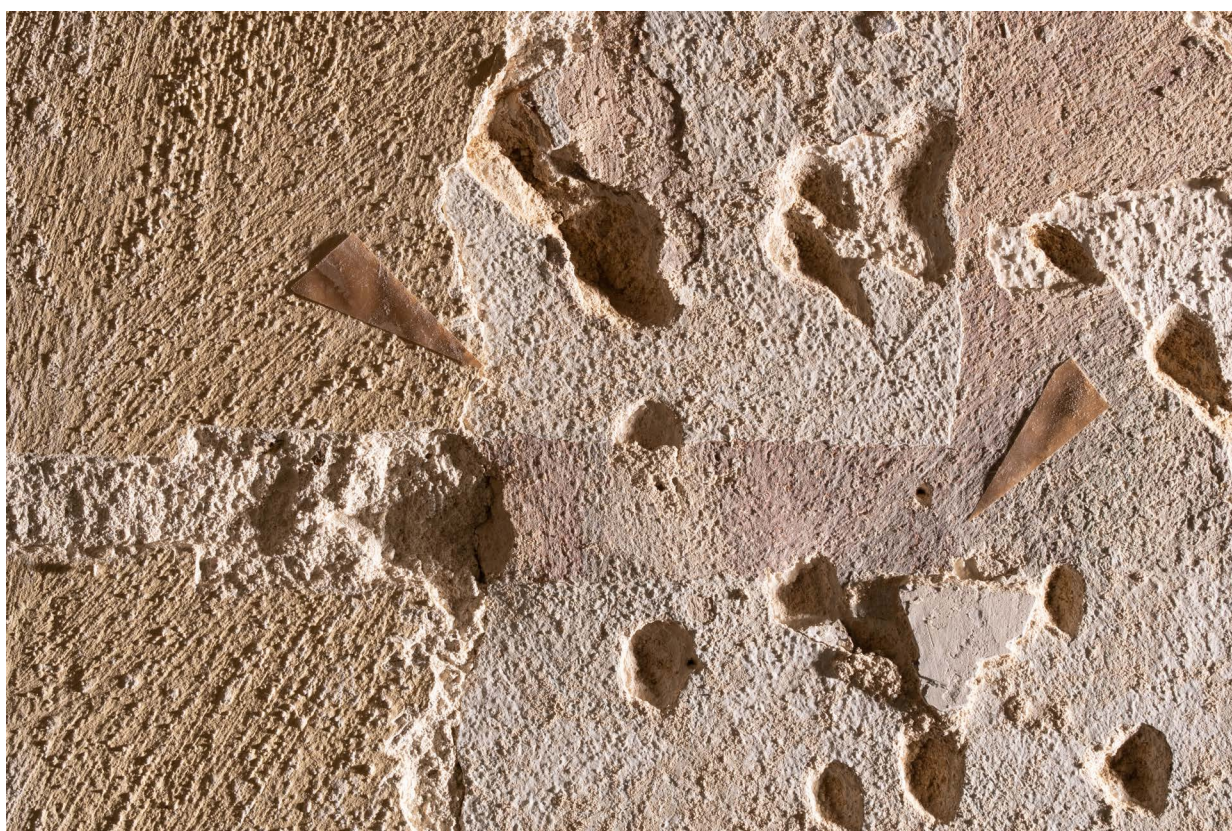
condition after the removal of the modern plaster layers on the second oldest plaster layer, partially exposing the original painted plaster layer  
details of defects and loosened plaster layers  
photographs in day and raking light, detail

preprepared japanies paper facing with 5% Aquazol in distilled water with little amount of ethanol, reactivated by spraying of distilled water - applied on loosened plaster with exposed original painting

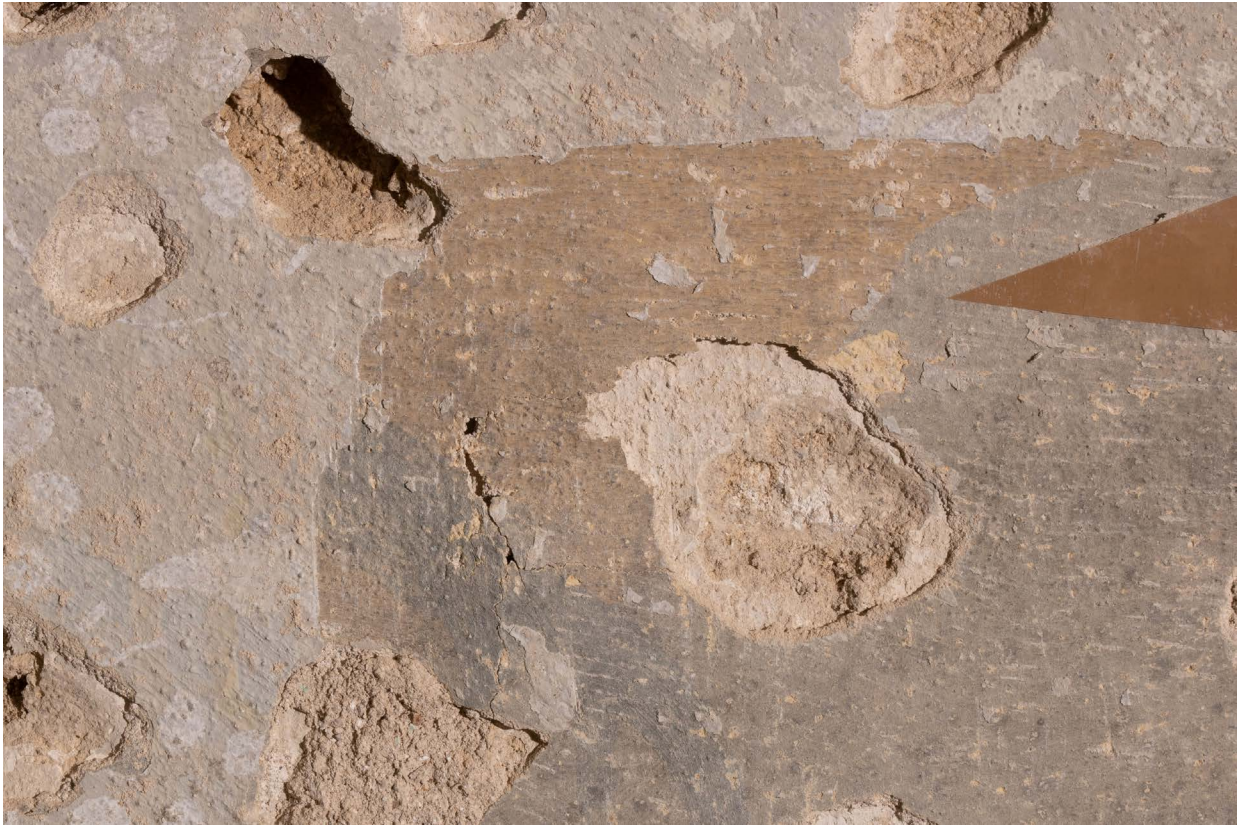
condition after the removal of the modern plaster layers on the second oldest plaster layer, partially exposing the original painted plaster layer  
details of defects and loosened plaster layers  
photographs in day and raking light, detail

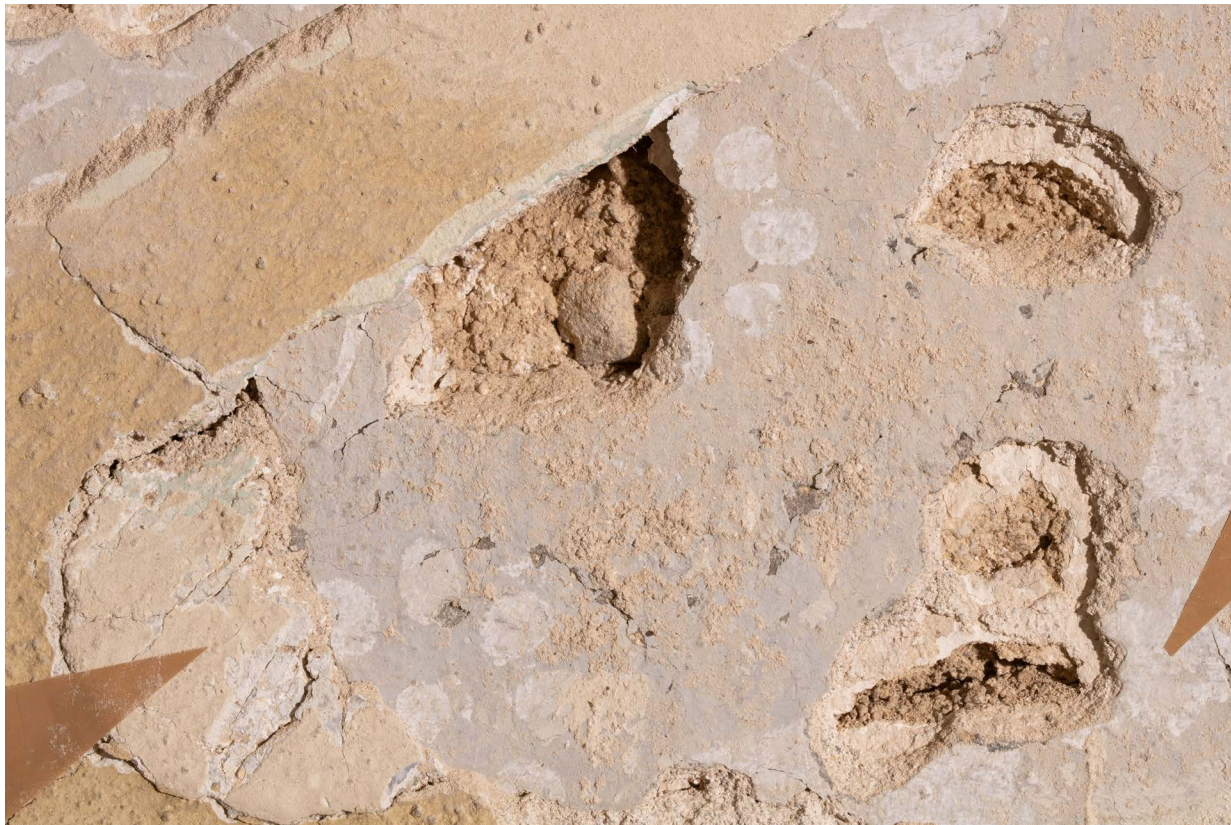
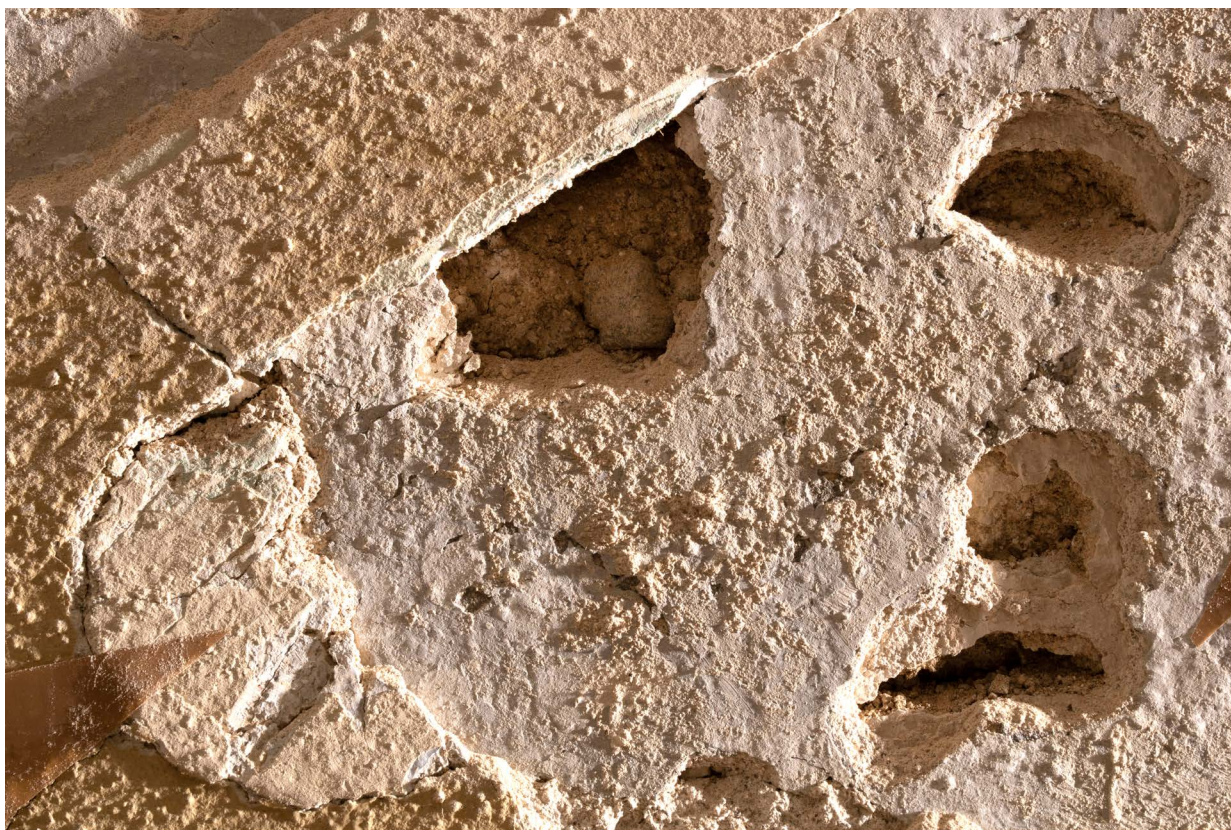
condition after the removal of the modern plaster layers on the second oldest plaster layer  
details of defects and loosened plaster layers around the pecks and electricity cables covered by plaster  
photographs in day and raking light, detail

7. Application of the facings around the defected areas caused by secondary inserted electricity cables and walled door. Consolidation and reinforcement of the plaster layers around these areas.

8. Mechanical removal of the non-original plaster within the electricity cables and plaster covering defects around the secondary inserted and lately walled door.

solution of Cyclododecan in White spirit applied on japanies paper in several layers for short-term facing before the removal of the plaster patches for the areas around the defects caused by inserting of electricity cables

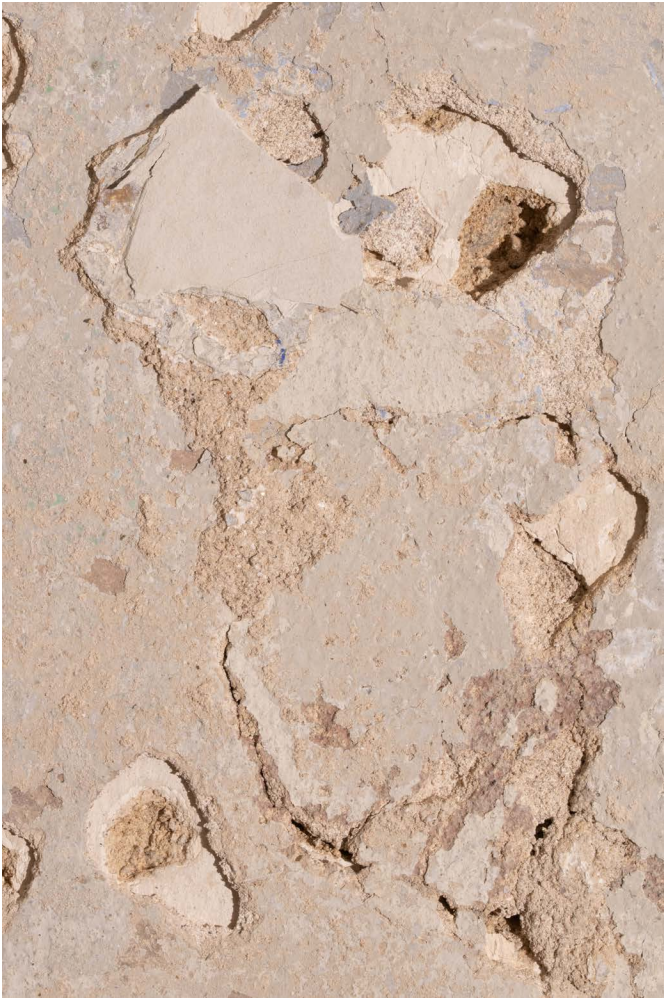
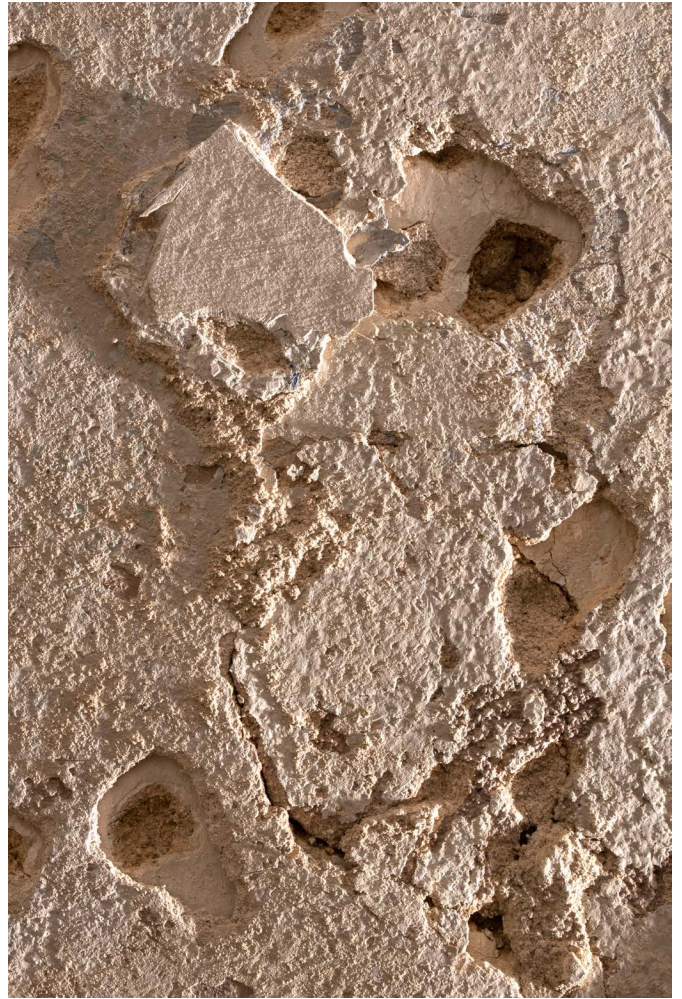
condition after the removal of the modern plaster layers on the second oldest plaster layer, partially exposing the original painted plaster layer  
details of defects and loosened plaster layers around the pecks  
photographs in day and raking light, detail

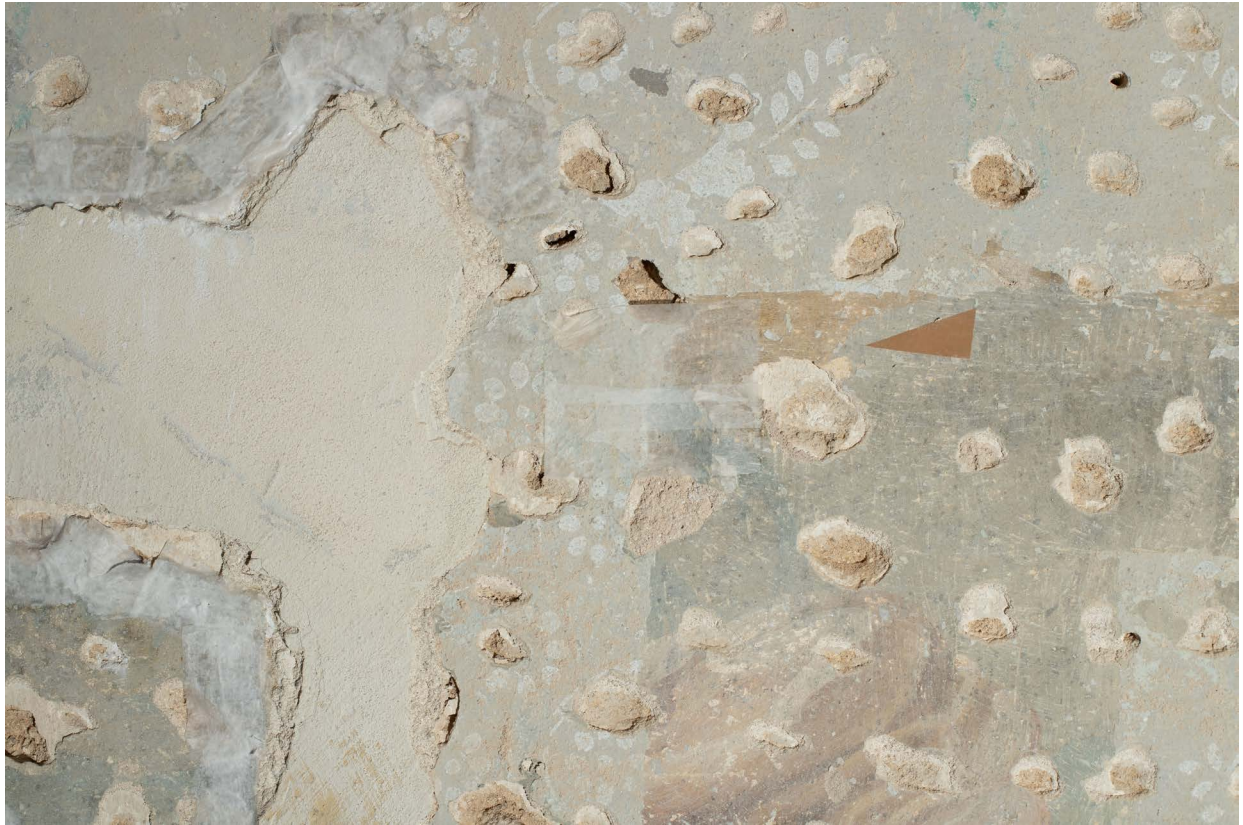
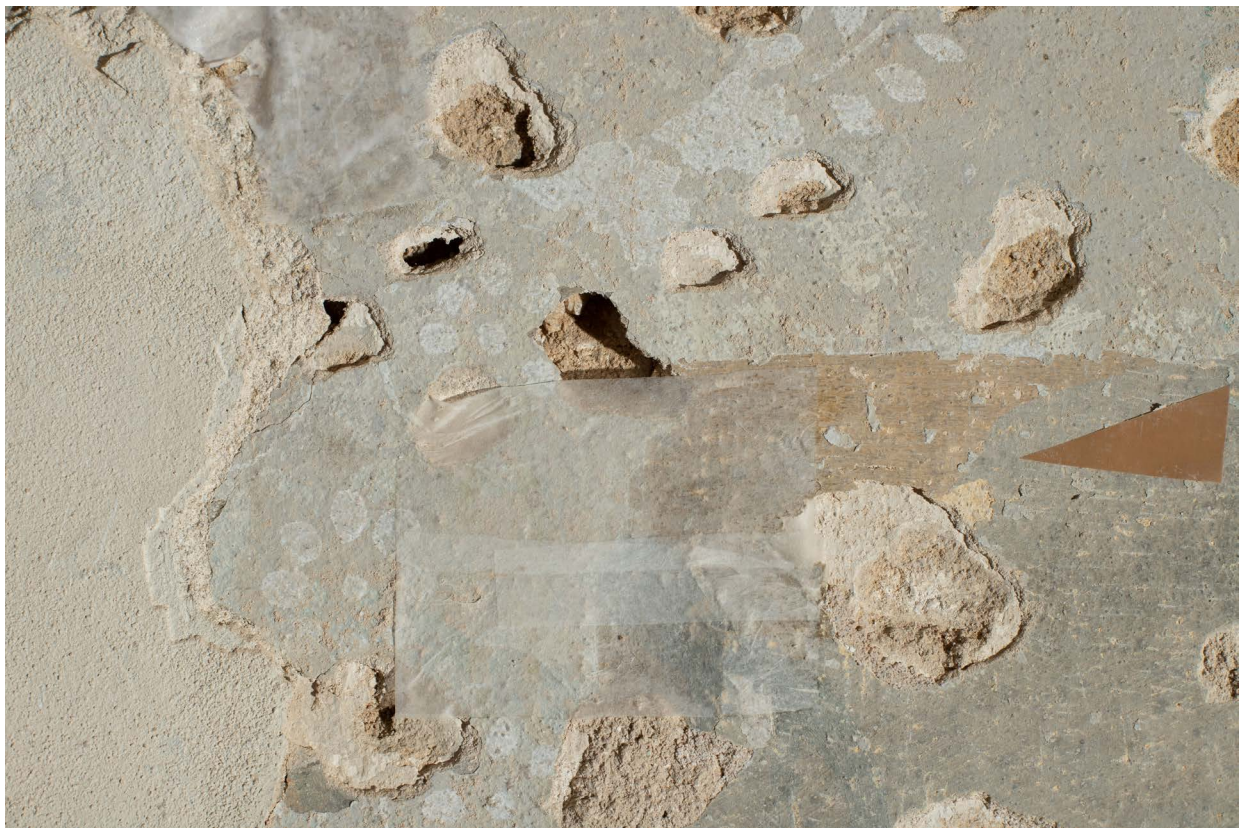
condition after the removal of the modern plaster layers on the second oldest plaster layer, partially exposing the original painted plaster layer  
detail of Aquazol's japanes paper facing applied on defected and loosened area  
photographs in day light, details

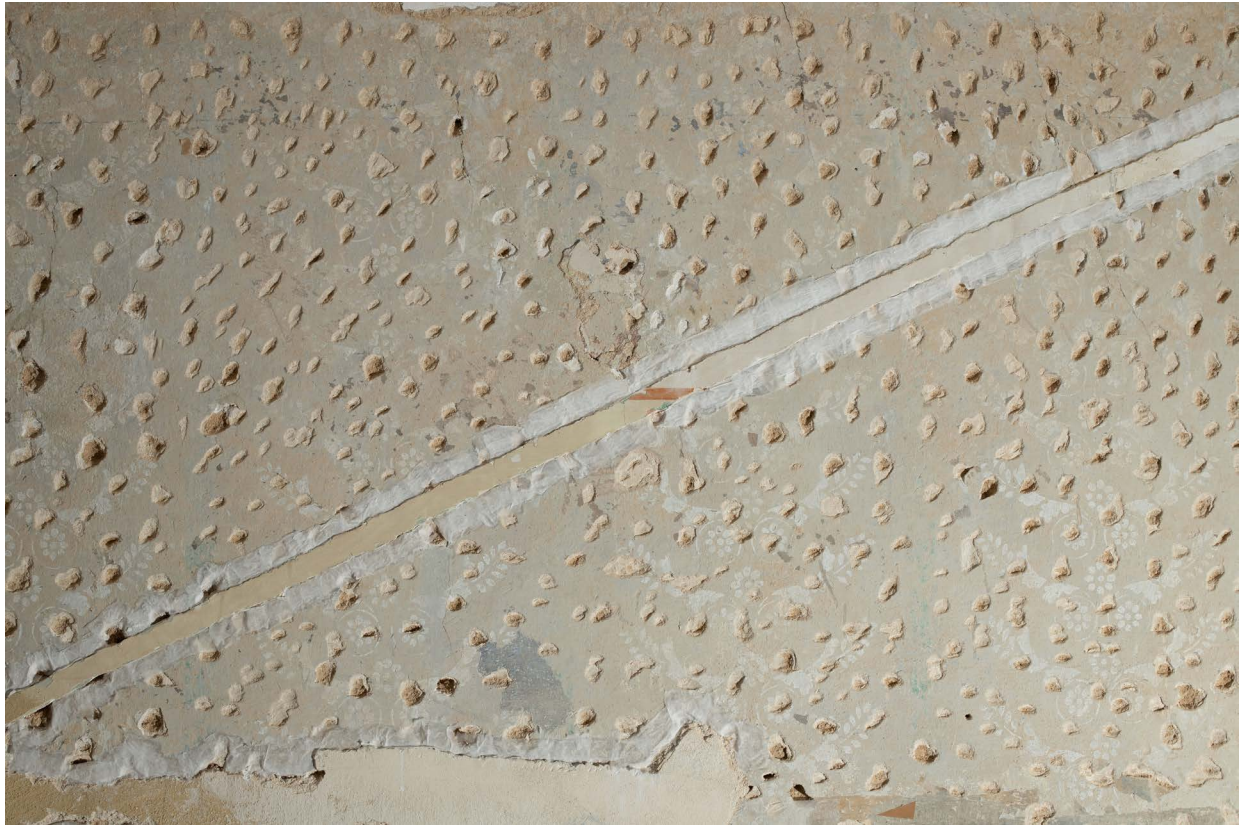
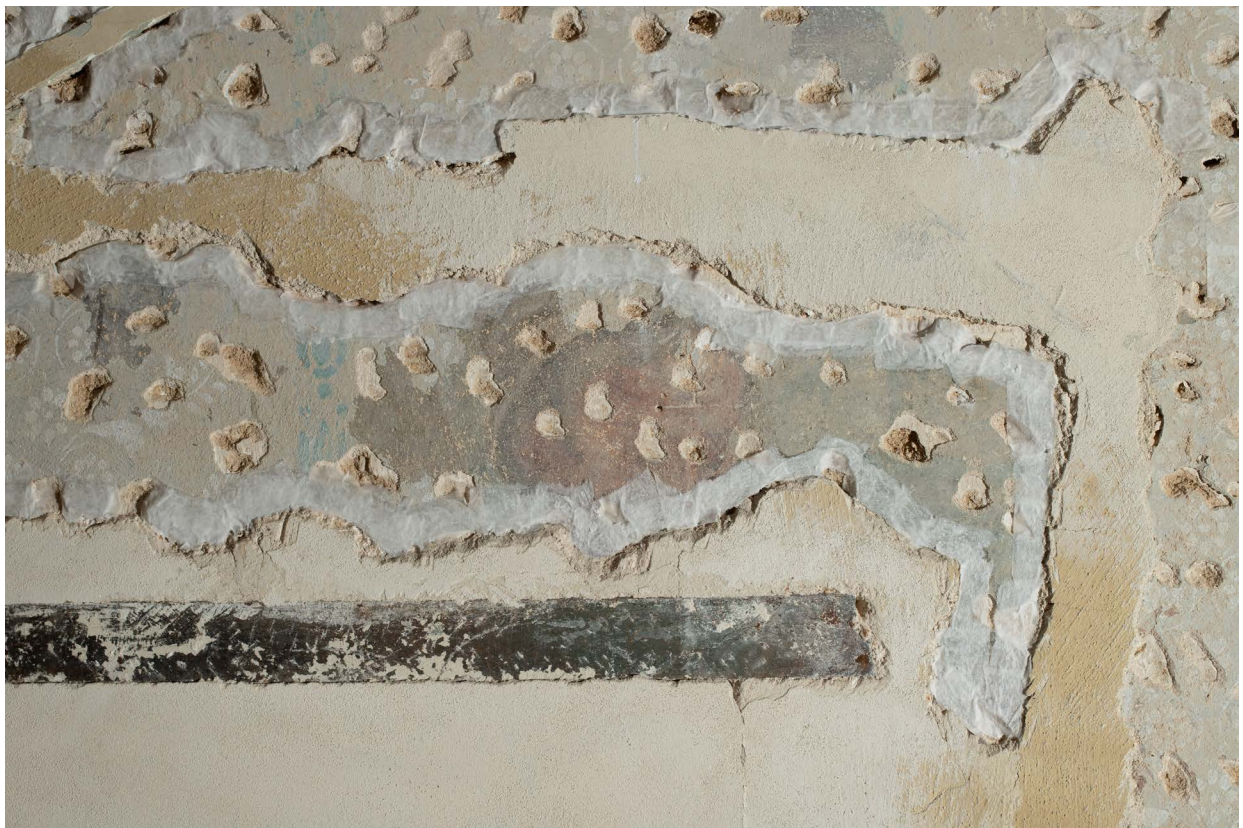
condition after the removal of the modern plaster layers on the second oldest plaster layer, partially exposing the original painted plaster layer  
detail of Cyclododecan's japanies paper facing applied on defected areas around the electricity cables and traverse  
photographs in day light, details

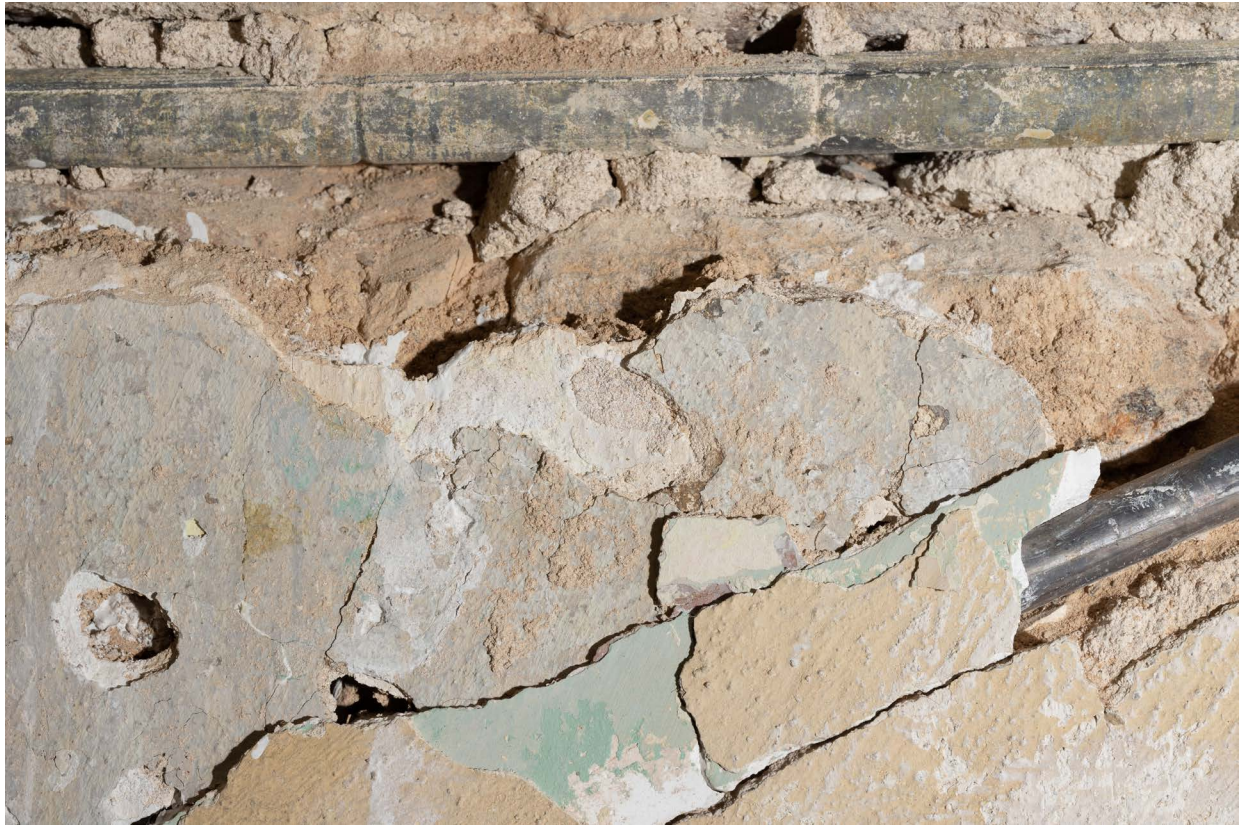
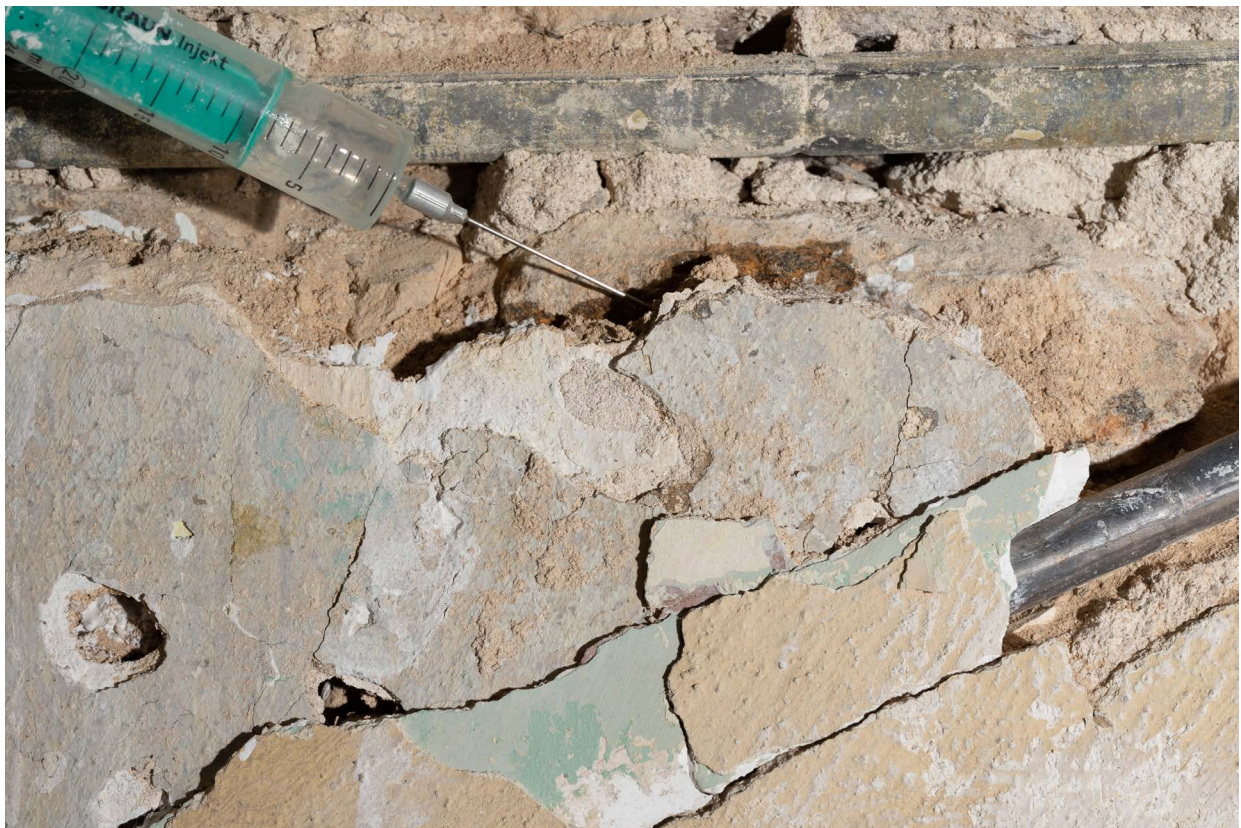
progress of consolidation by Ledan solution  
details of defected area after the removal of dust and disattached plaster particles and during the injection of ethanol water for better penetration of the adhesive  
macrophotographs in day light

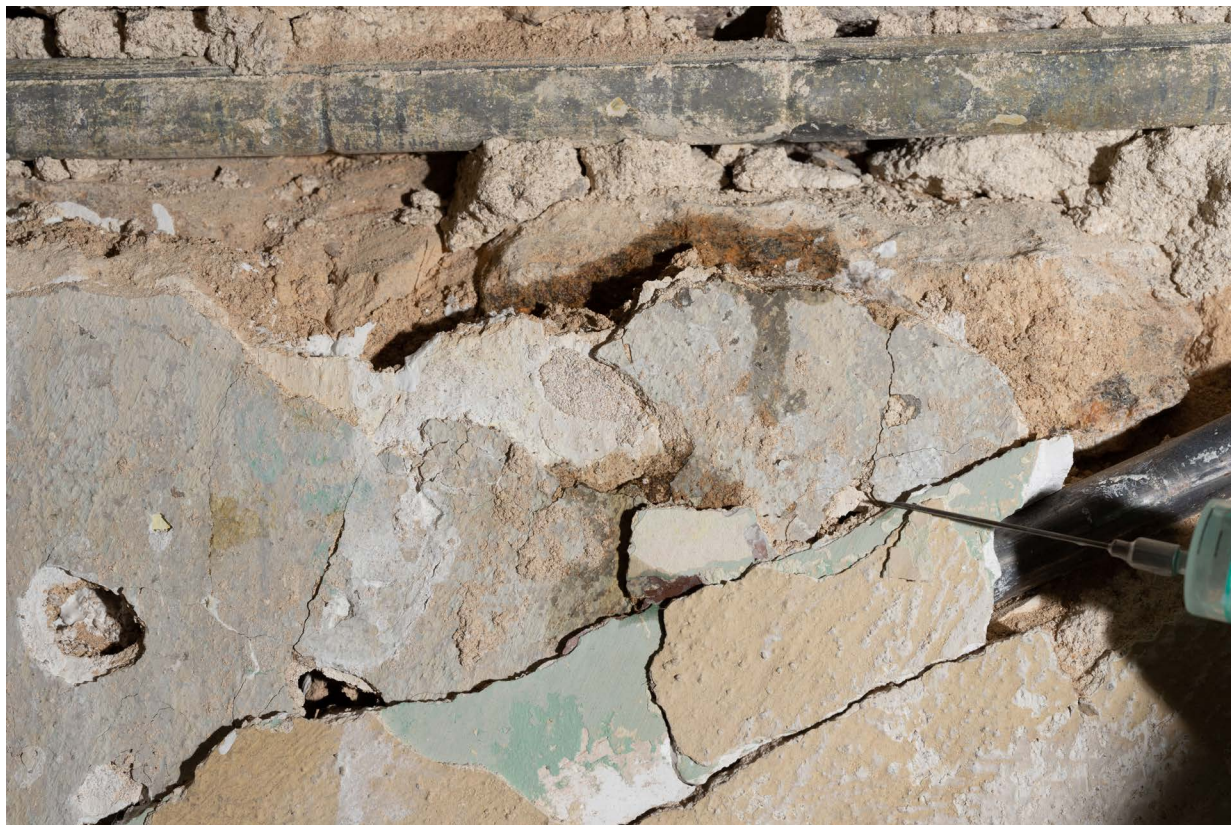
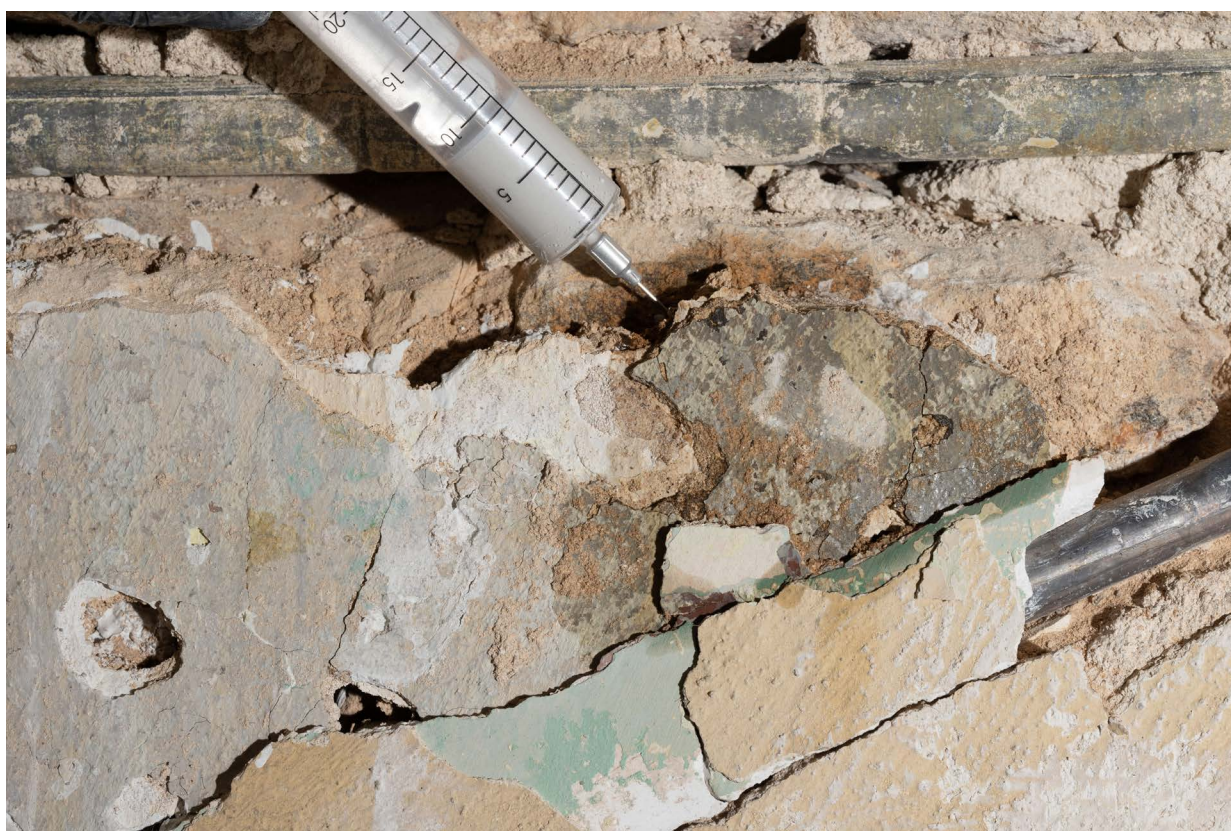
progress of consolidation by Ledan solution  
details of defected area after the injection of ethanol water for better penetration of the adhesive and during the injection of liquid Ledan solution  
macrophotographs in day light

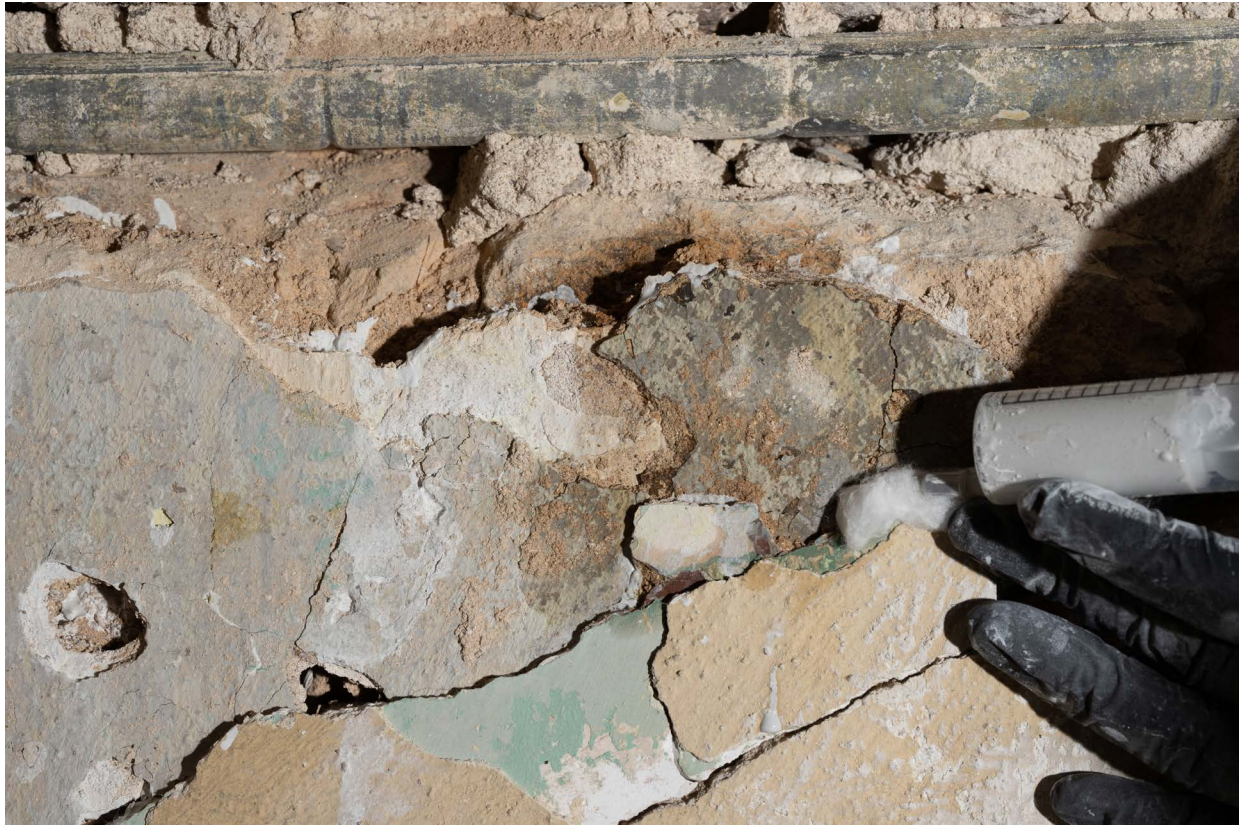
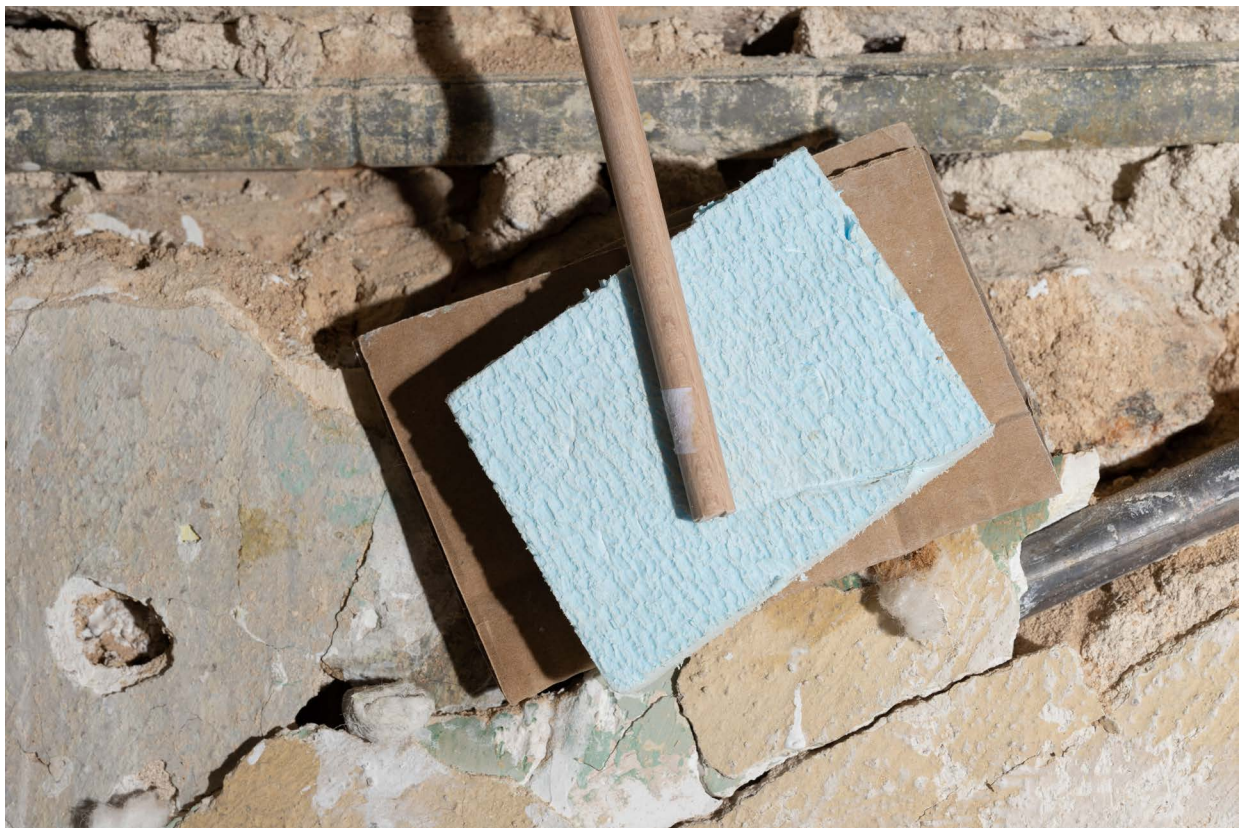
progress of consolidation by Ledan solution  
details of defected area during the injection of liquid Ledan solution and after fixation of the loosened plaster to the wall by a moderate pressure system  
macrophotographs in day light
