# RESTORATION TREATMENT REPORT

## THE STORY OF MOSES KAREL JOSEF MORAVINI

wall painting in the interior of chamber in a ground floor of southwest part of castle Kácov  
1730s  
private owner

Alžběta Mirjam Procházková  
Academy of Fine Arts in Prague  
Studio of Restoration of Painted Artworks and Polychrome Sculpture  
akademic years 2022/2023 - 2022/2024

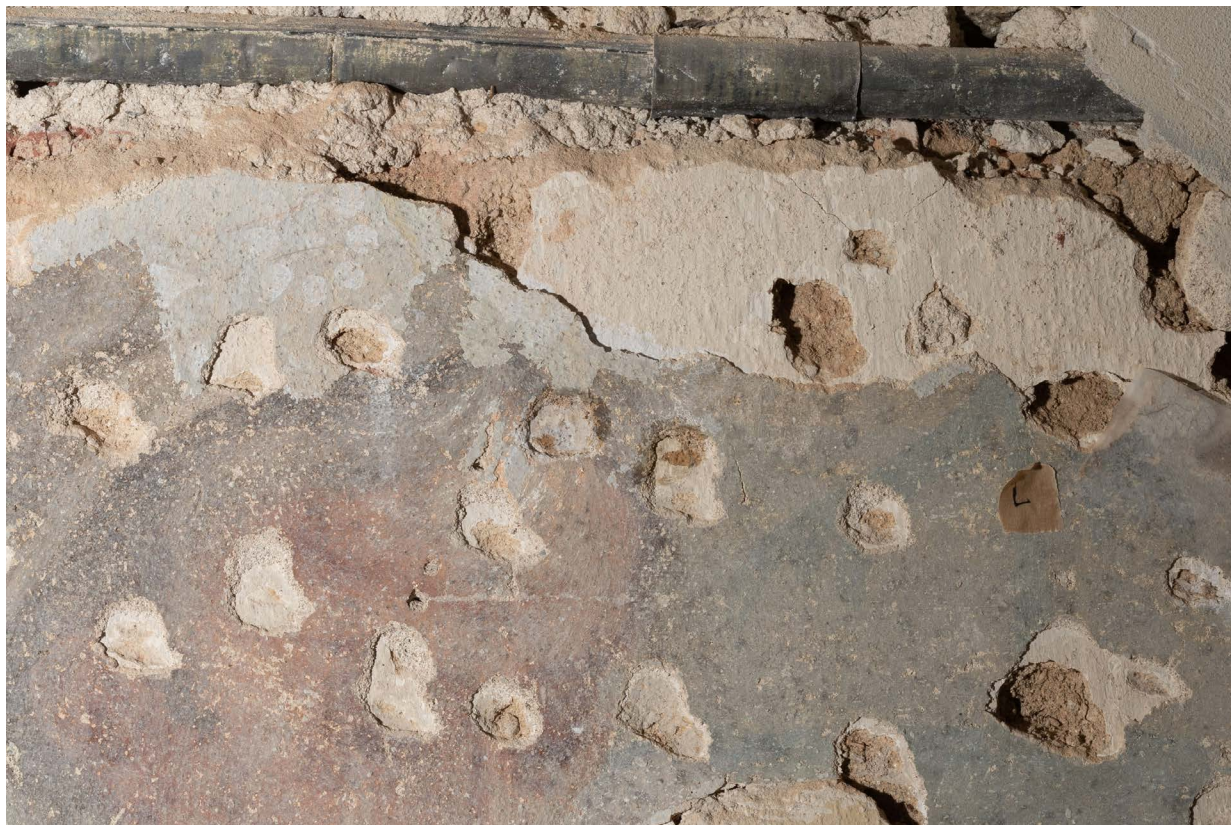
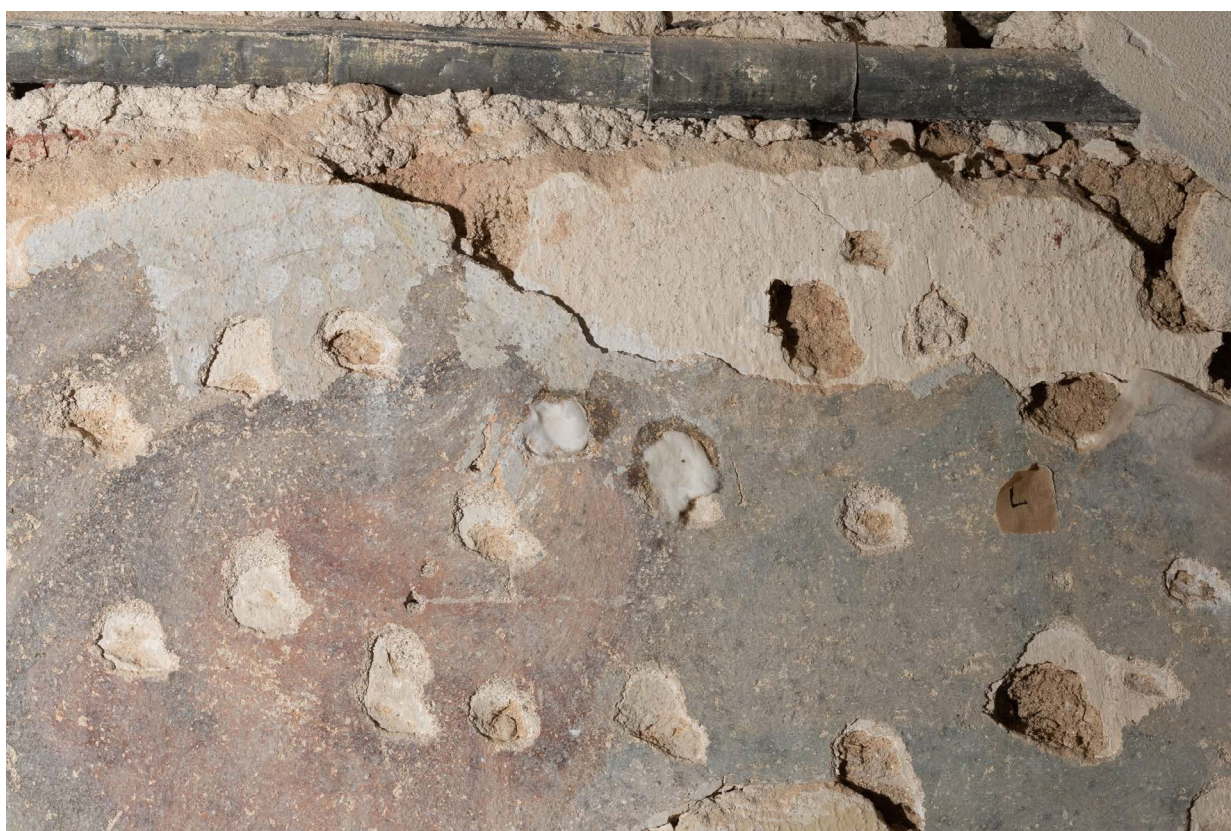
progress of consolidation by Ledan solution  
details of defected area before the consolidation and after injection of ethanol water solution to increase the penetration of the Ledan solution and fixation of cotton swabs to reduce the pouring out the adhesive solution  
macrophotographs in day light

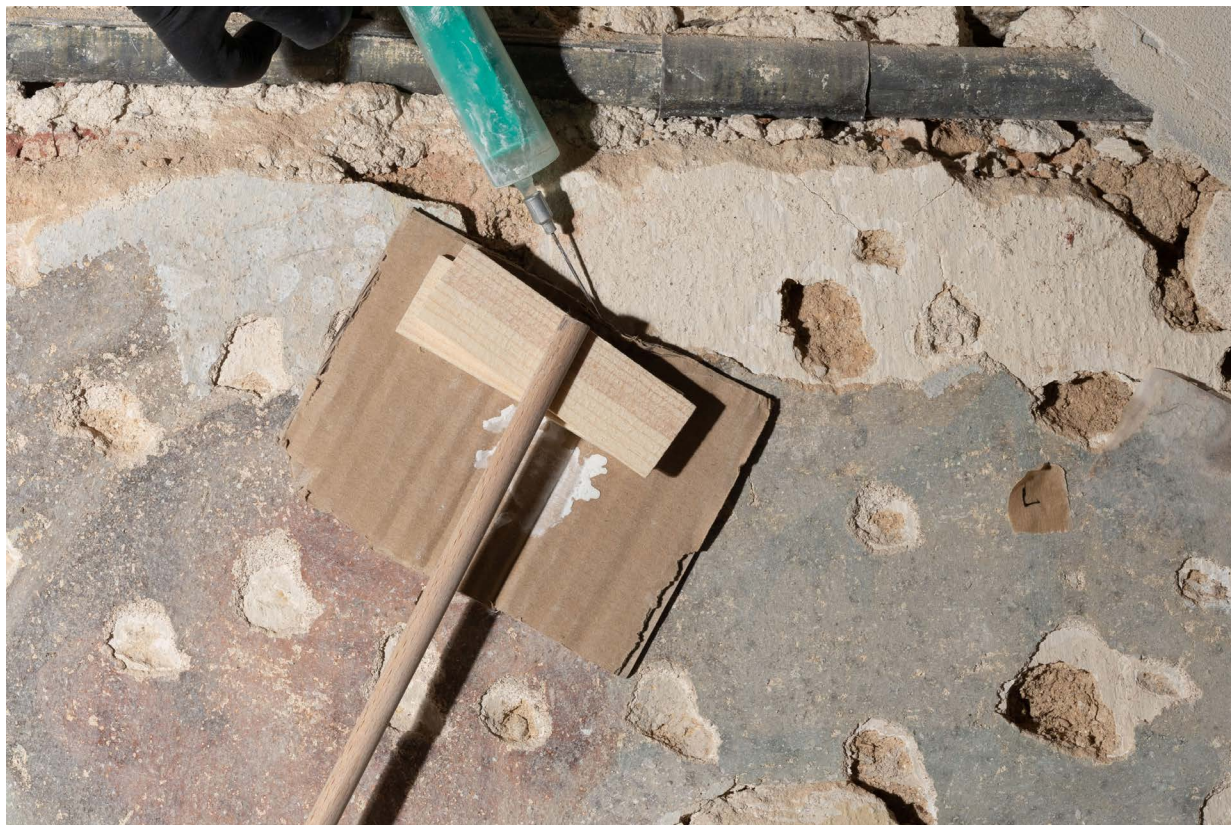
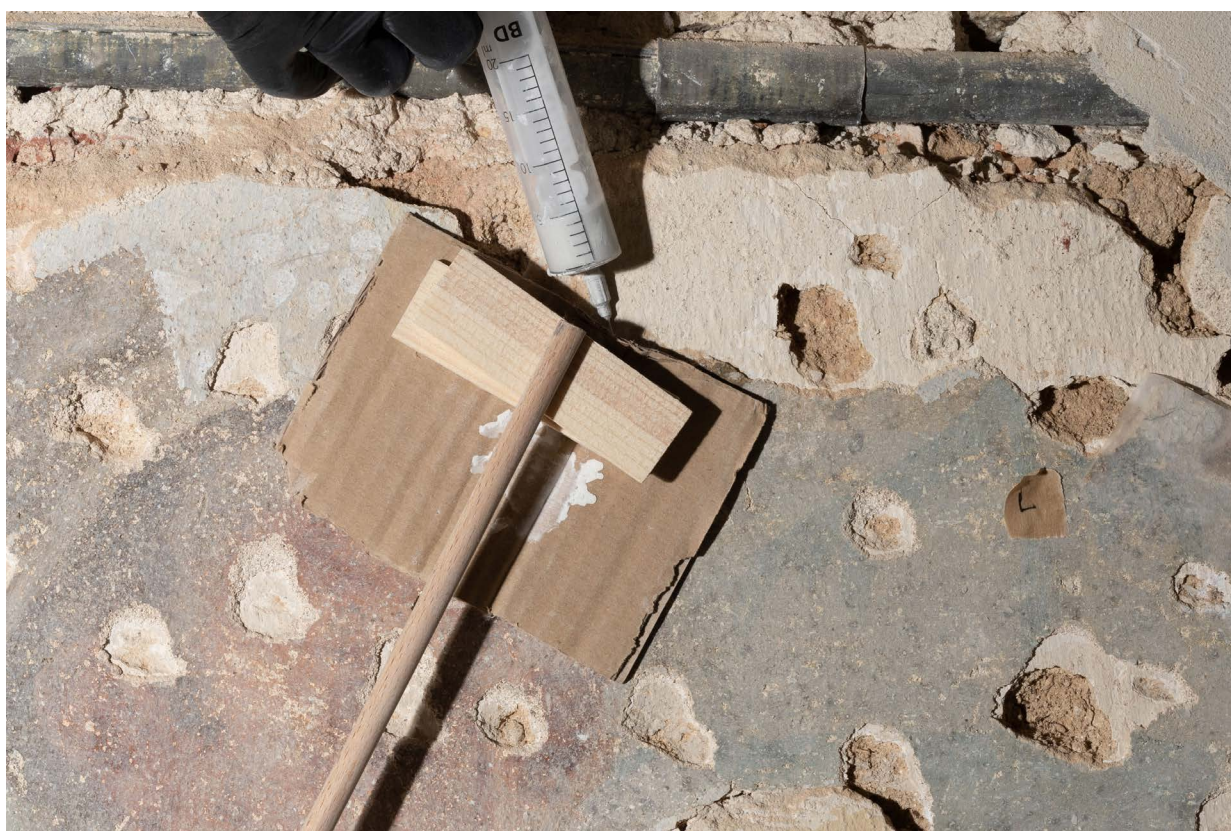
progress of consolidation by Ledan solution  
details of defected area during injection of ethanol water solution to increase the penetration and during the injection of the Ledan solution, both applied after fixation of the loosened plaster layer by the moderate pressure system  
macrophotographs in day light

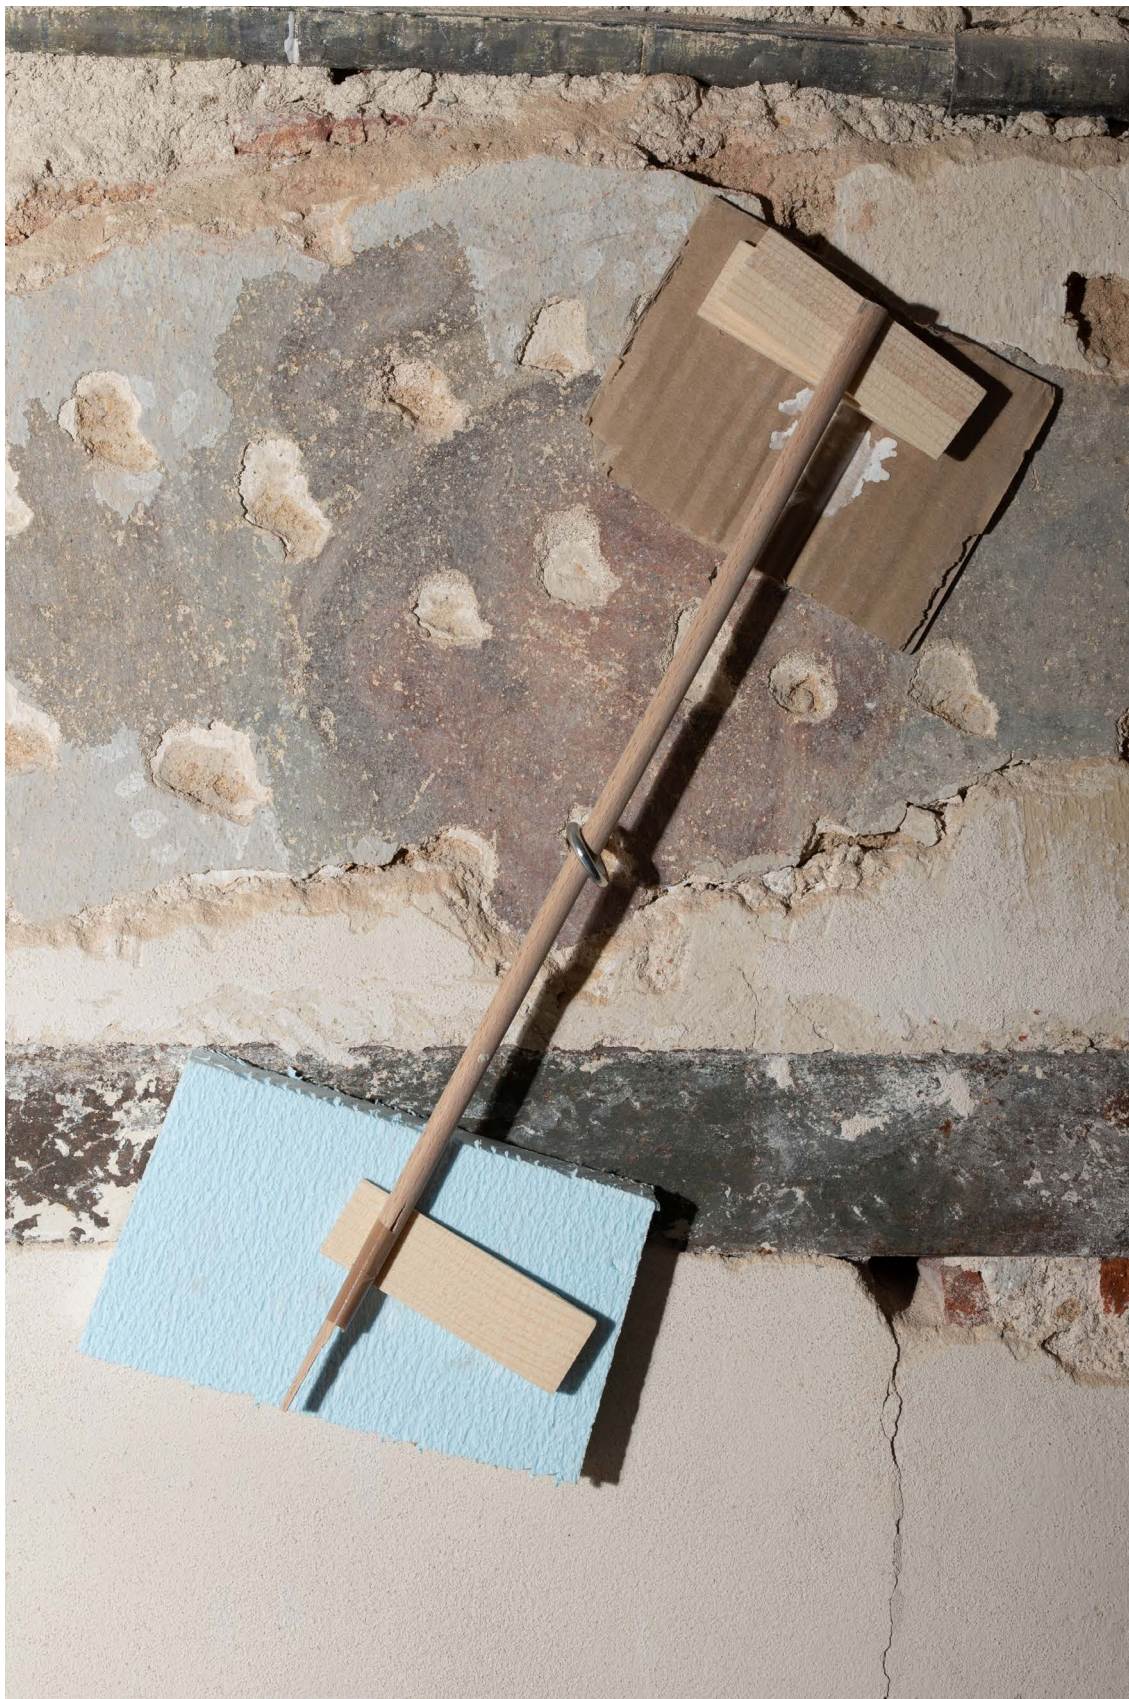
progress of consolidation by Ledan solution  
detail of fixation of the loosened plaster layers by moderate pressure system  
macrophotography in day light

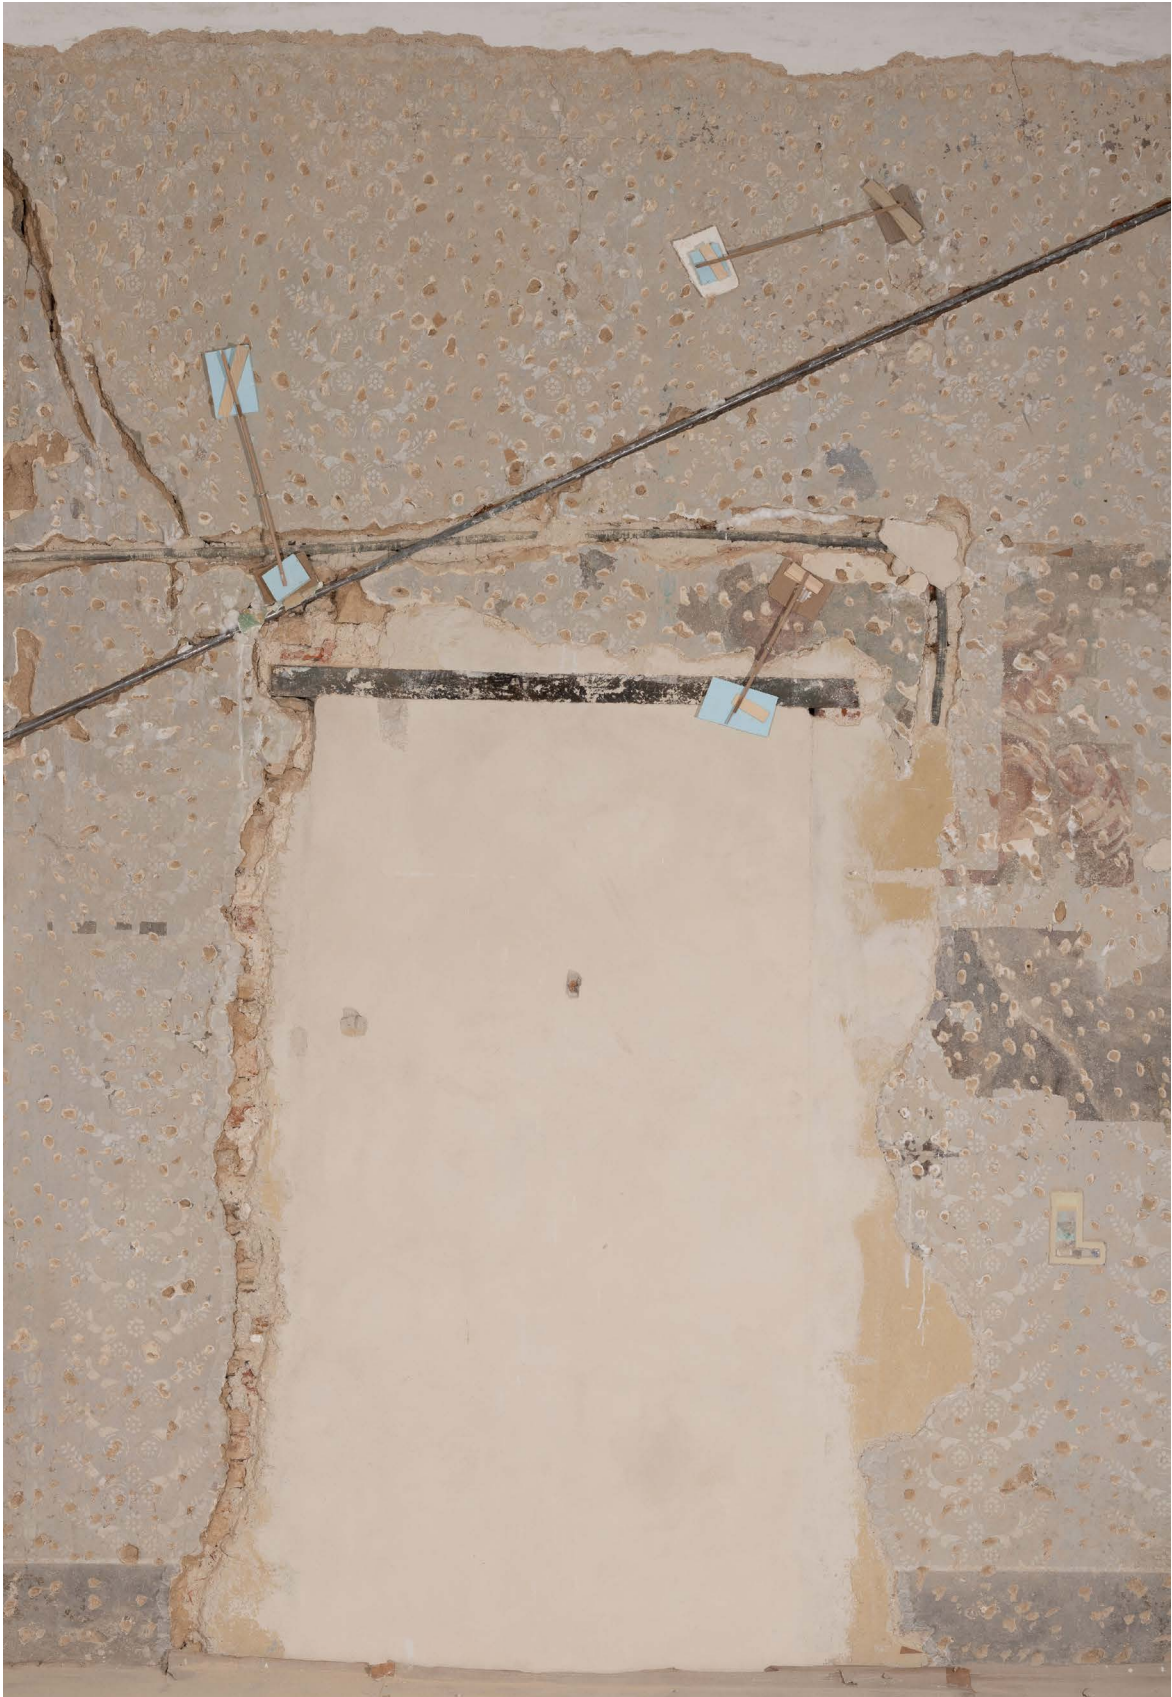
progress of consolidation by Ledan solution  
detail of fixation of the loosened plaster layers by moderate pressure systems  
photography in day light

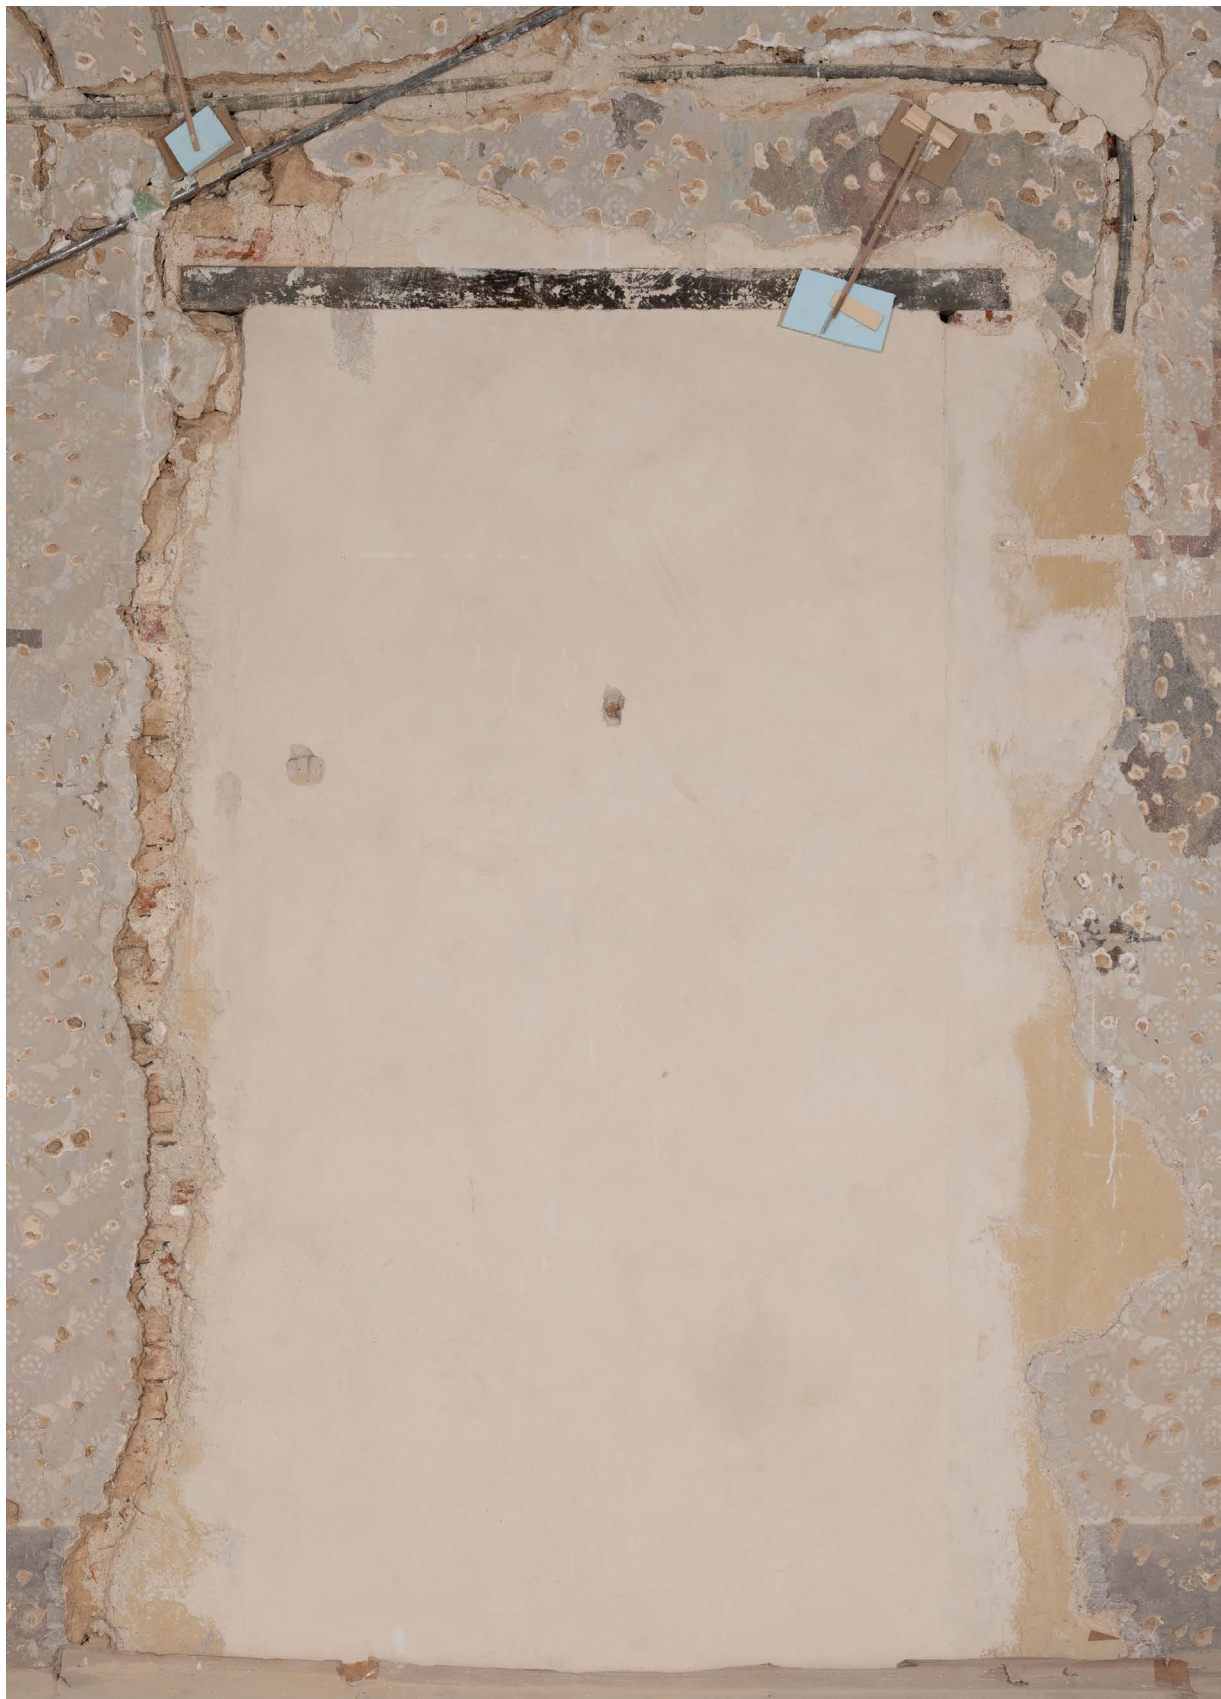
progress of the removal of modern plaster around the walled door  
photography in day light, detail

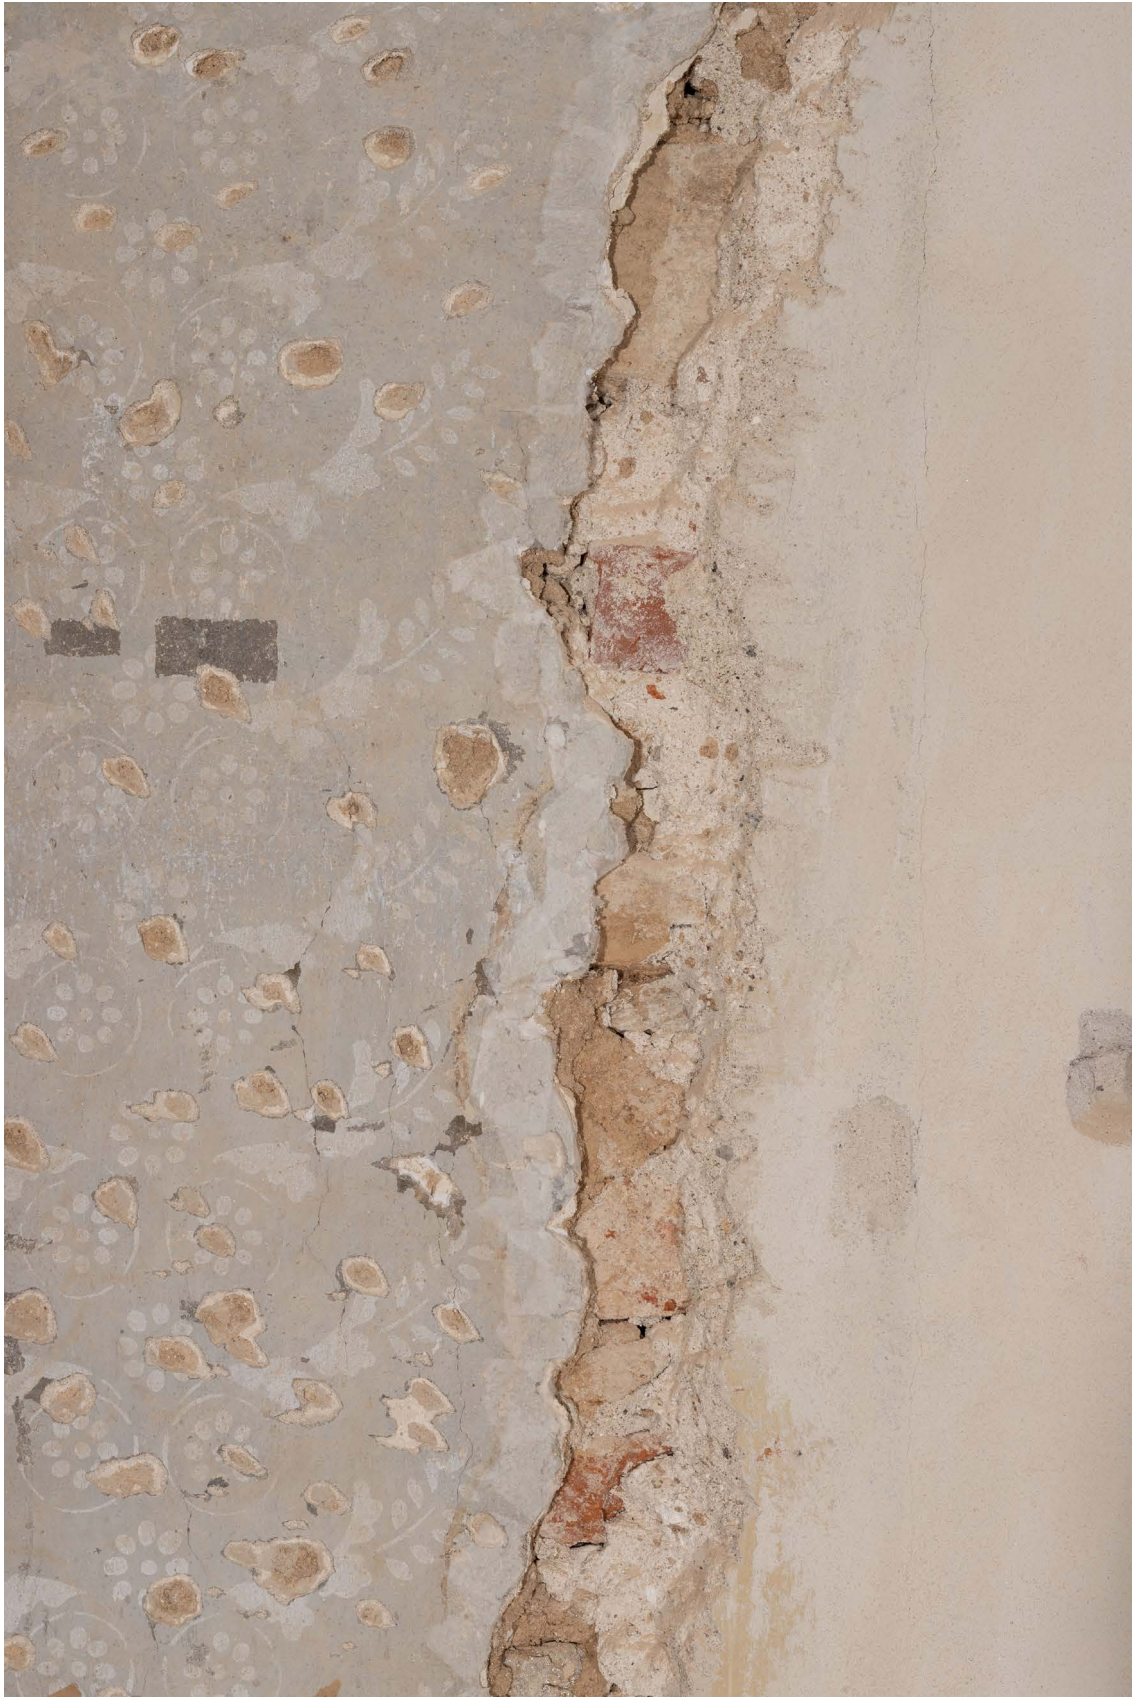
progress of the removal of modern plaster around the walled door  
detail of the tylose facing for protection of the original painted plaster  
photography in day light

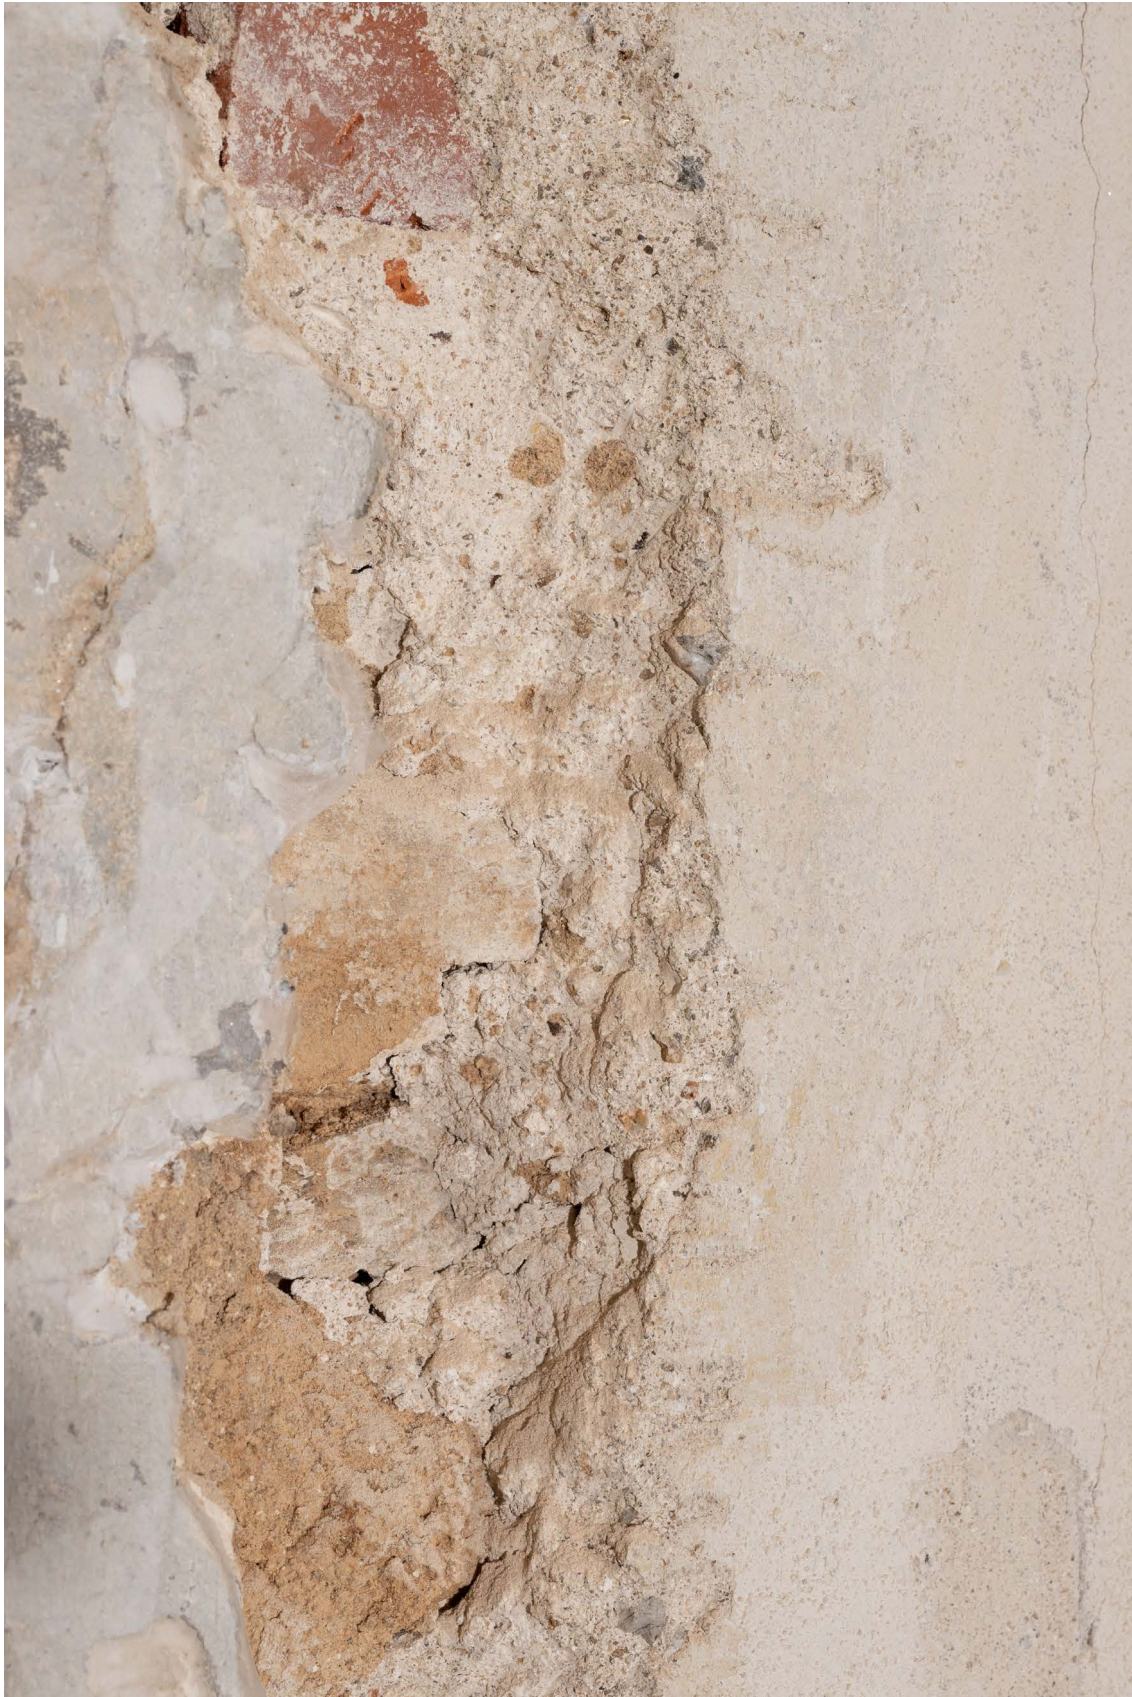
progress of the removal of modern plaster around the walled door  
detail of the tylose facing for portecion of the original painted plaster  
photography in day light

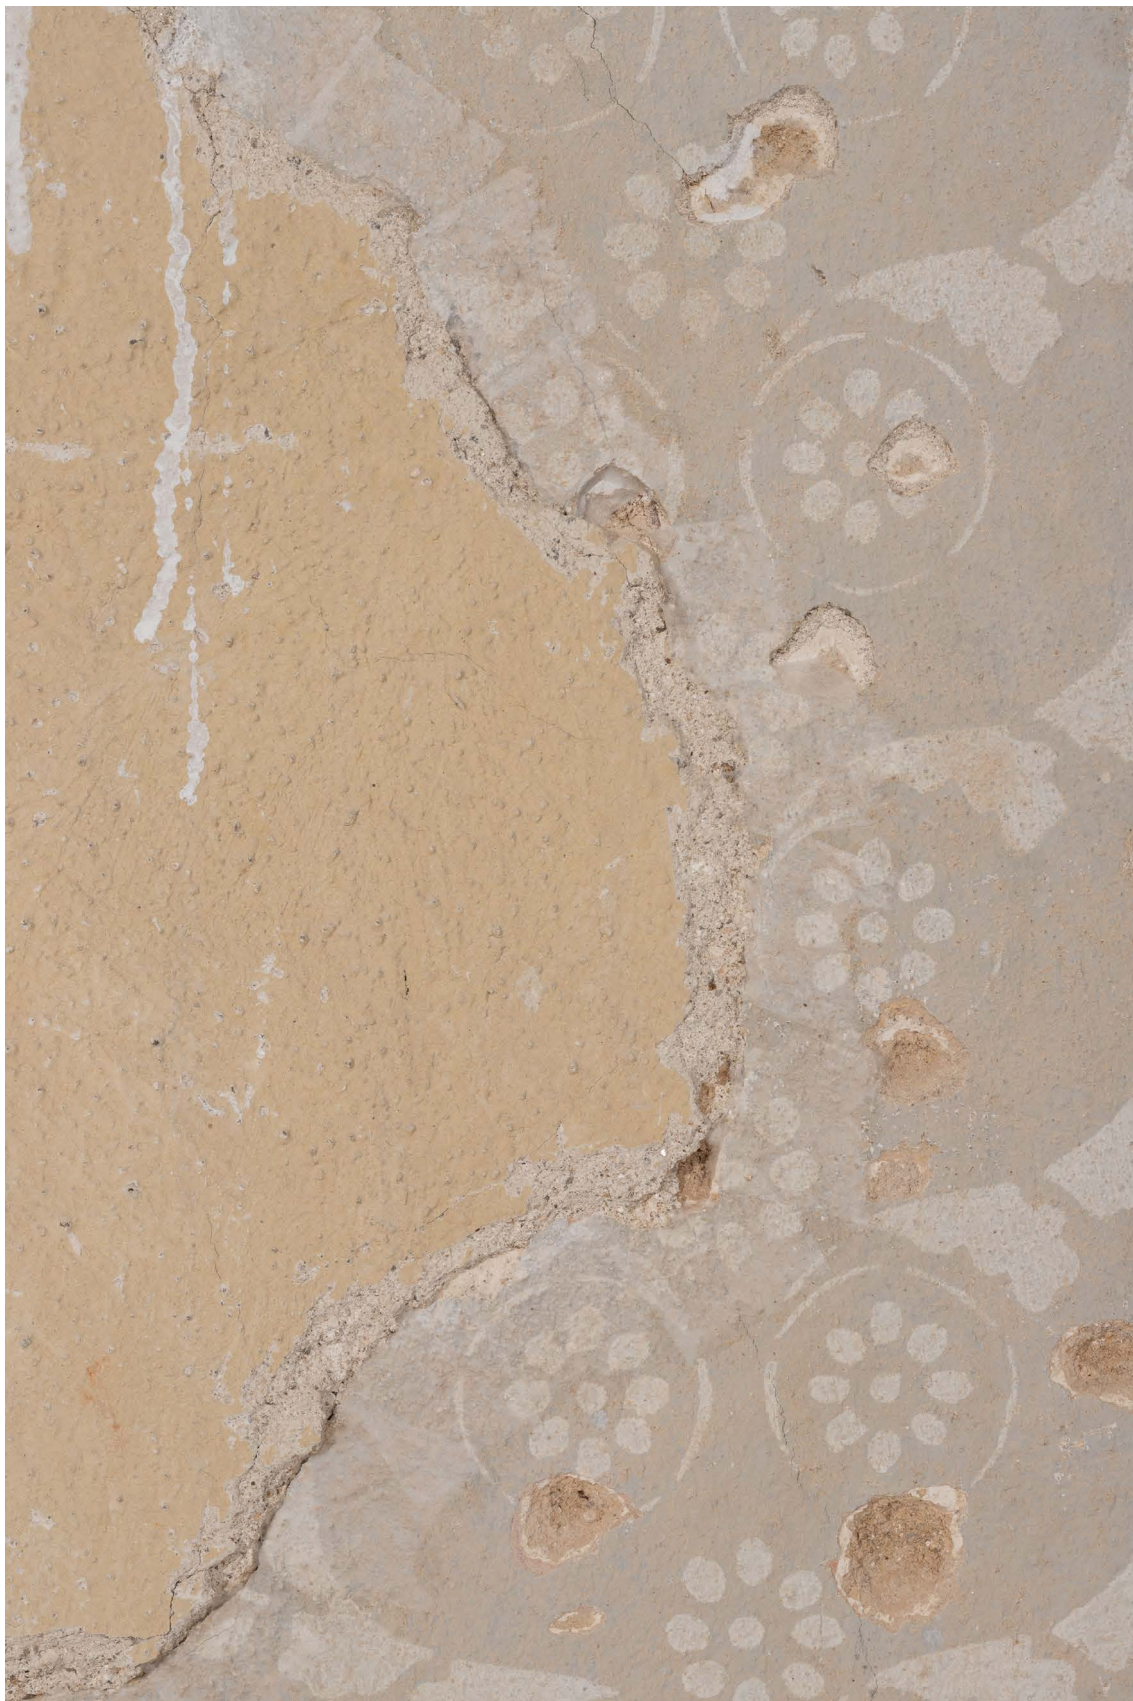
progress of the removal of modern plaster around the walled door  
detail of the tylose facing for portection of the original painted plaster  
photography in day light

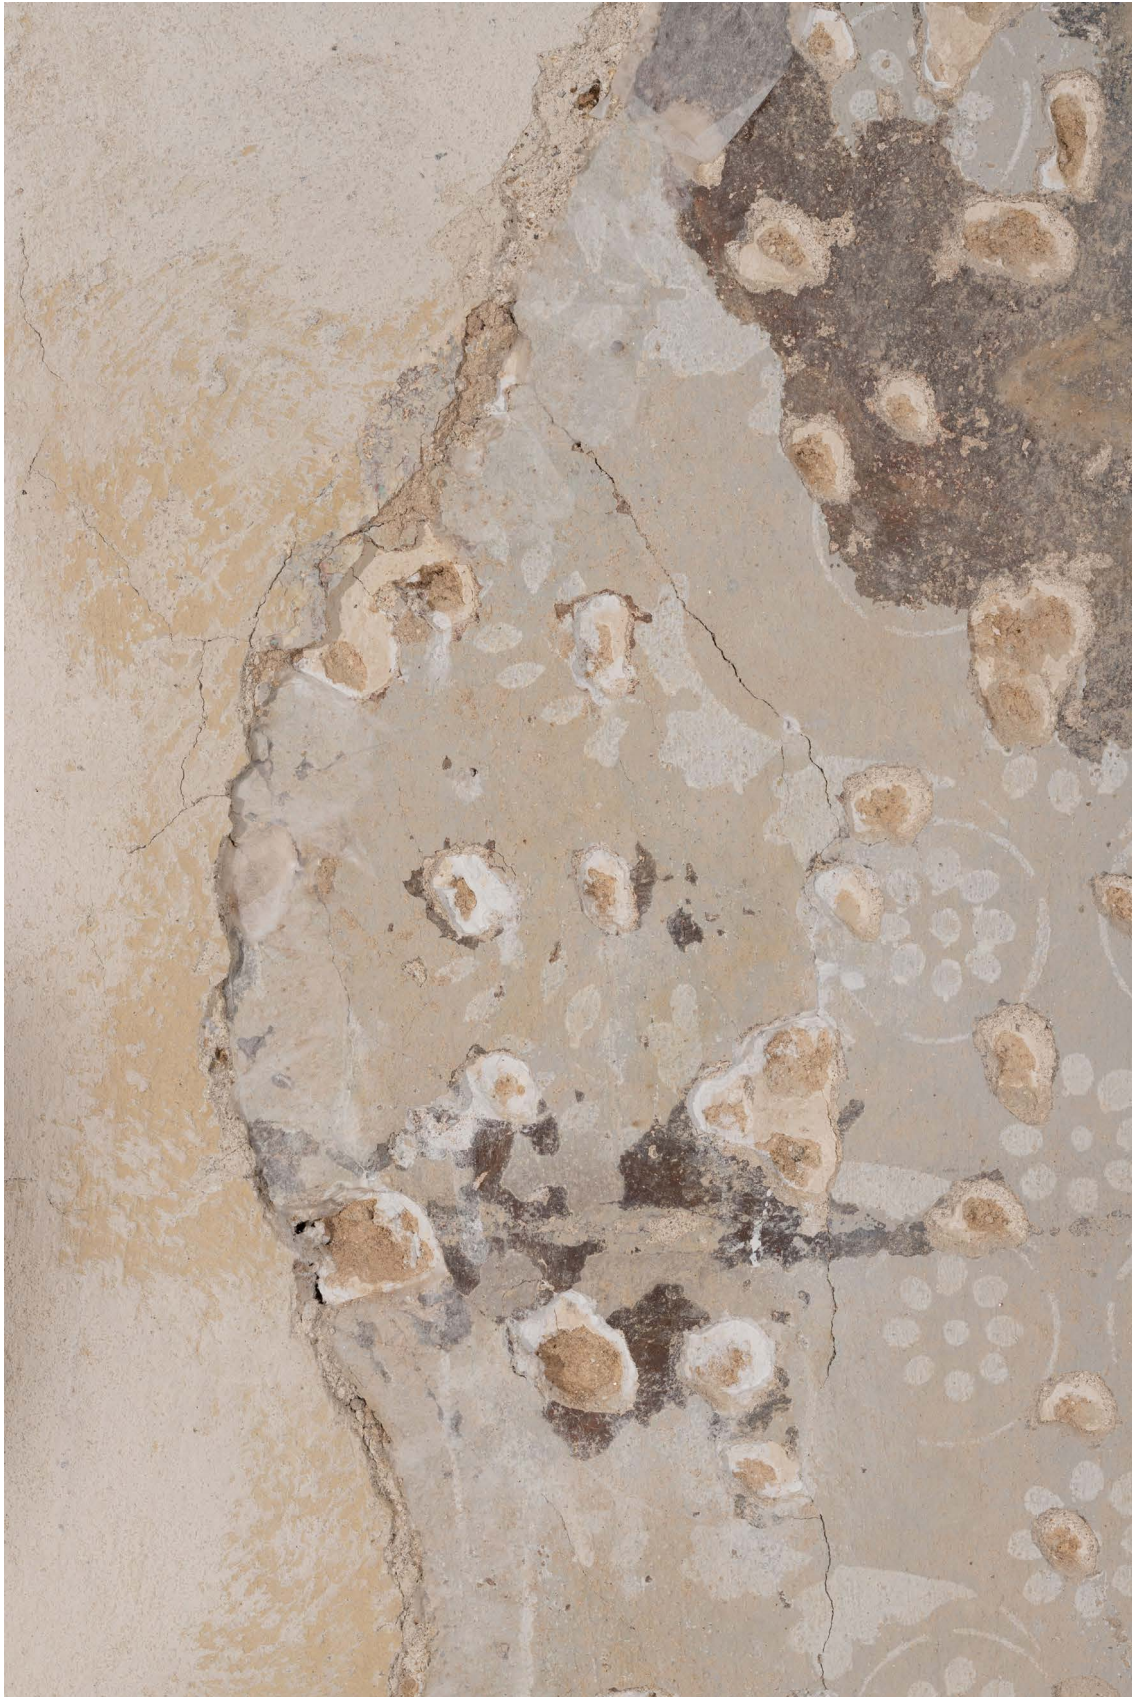
progress of the removal of modern plaster around the walled door  
detail of the consolidation with Ledan solution of the original painted plaster before the removal of the plaster around the walled door  
photography in day light

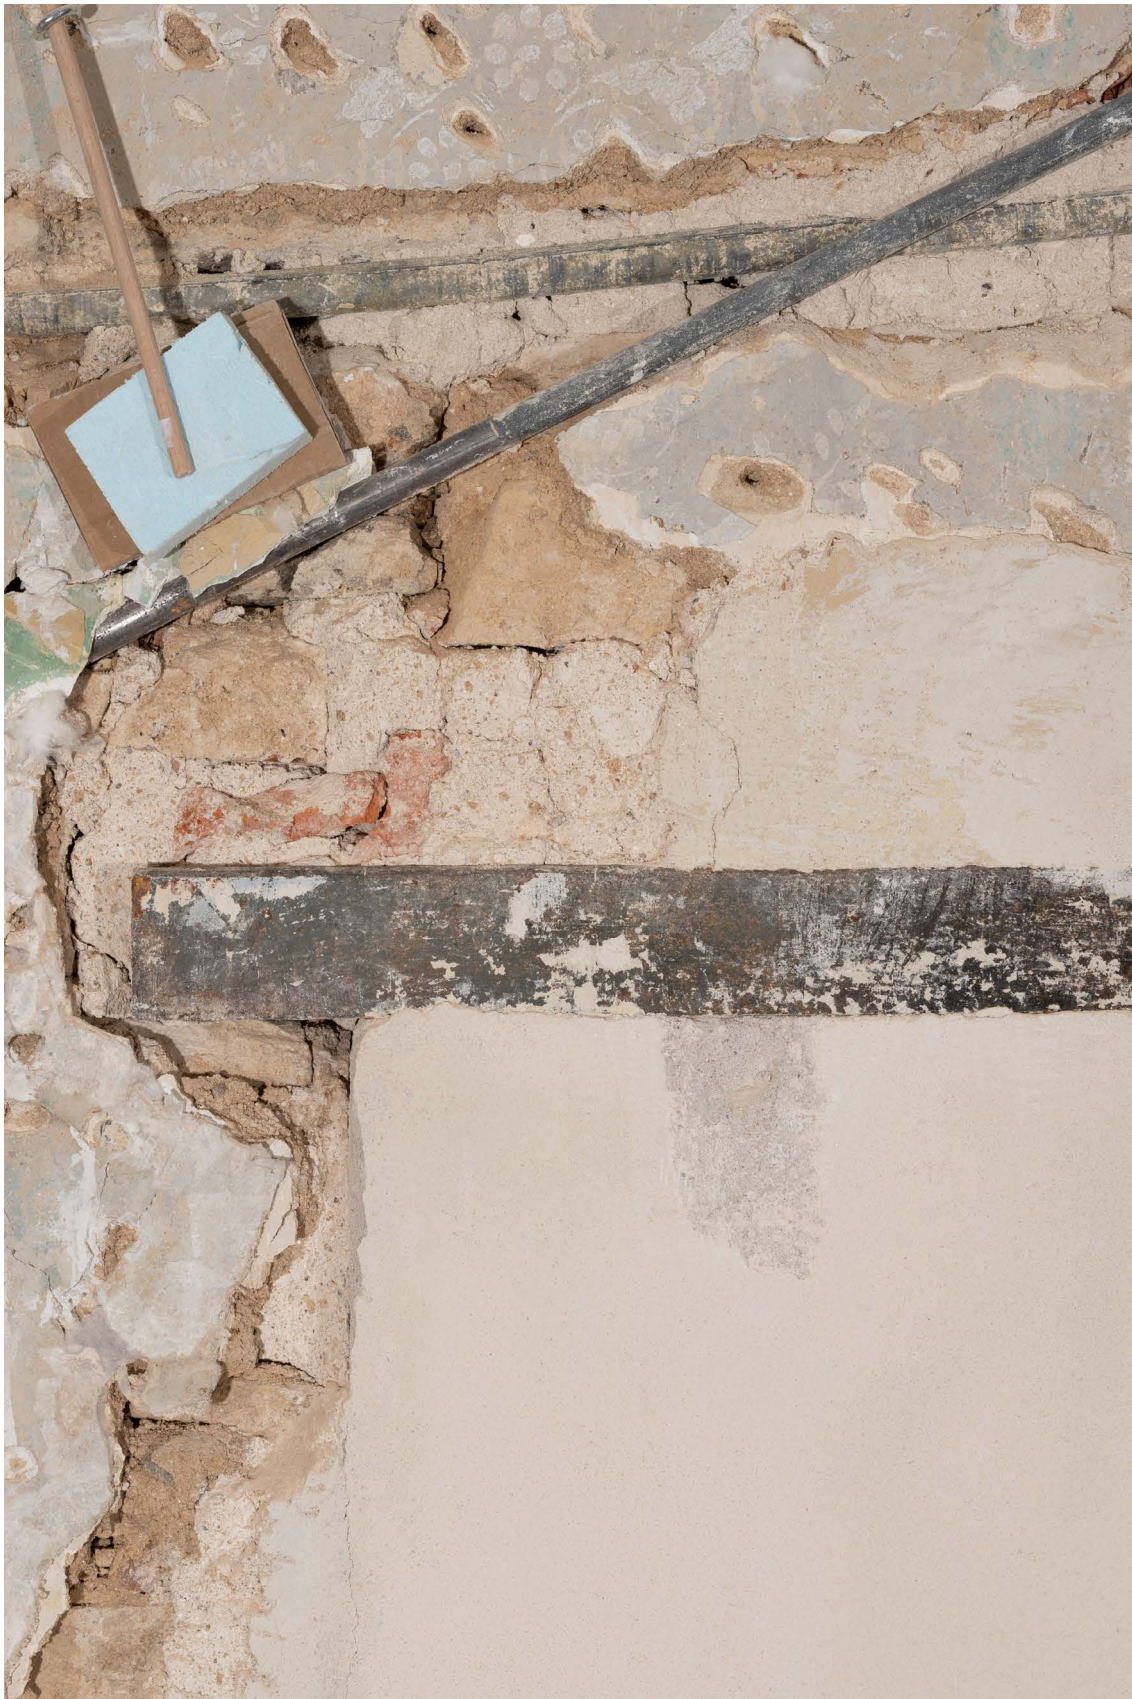
progress of the removal of modern plaster around the walled door  
detail of the tylose facing for portection of the original painted plaster around the defected areas caused by insertion of door and electricity cables  
photography in day light

7. Application of the facings around the defected areas caused by secondary inserted electricity cables and walled door. Consolidation and reinforcement of the plaster layers around these areas.

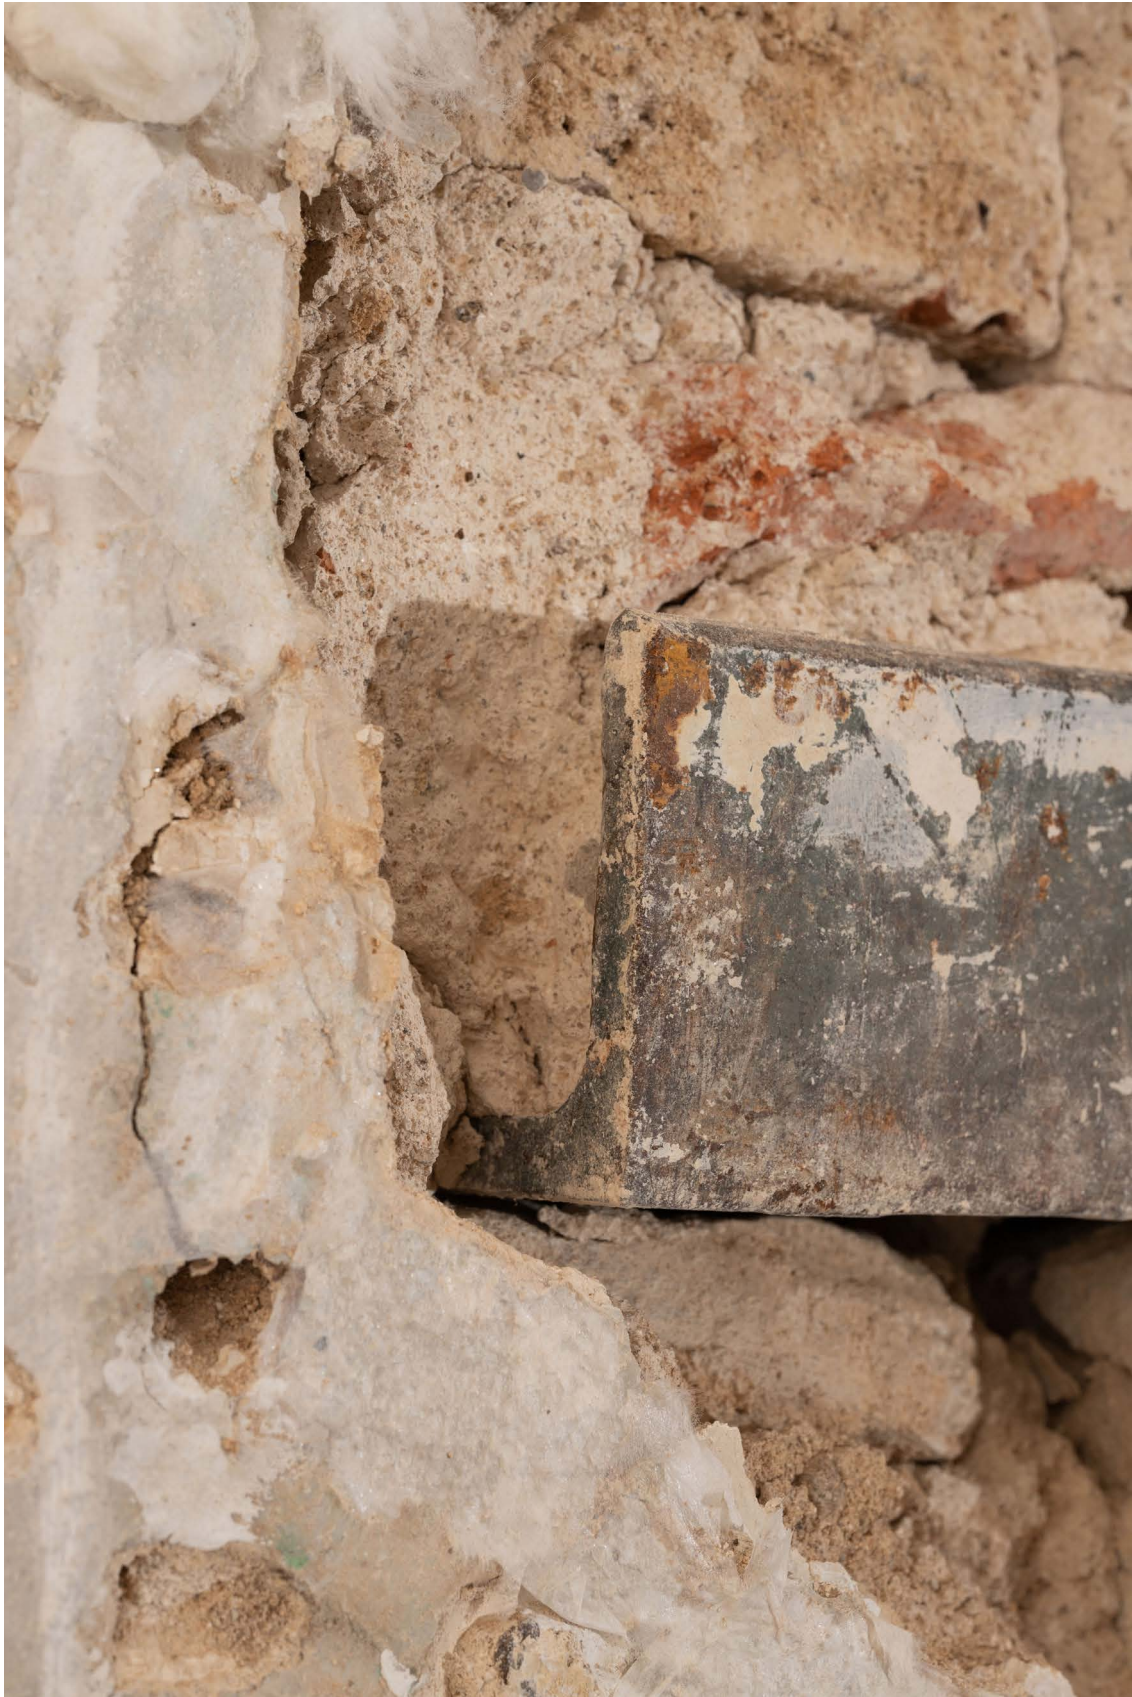
progress of the removal of modern plaster around the walled door  
detail of the tylose facing for portecion of the original painted plaster around the traverse extending beyond the level of the original painted plaster layer  
photography in day light
