# RESTORATION TREATMENT REPORT

## THE STORY OF MOSES KAREL JOSEF MORAVINI

wall painting in the interior of chamber in a ground floor of southwest part of castle Kácov  
1730s  
private owner

Alžběta Mirjam Procházková  
Academy of Fine Arts in Prague  
Studio of Restoration of Painted Artworks and Polychrome Sculpture  
akademic years 2022/2023 - 2022/2024

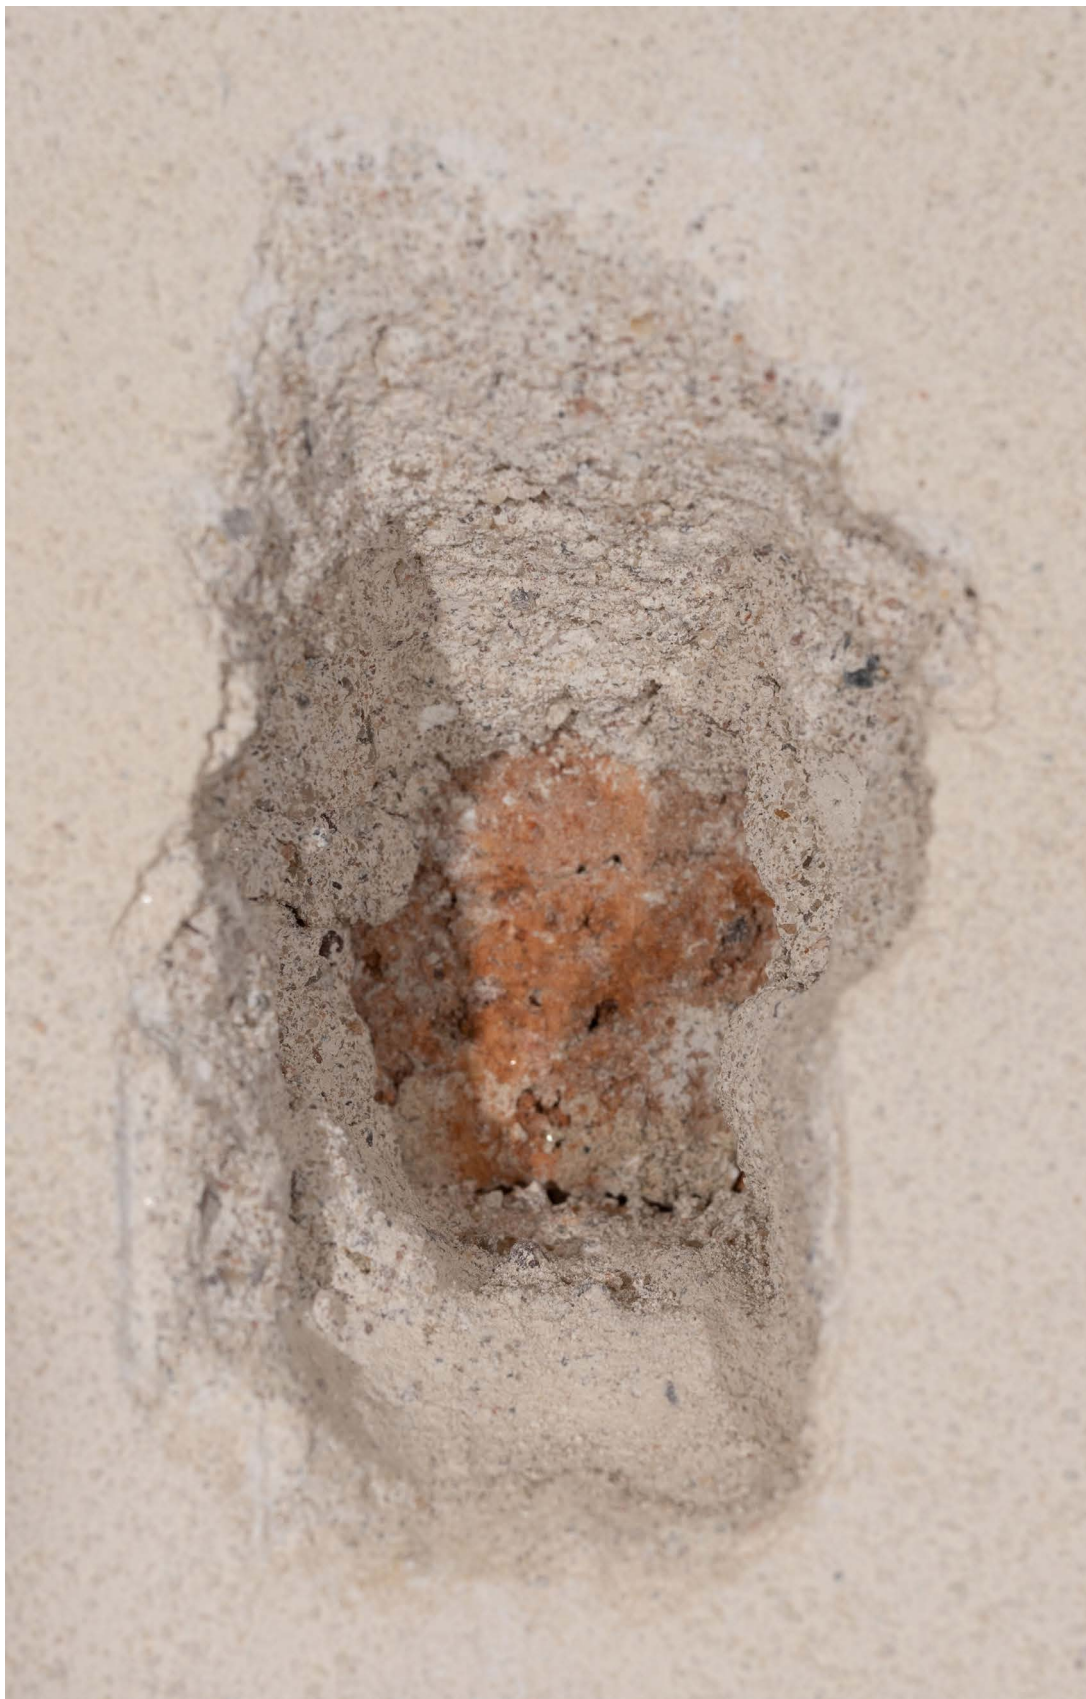
progress of the removal of modern plaster around the walled door  
detail of probe on the brick of the walled door exhibiting the thickness of the plaster layer  
macrophotography in day light

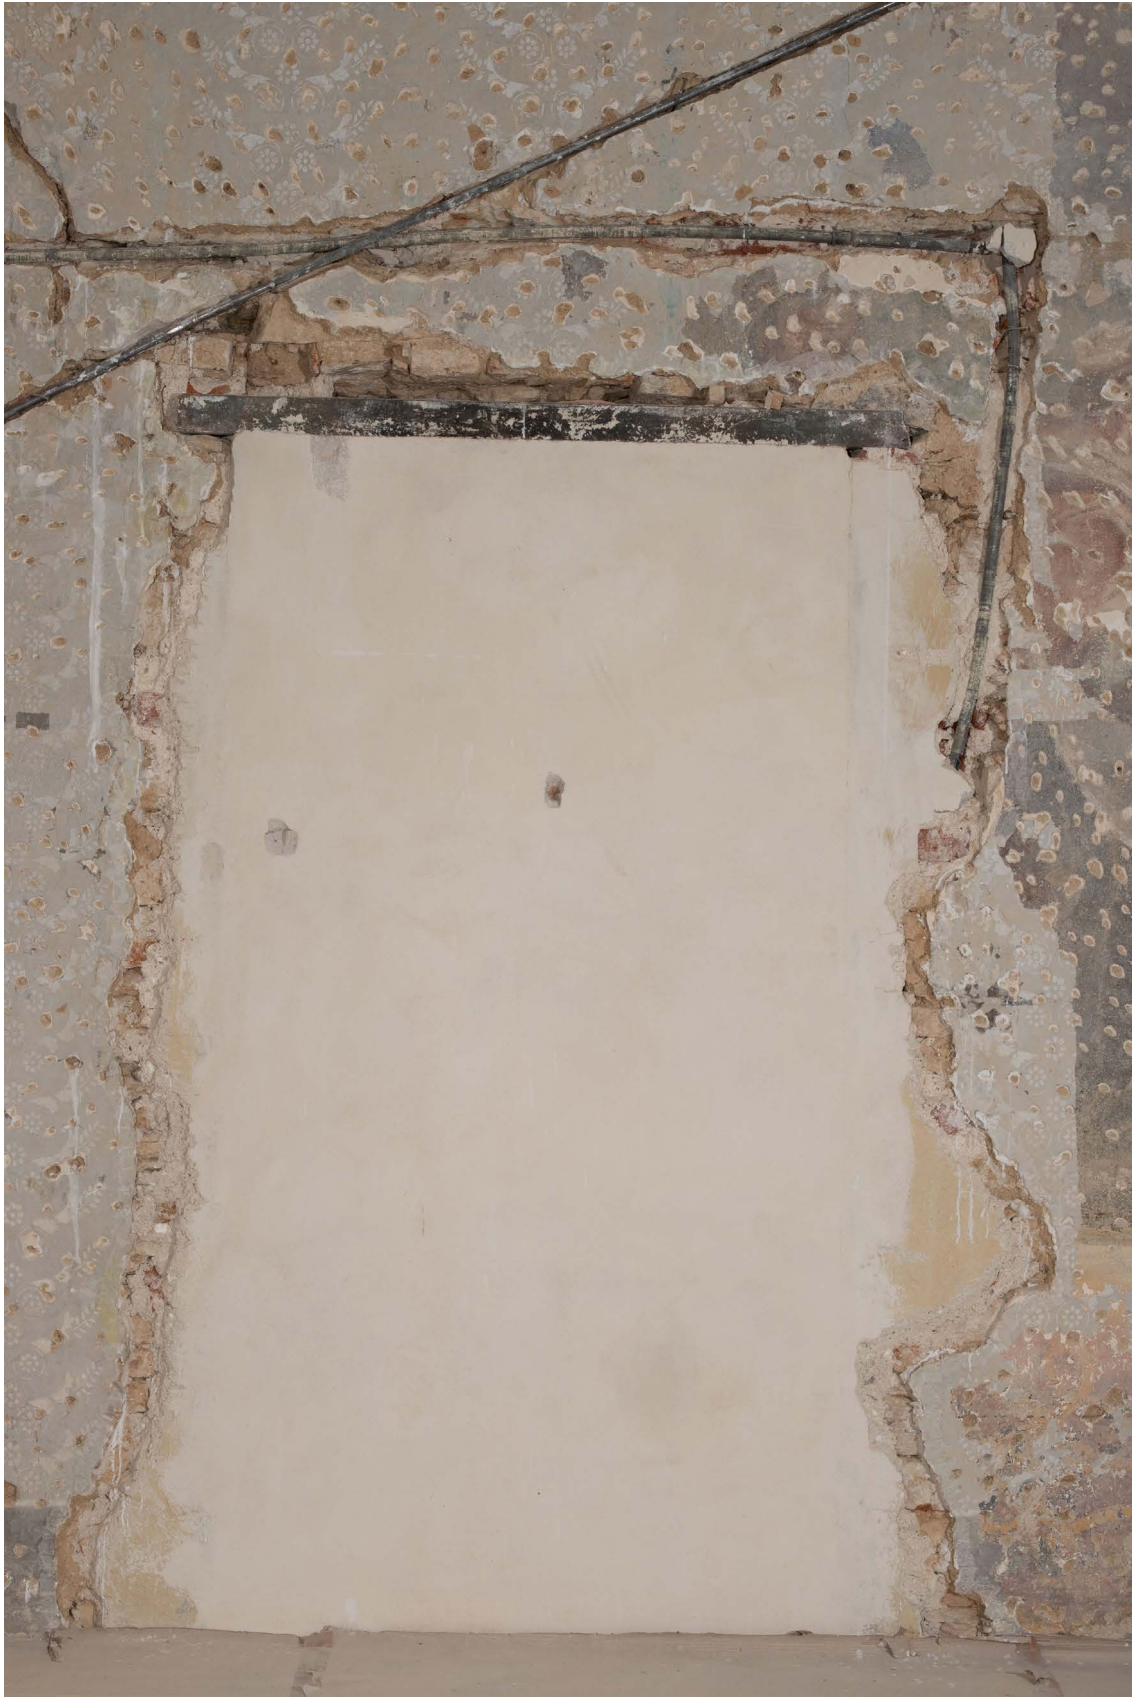
condition after the removal of modern plaster around the walled door  
photography in day light

8. Mechanical removal of the non-original plaster within the electricity cables and plaster covering defects around the secondary inserted and lately walled door.

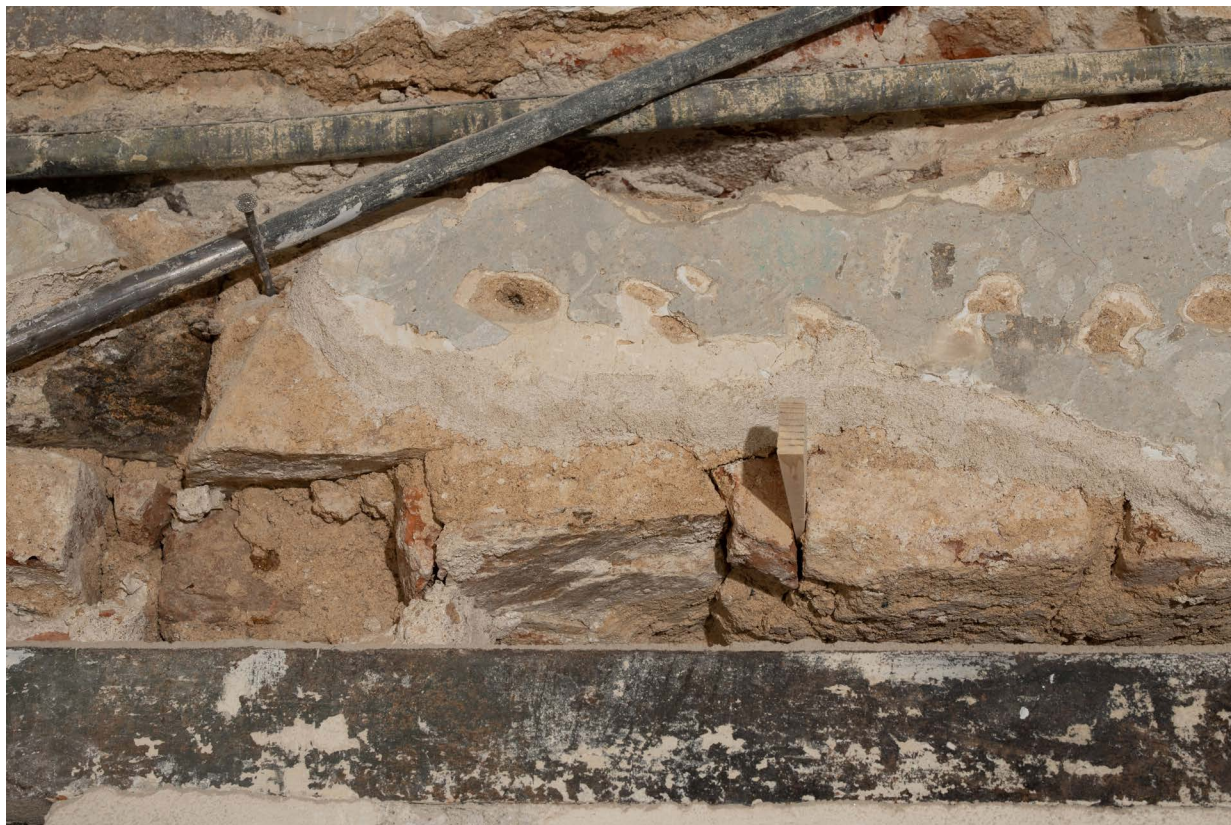
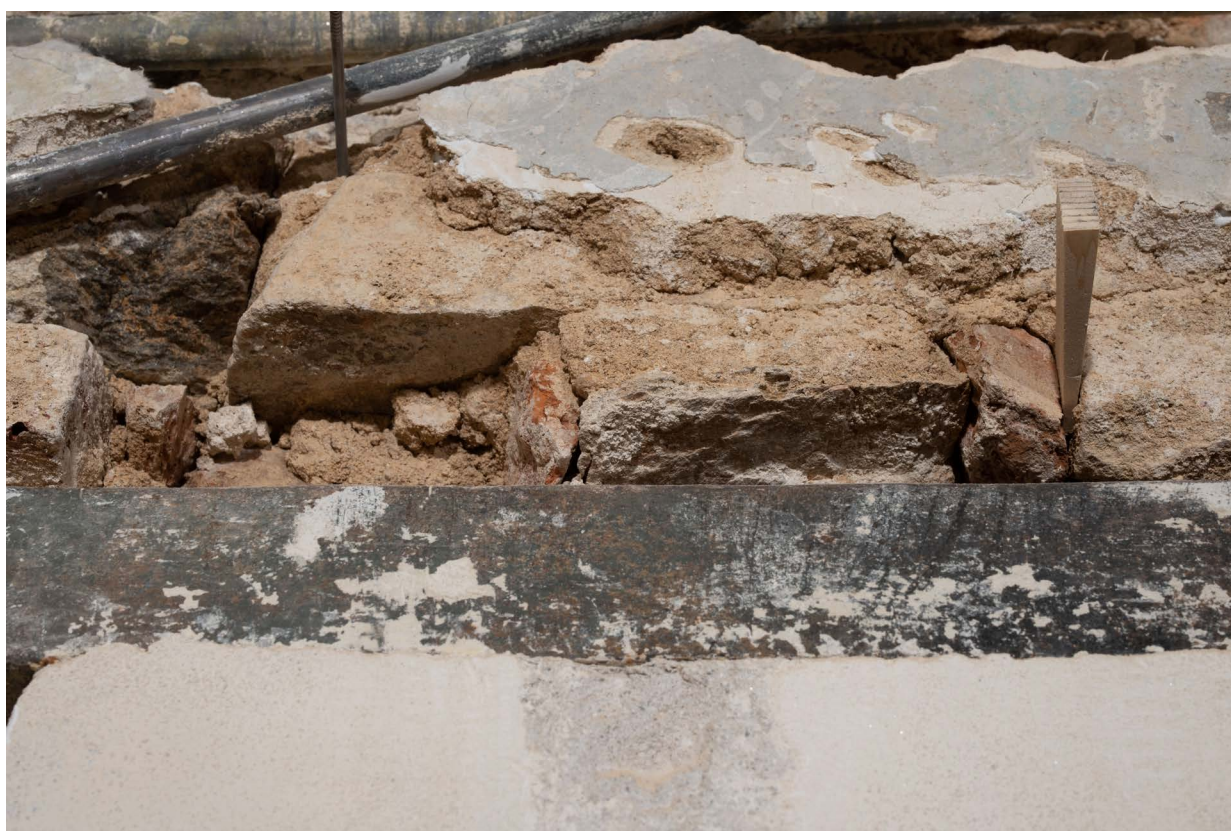
condition after the removal of modern plaster around the walled door

detail of range of defects in wall and lost of original painted plaster layer around the traverse and electricity cables and fixation of the plaster with original wall painting in the position by wooden pins

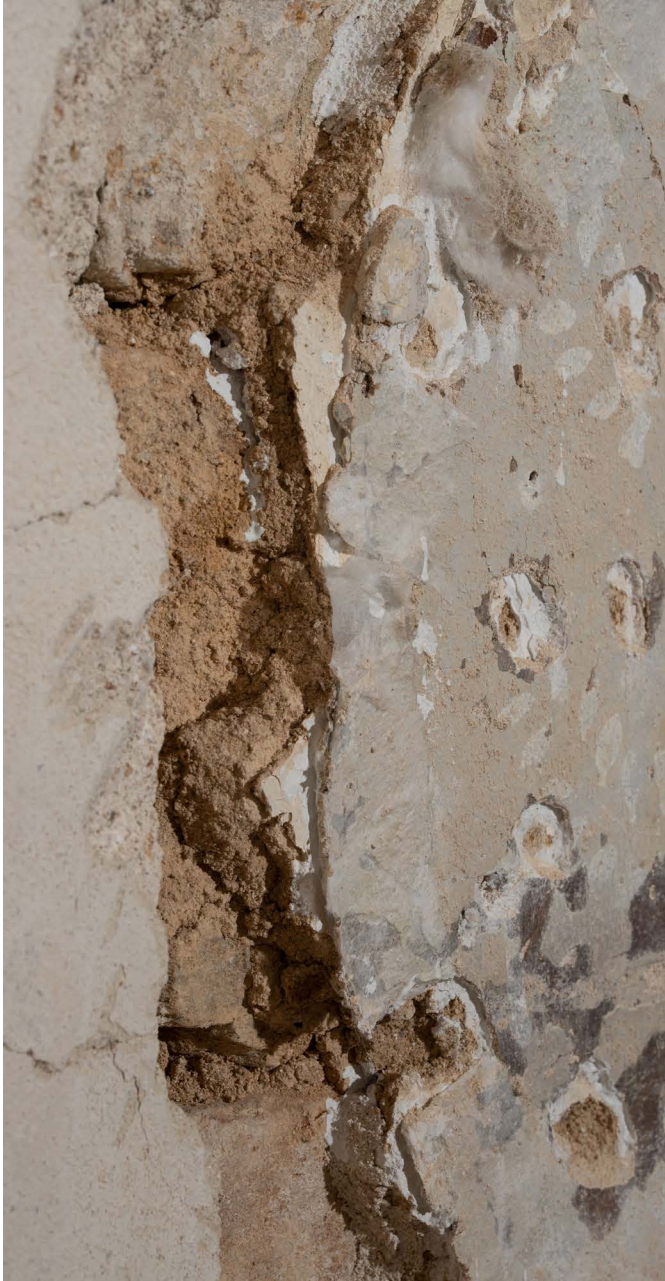
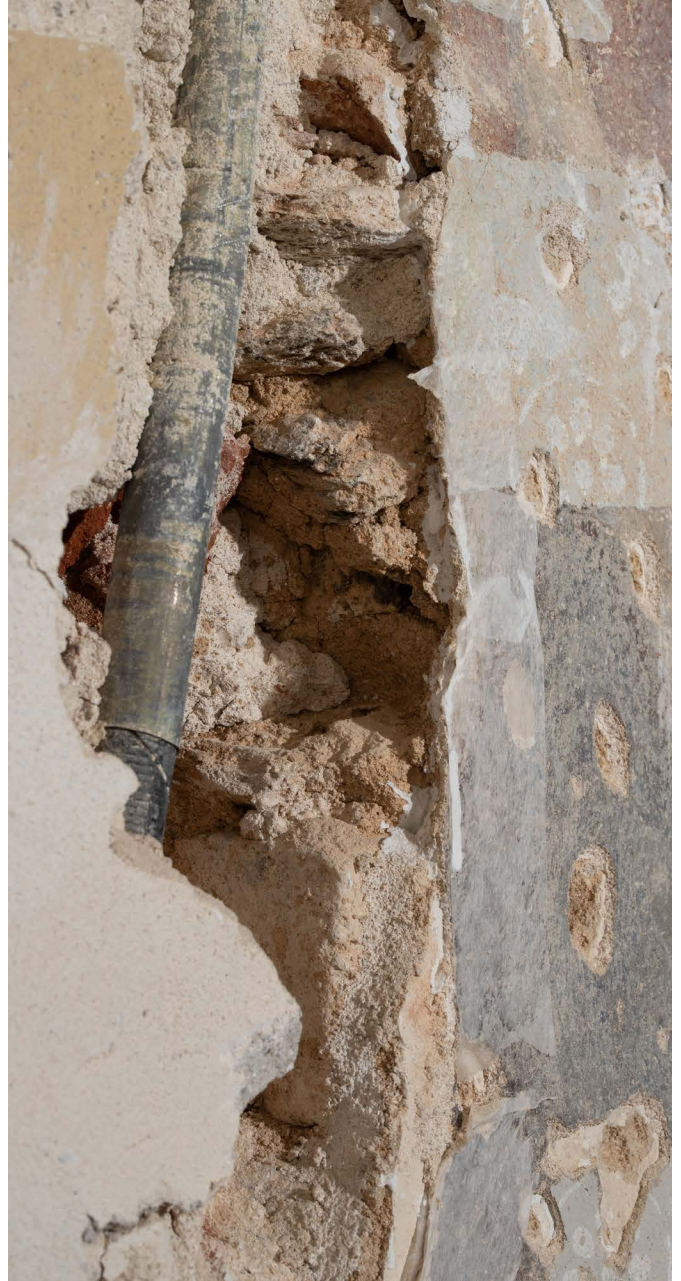
condition after the removal of modern plaster around the walled door  
detail of range of defects and lost of original painted plaster layer around the walled door  
photographs in day light

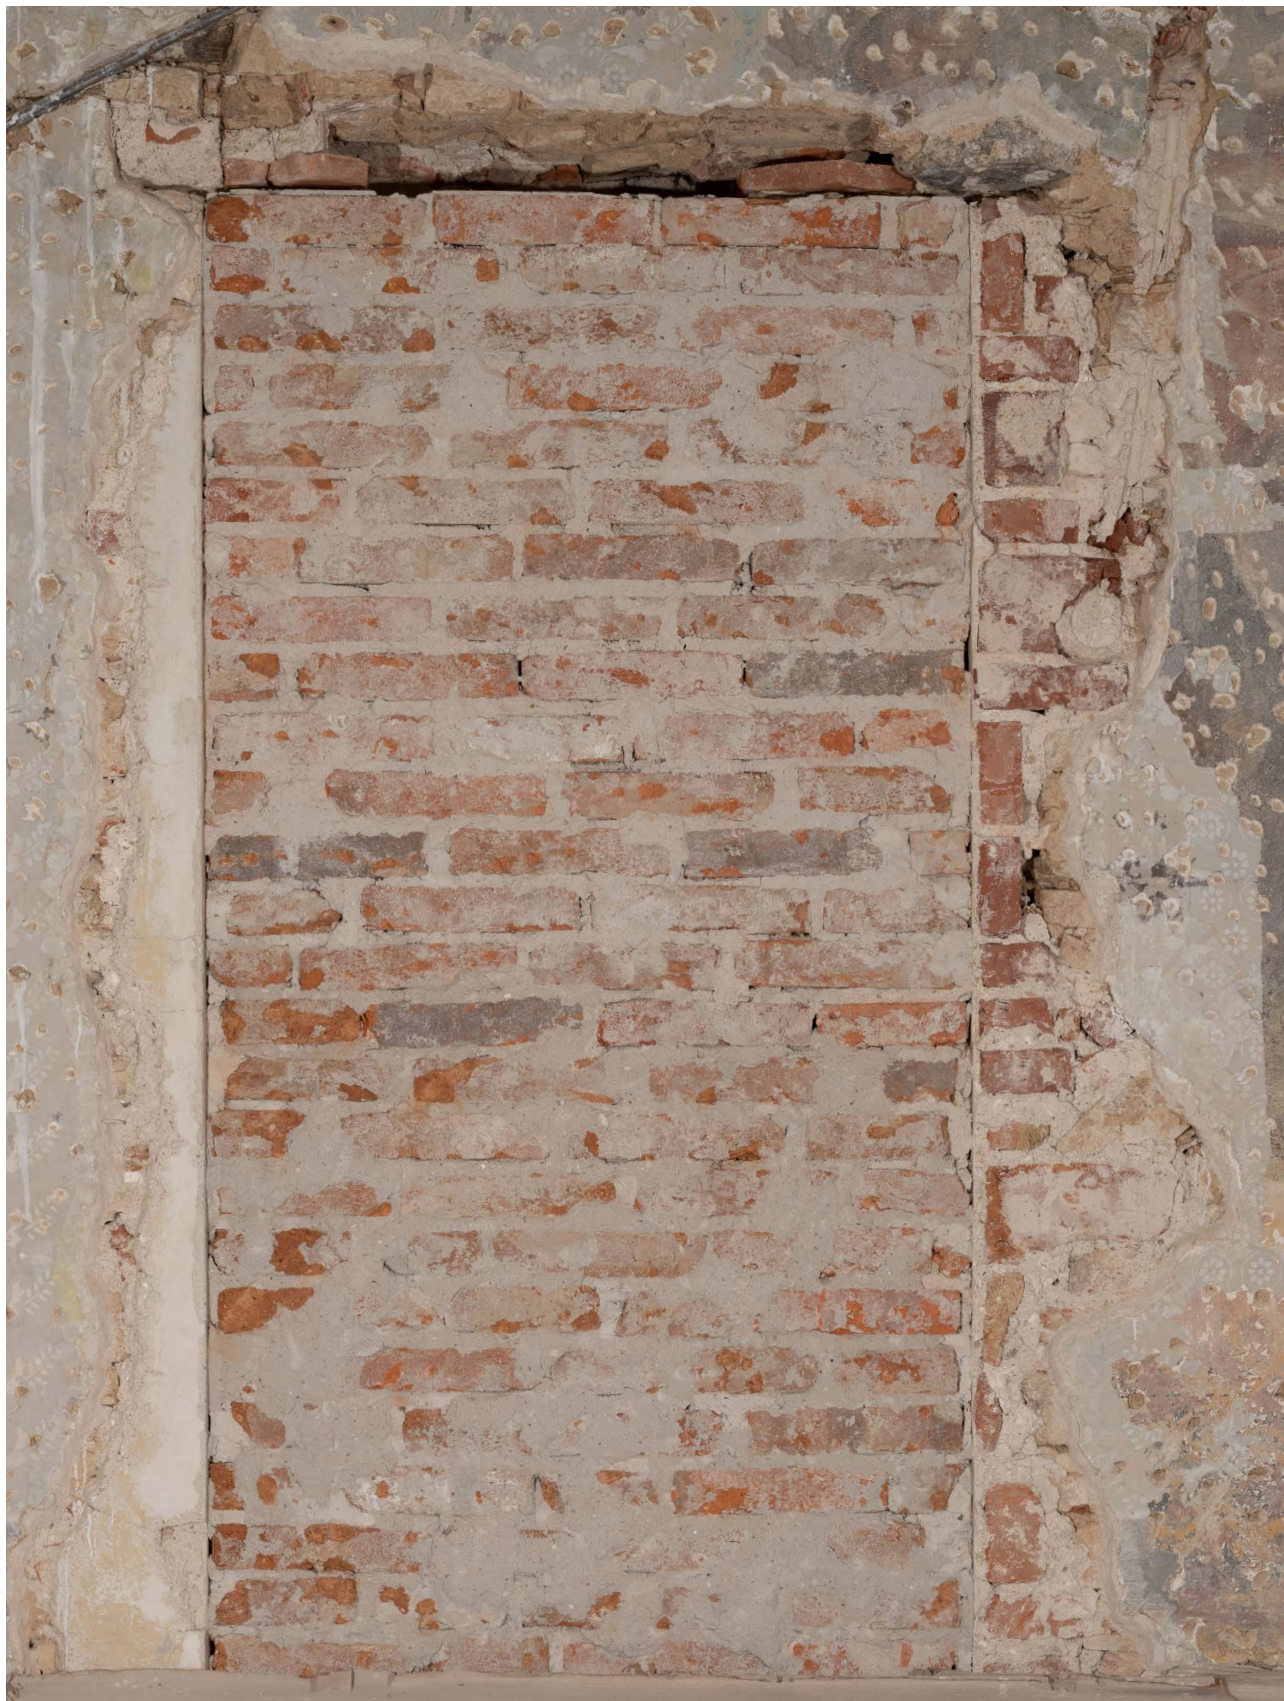
condition during the removal of modern plaster covering the walled door  
photography in day light

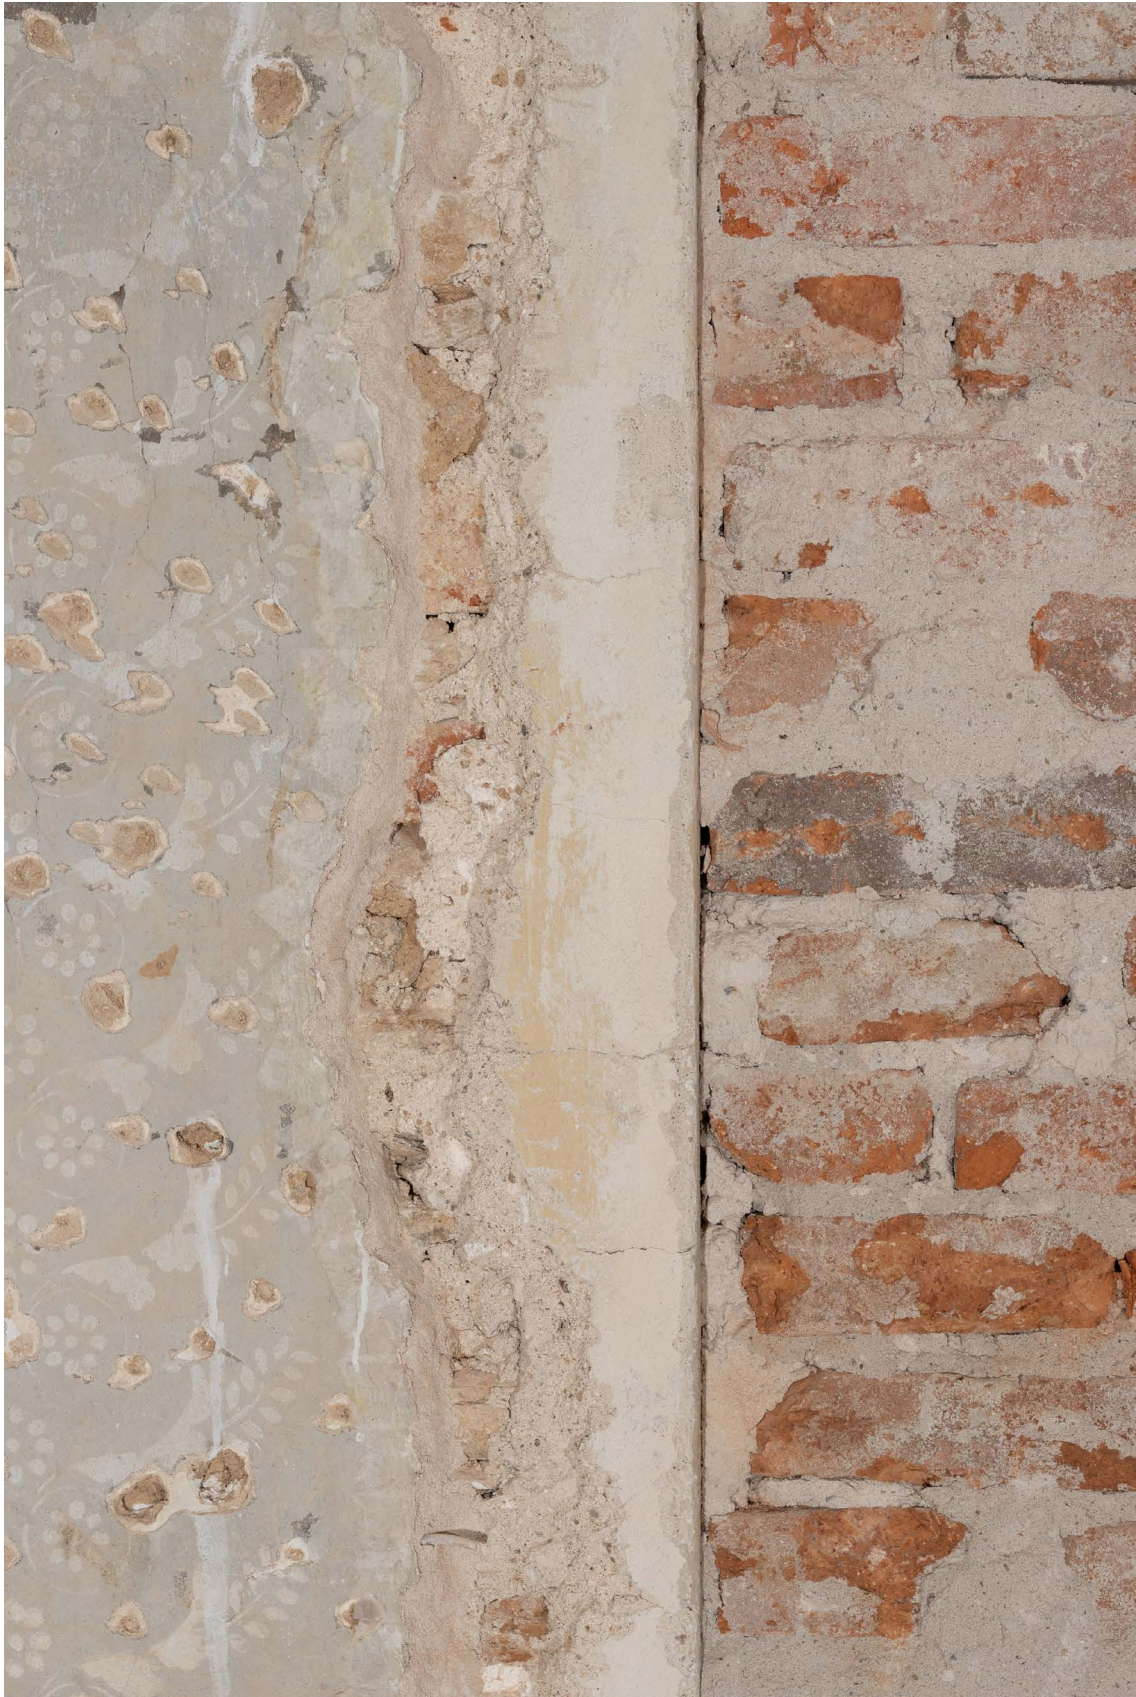
condition during the removal of modern plaster covering the walled door  
photography in day light, detail

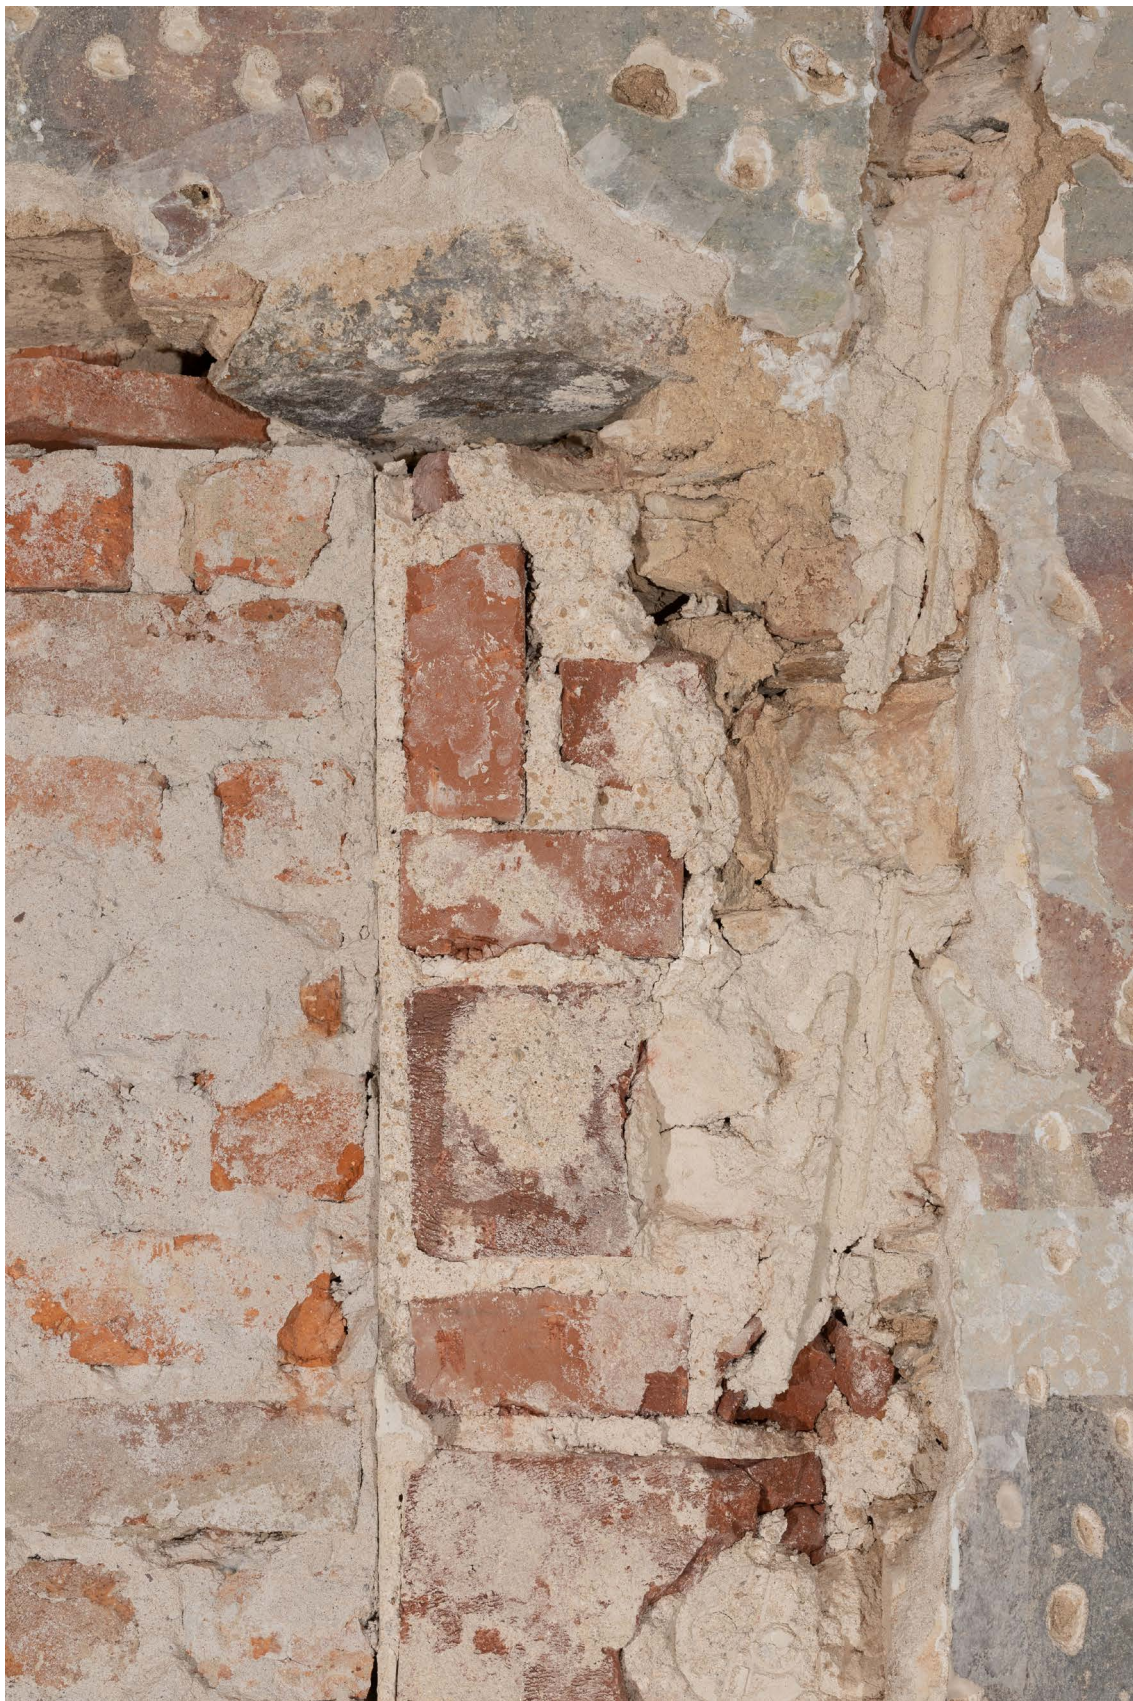
condition during the removal of modern plaster covering the walled door  
photography in day light, detail

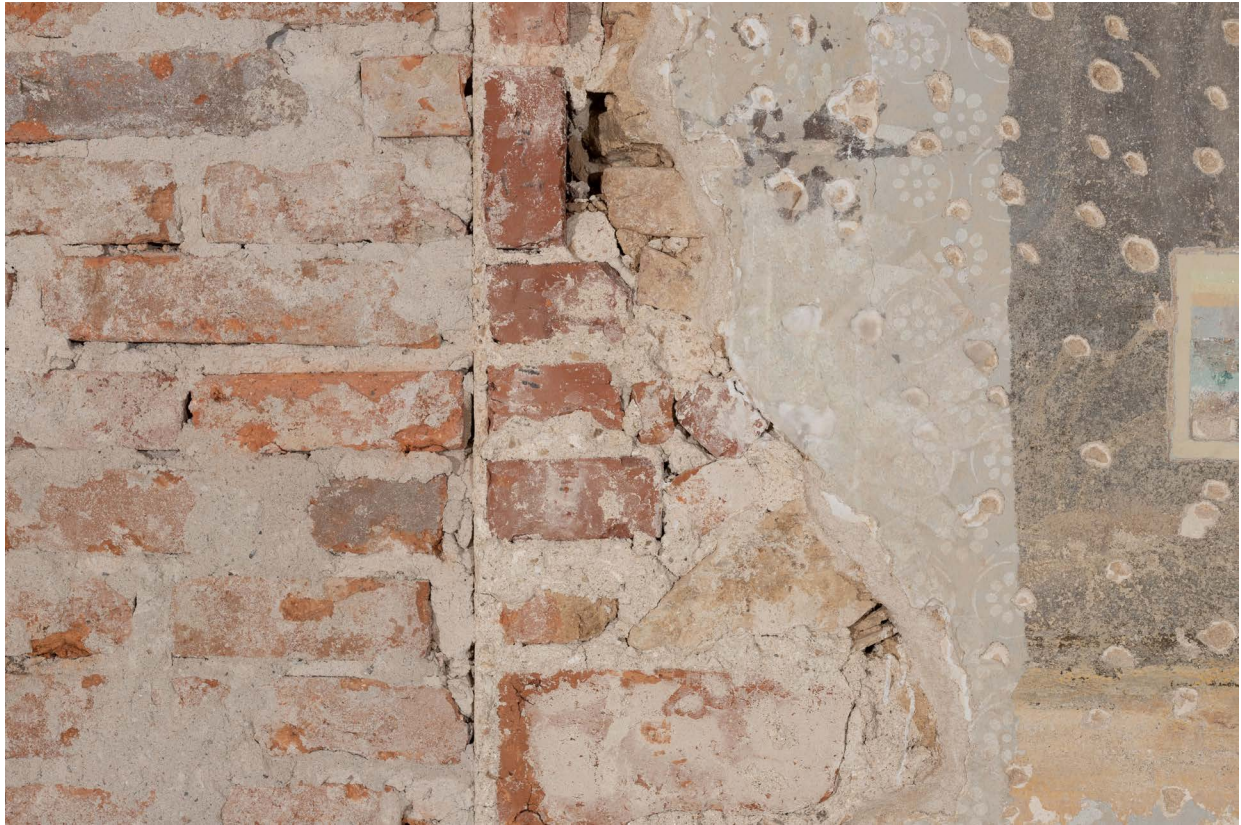
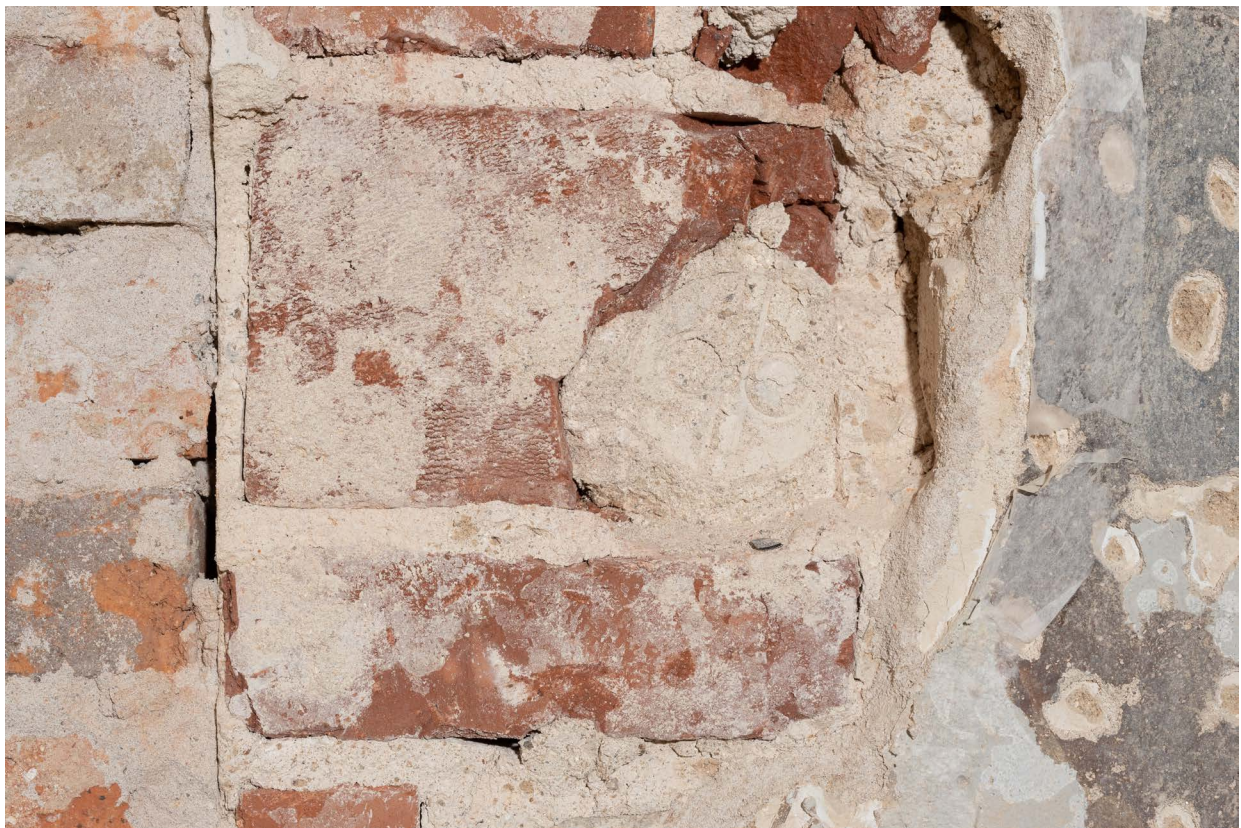
condition during the removal of modern plaster covering the walled door  
photographs in day light, details

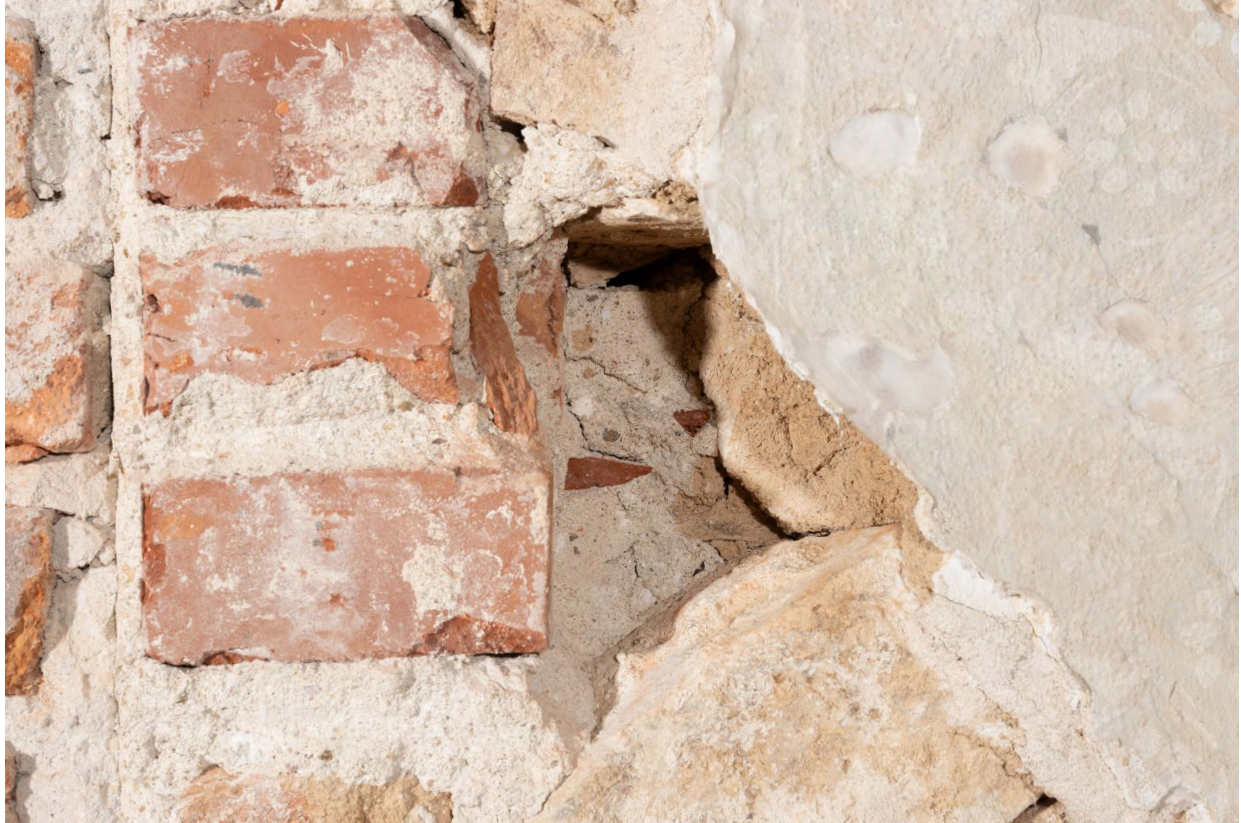
condition before the brickworking and reinforcement of the masonry of the wall  
details of the deepness of the defect  
photographs in day light

11. Brickworking of the defected areas within the reinforcement of the masonry in the hole caused by removal of the traverse.
12. Surface cleaning of the exposed wall painting.

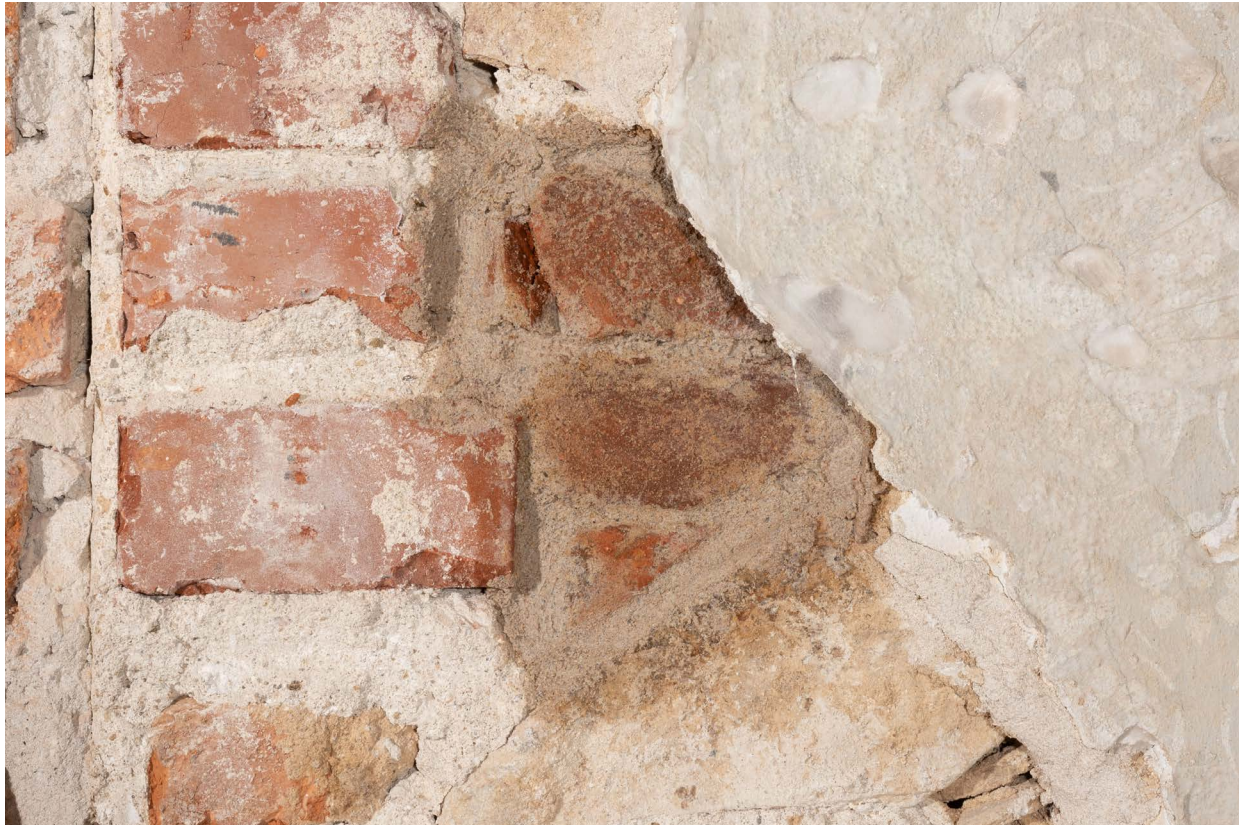
condition after the brickworking and reinforcement of the masonry of the wall  
photographs in day light, detail

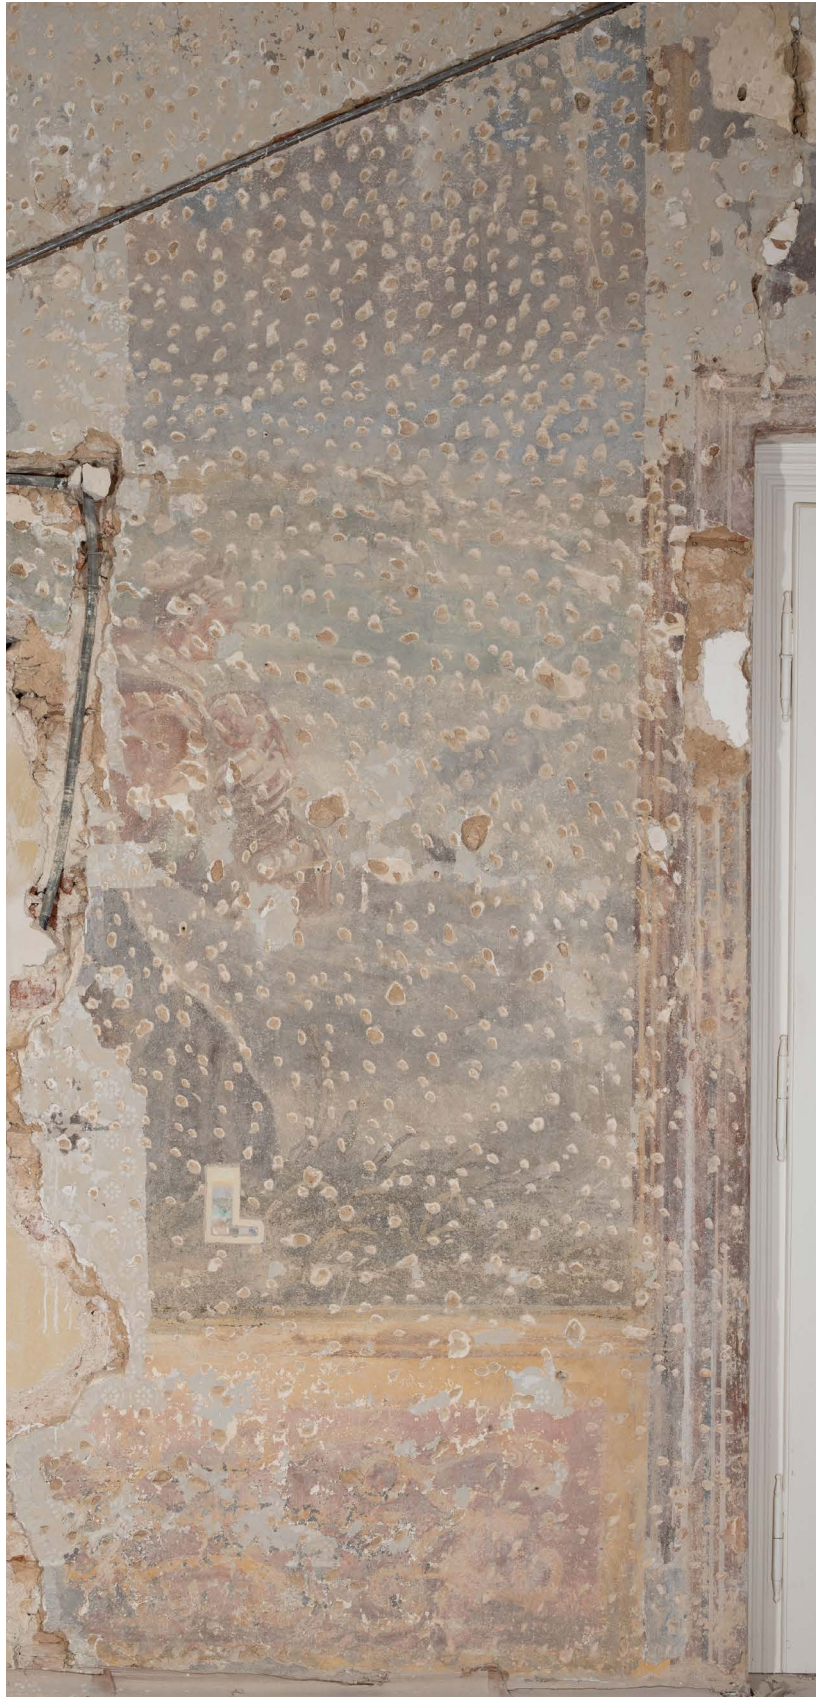
condition of a segment of the restored section after removal of the second oldest plaster layer by ultrasonic scalpels on the original plaster layer exposing the wall painting  
photography in day light
