# RESTORATION TREATMENT REPORT

## WATER FAIRY

EMIL JOHANN LAUFFER

NATIONAL GALLERY IN PRAGUE

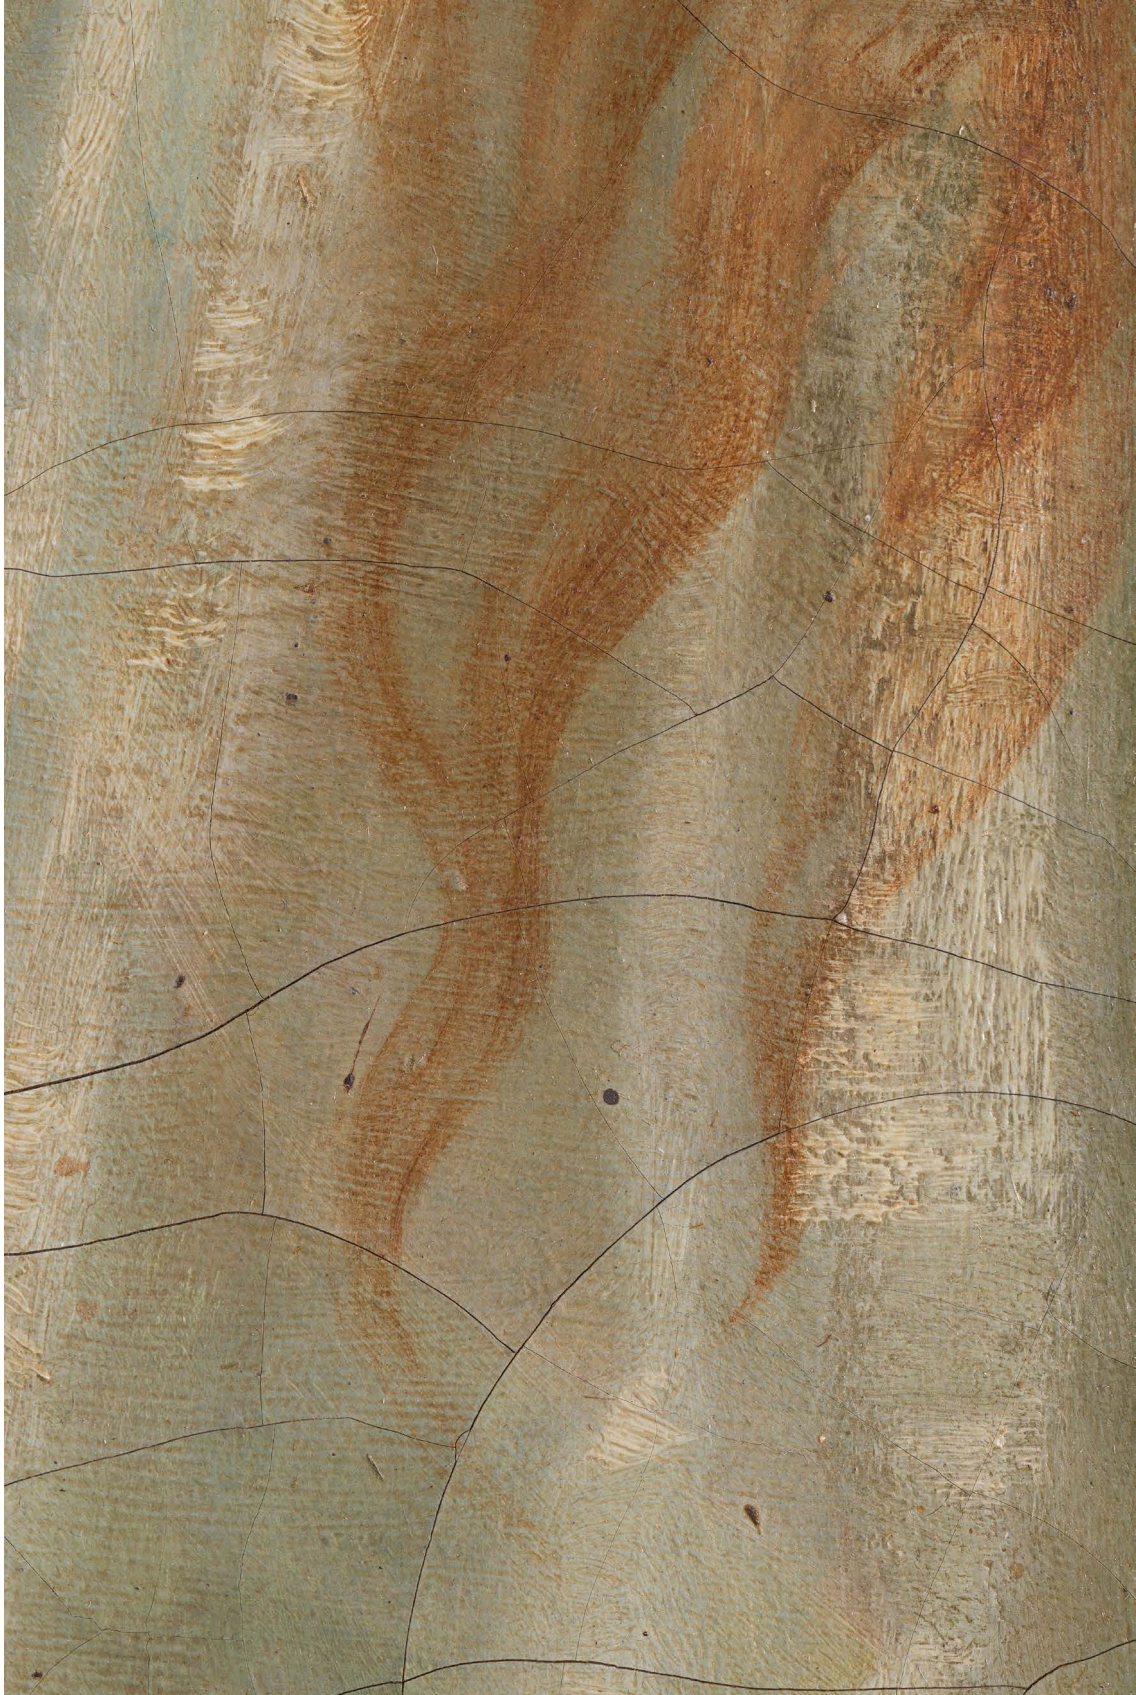
macrophotography in raking light  
detail

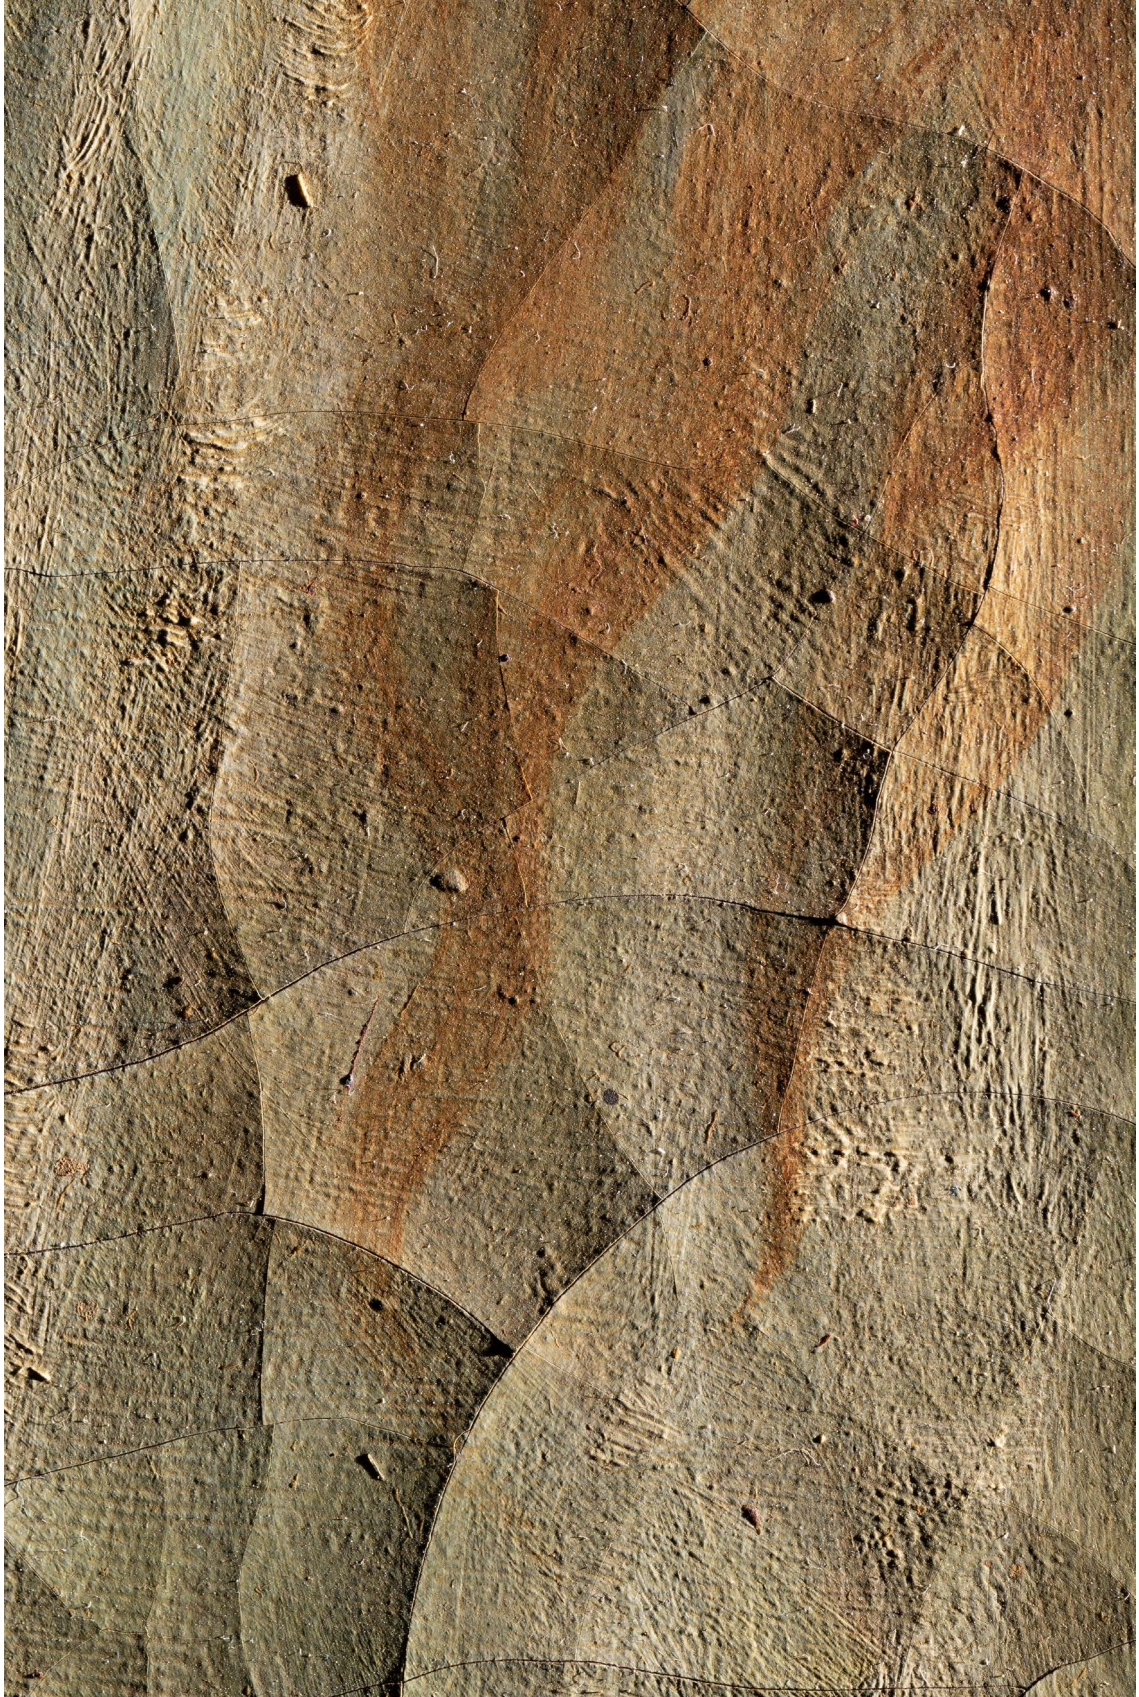
macrophotography in day light  
detail

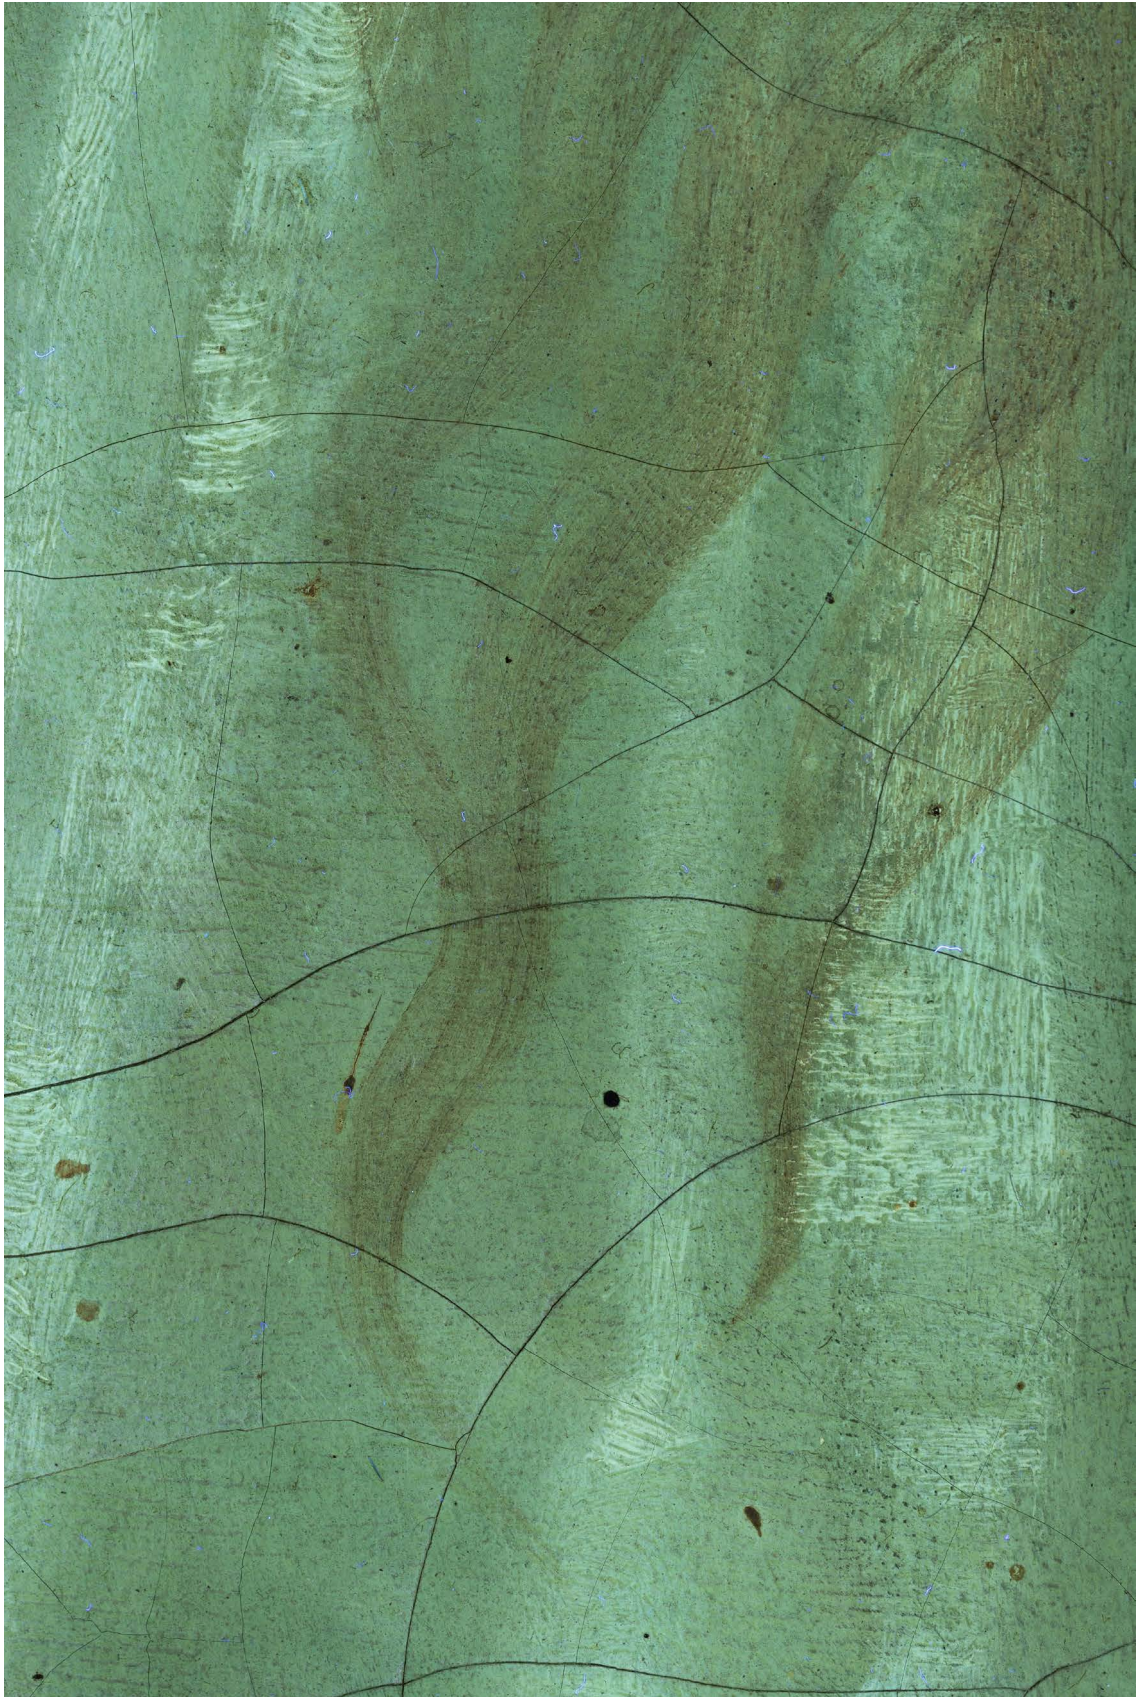
macrophotography in raking light  
detail

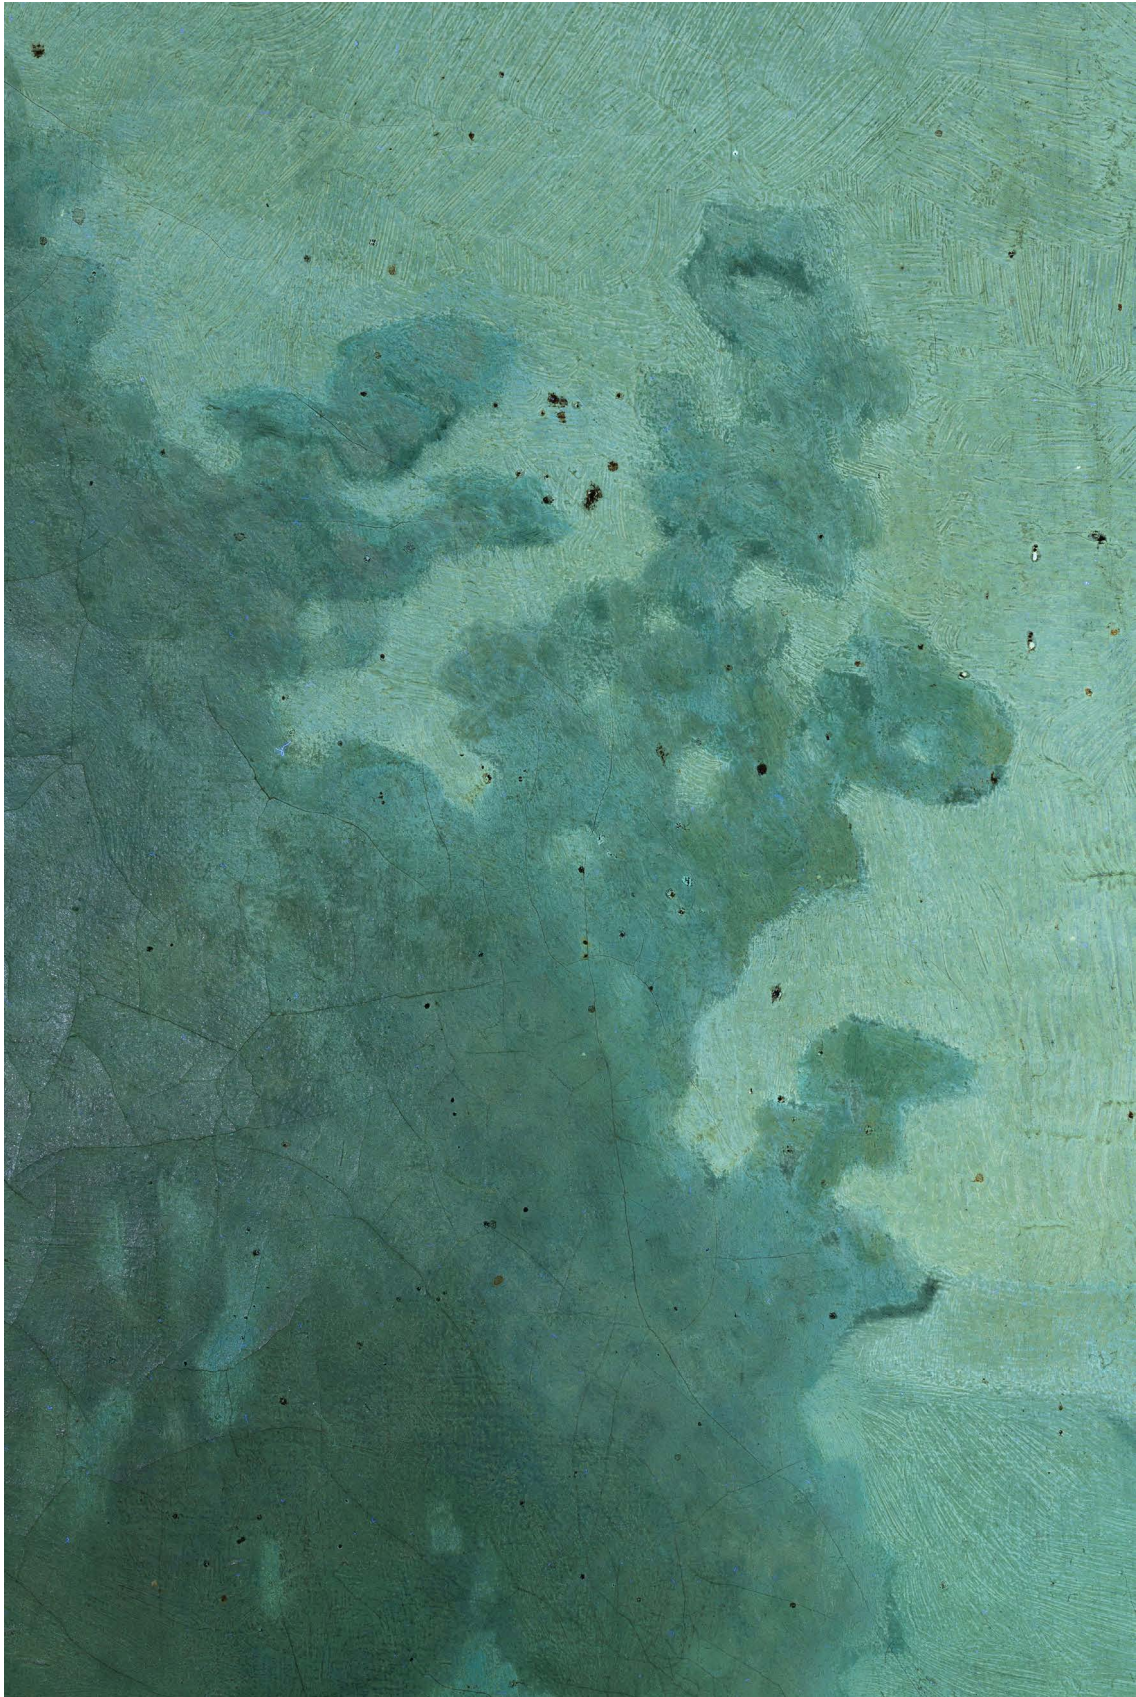
macrophotography in raking light  
detail

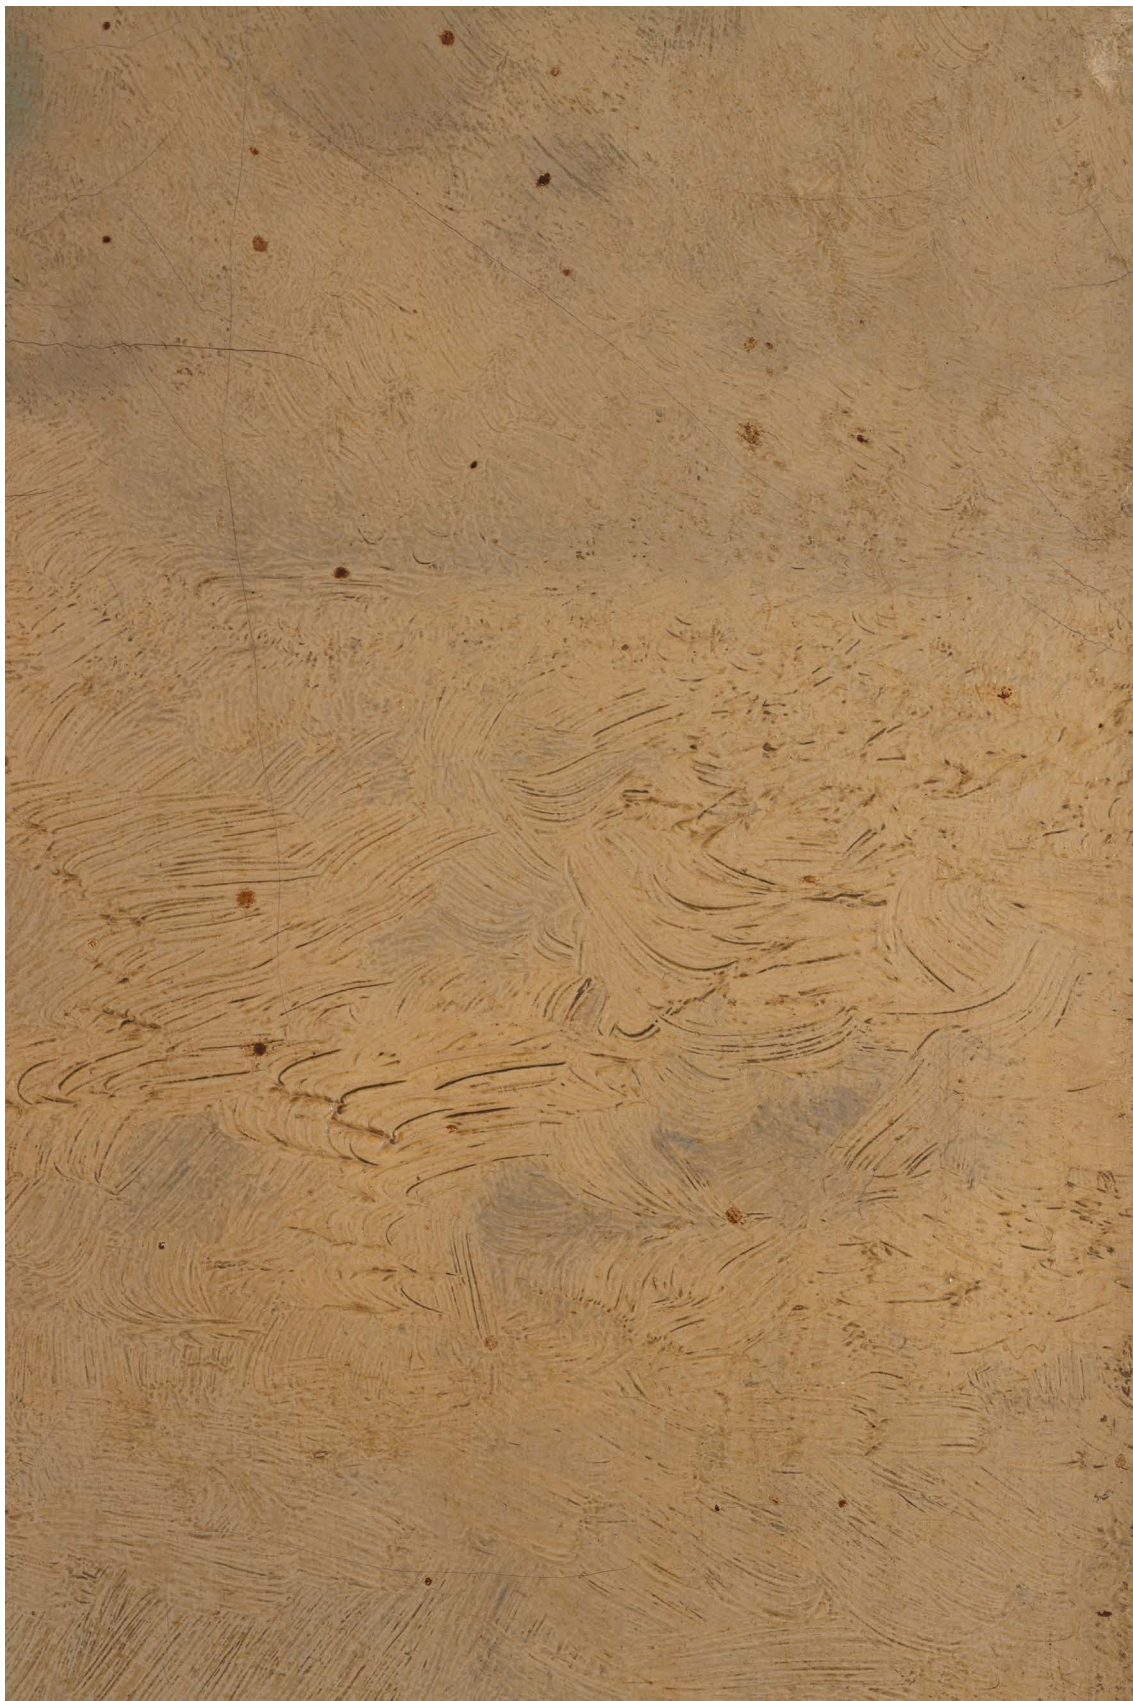
IR false colour picture  
detail

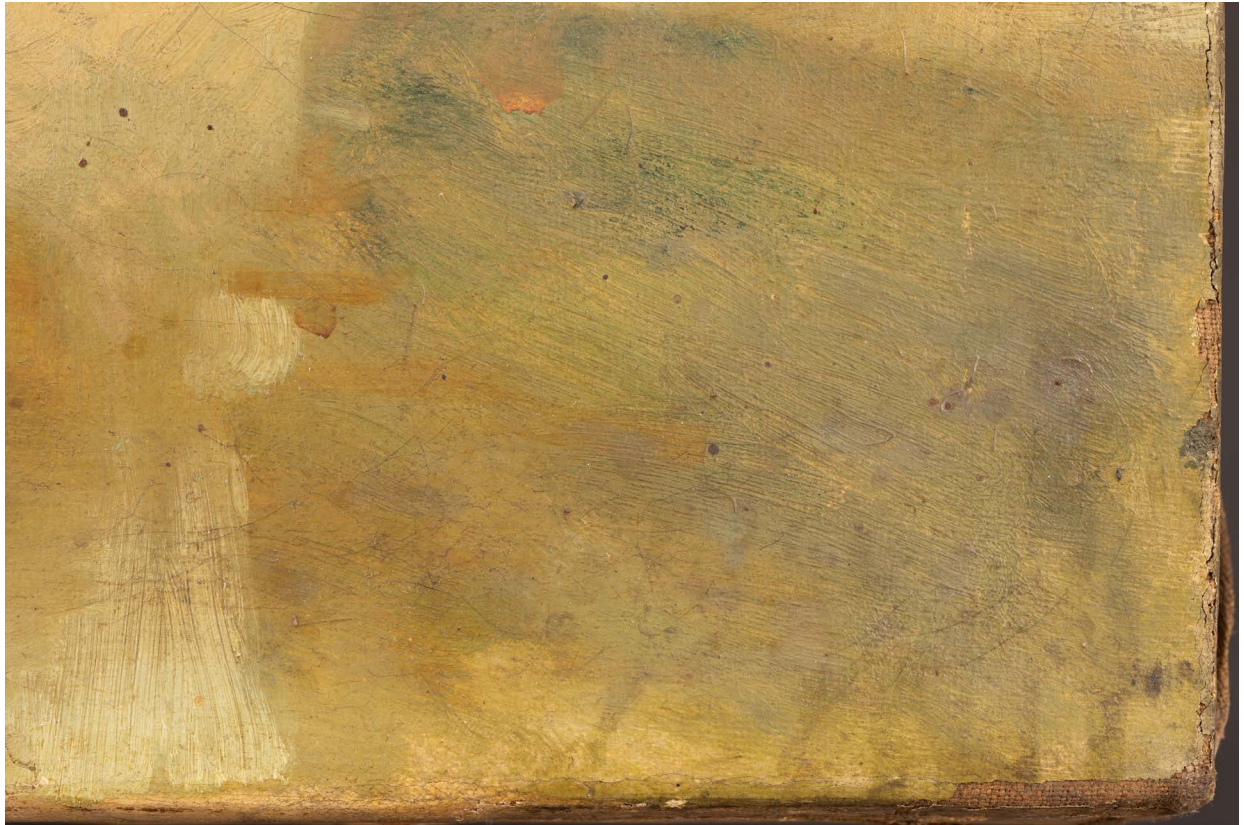
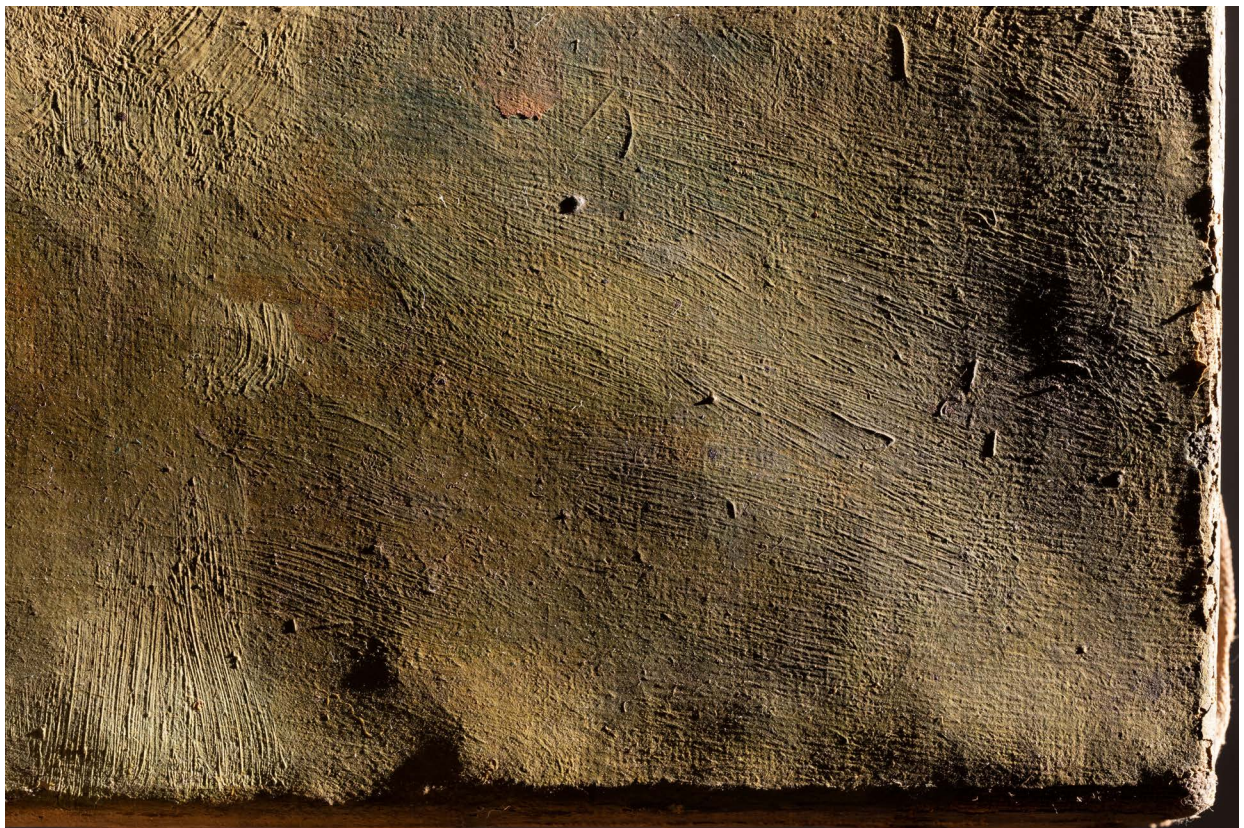
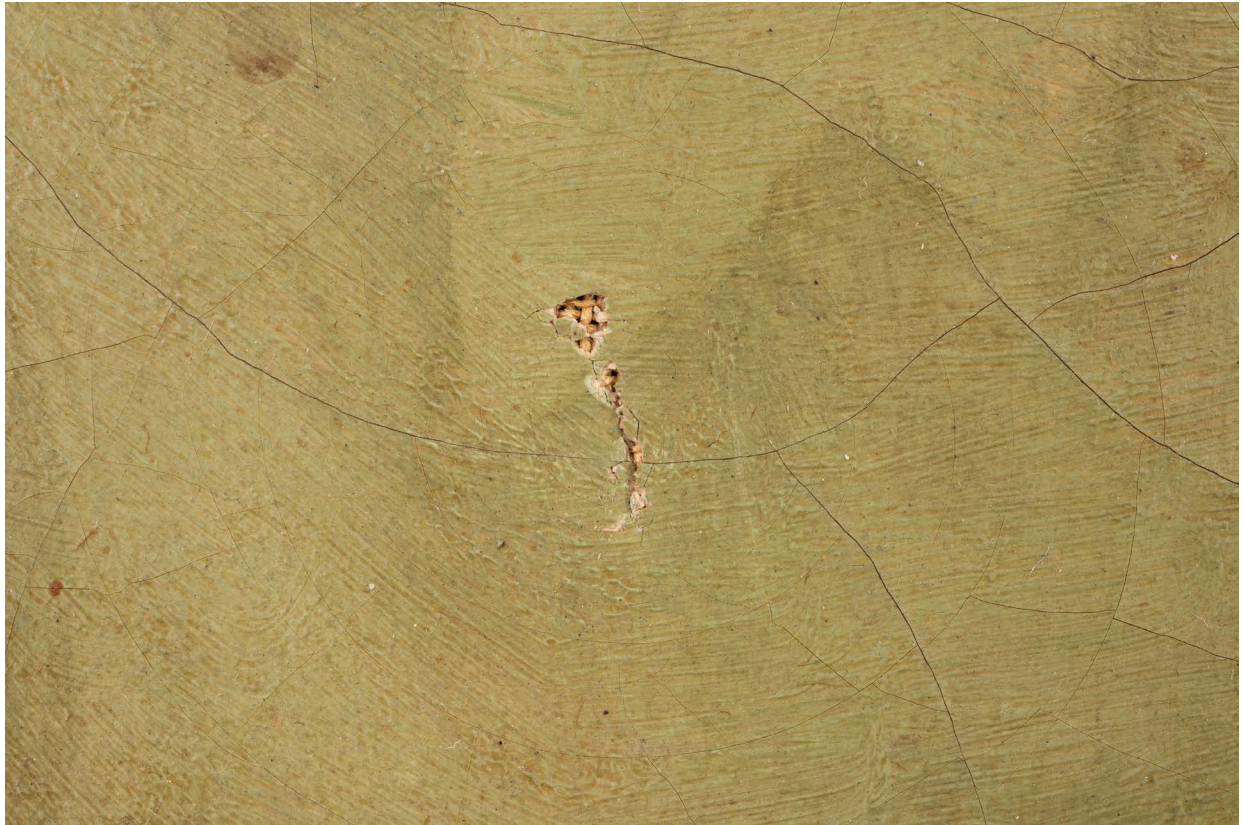
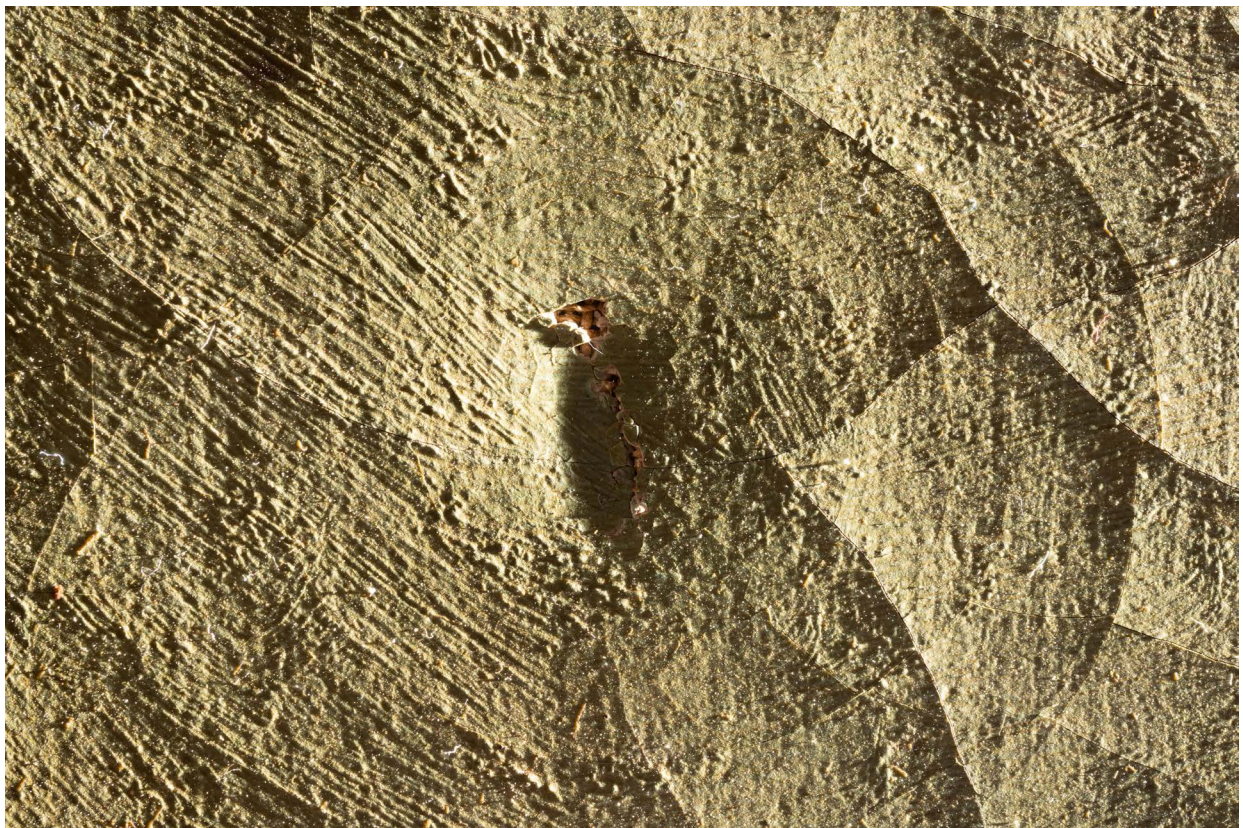
macrophotographs in day and raking light  
detail

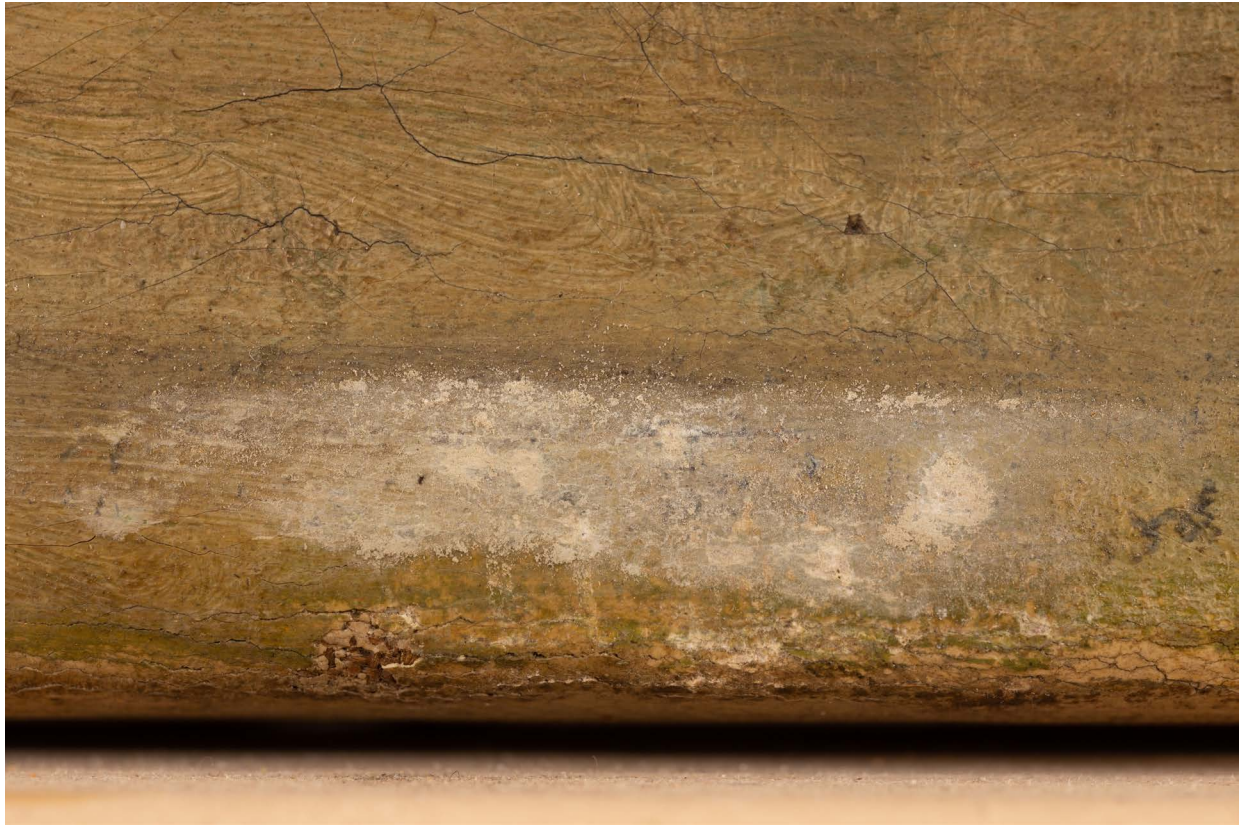
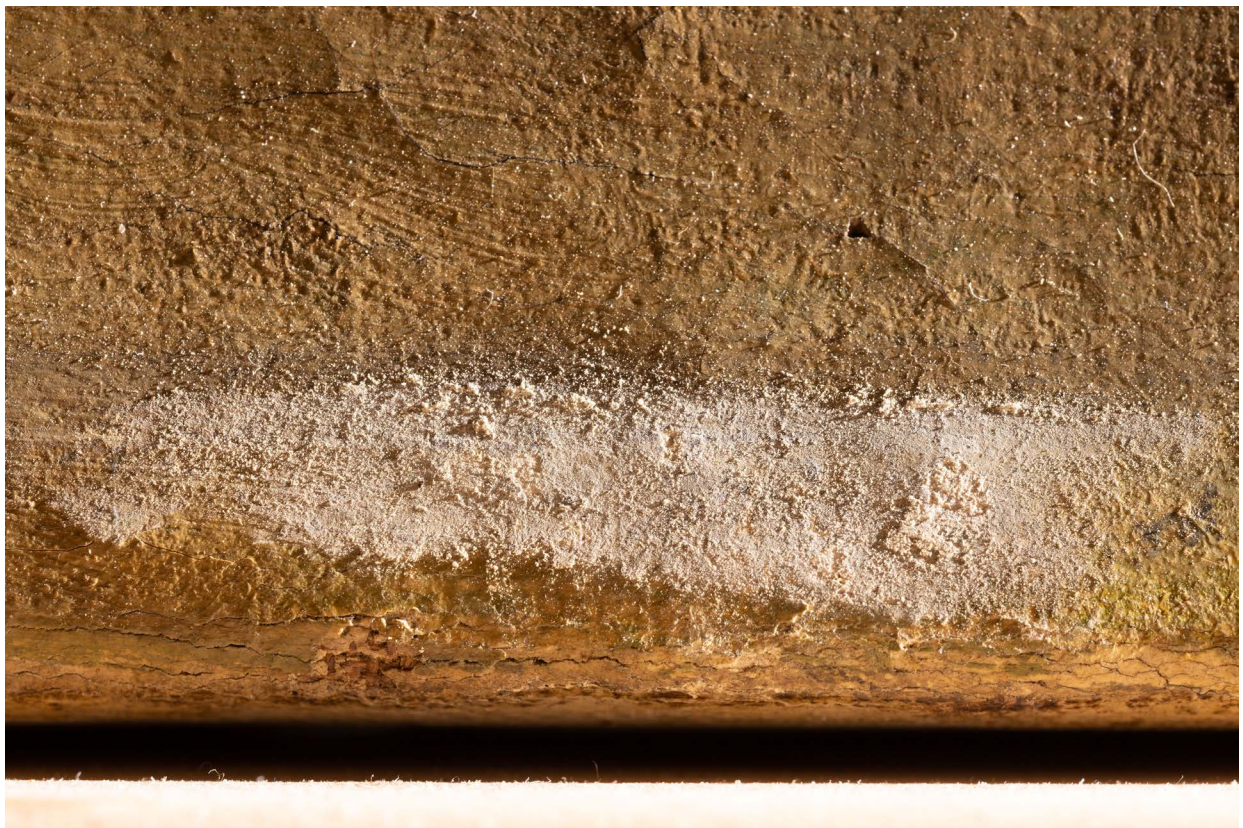
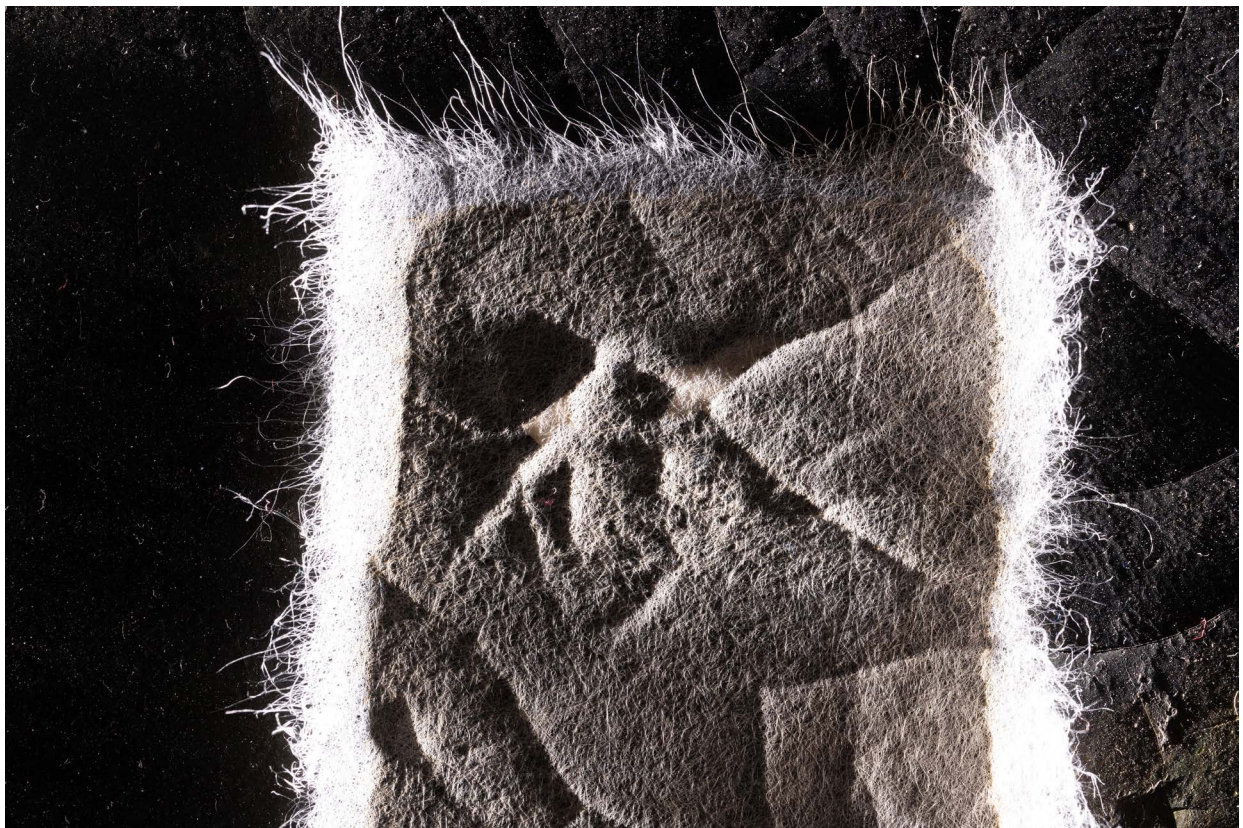
macrophotographs in day and raking light  
detail

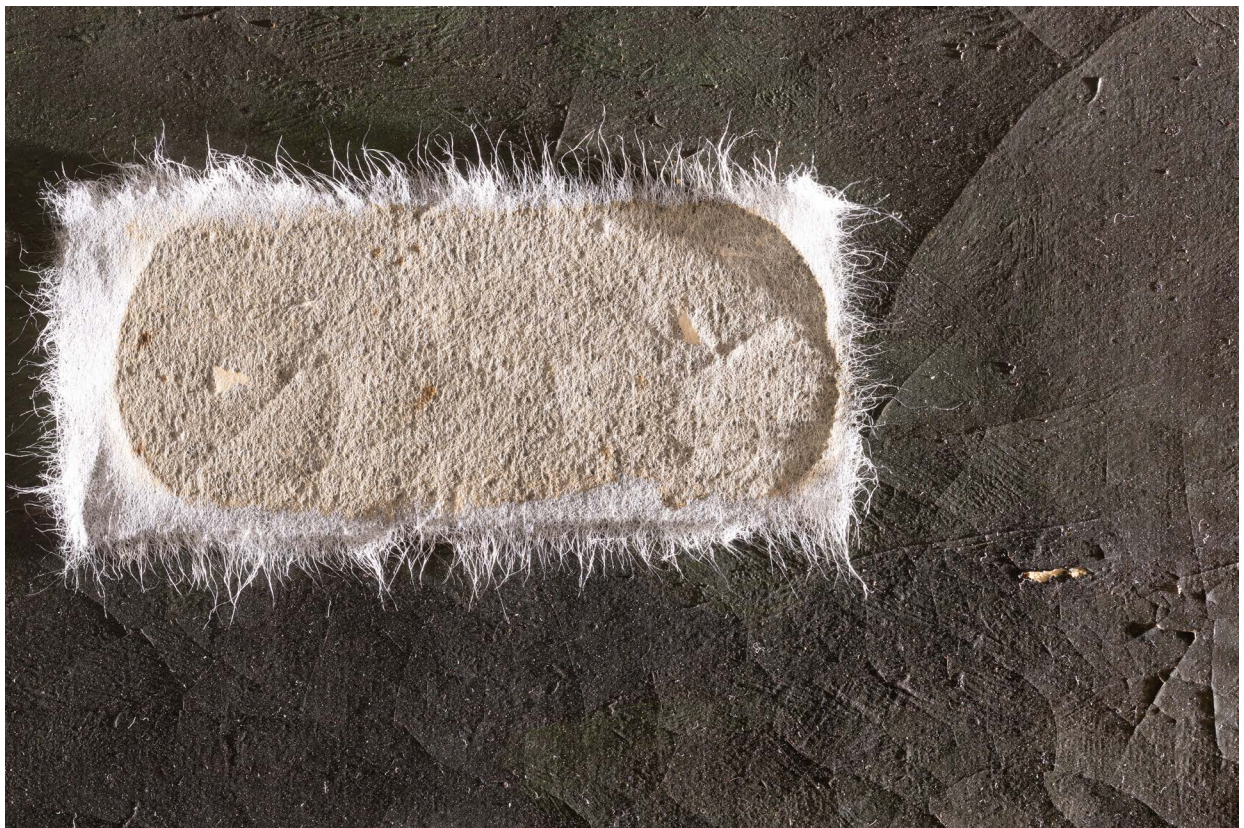
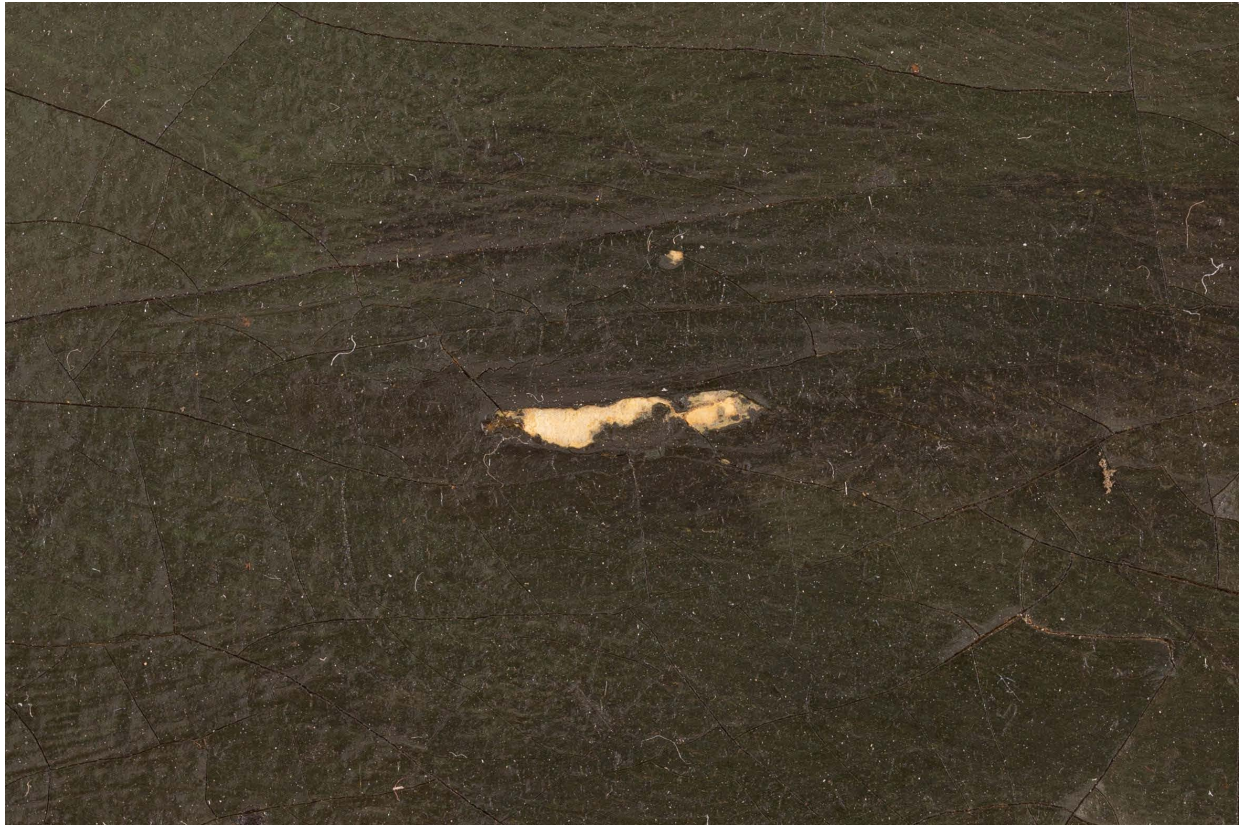
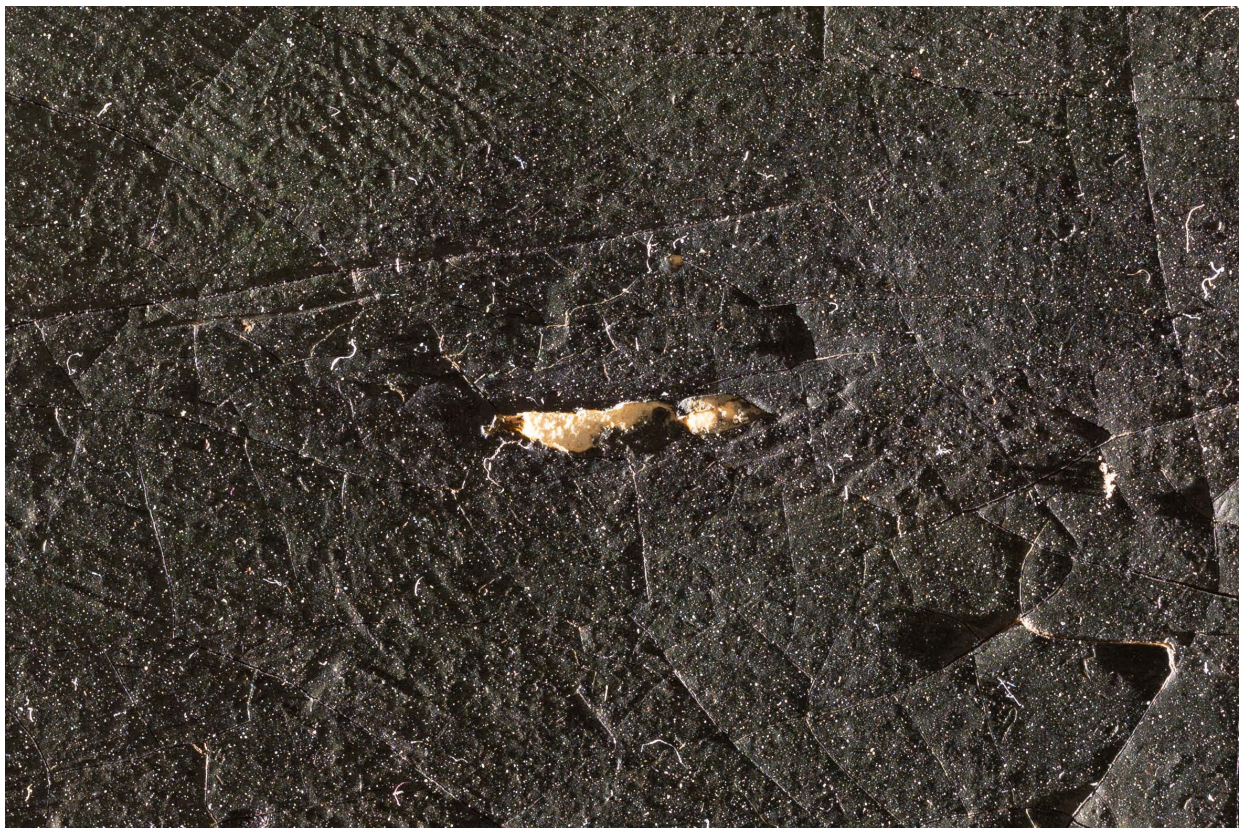
macrophotographs in day and raking light  
detail

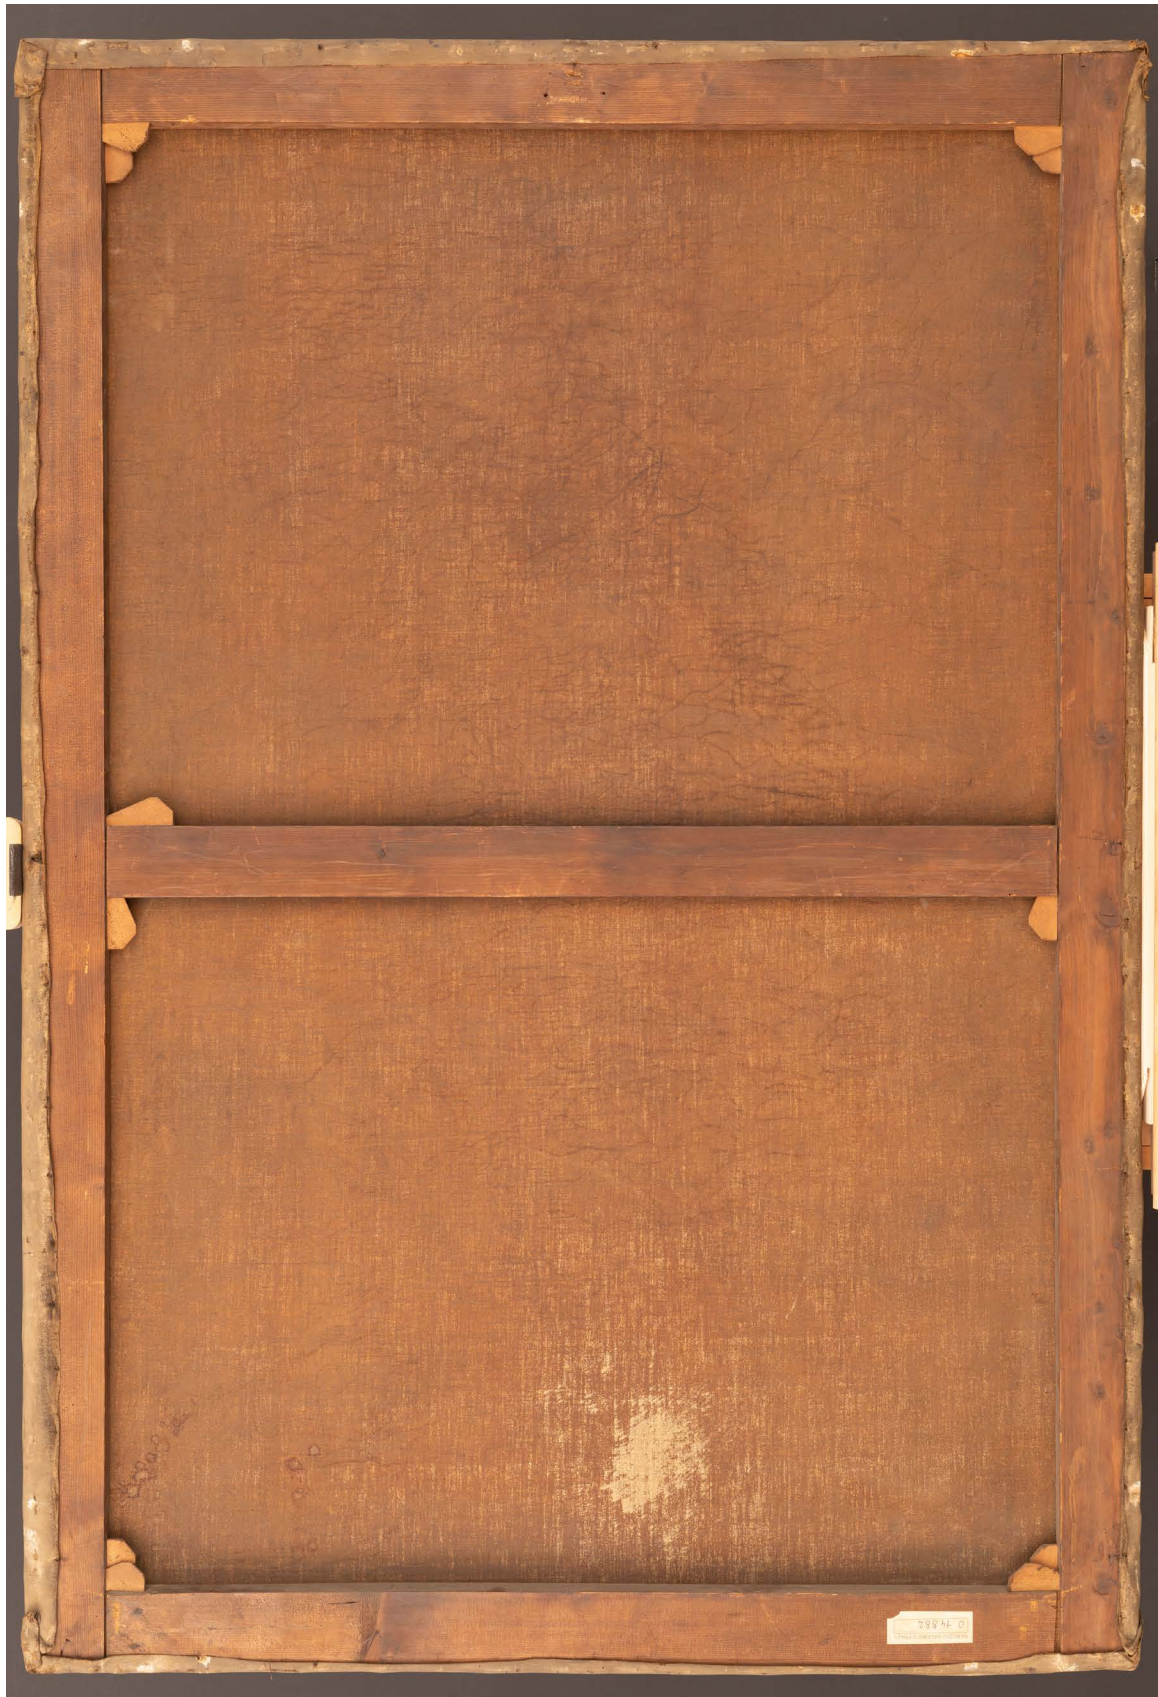
photography in day light  
back side of the painting
