# RESTORATION TREATMENT REPORT

## WATER FAIRY

EMIL JOHANN LAUFFER

NATIONAL GALLERY IN PRAGUE

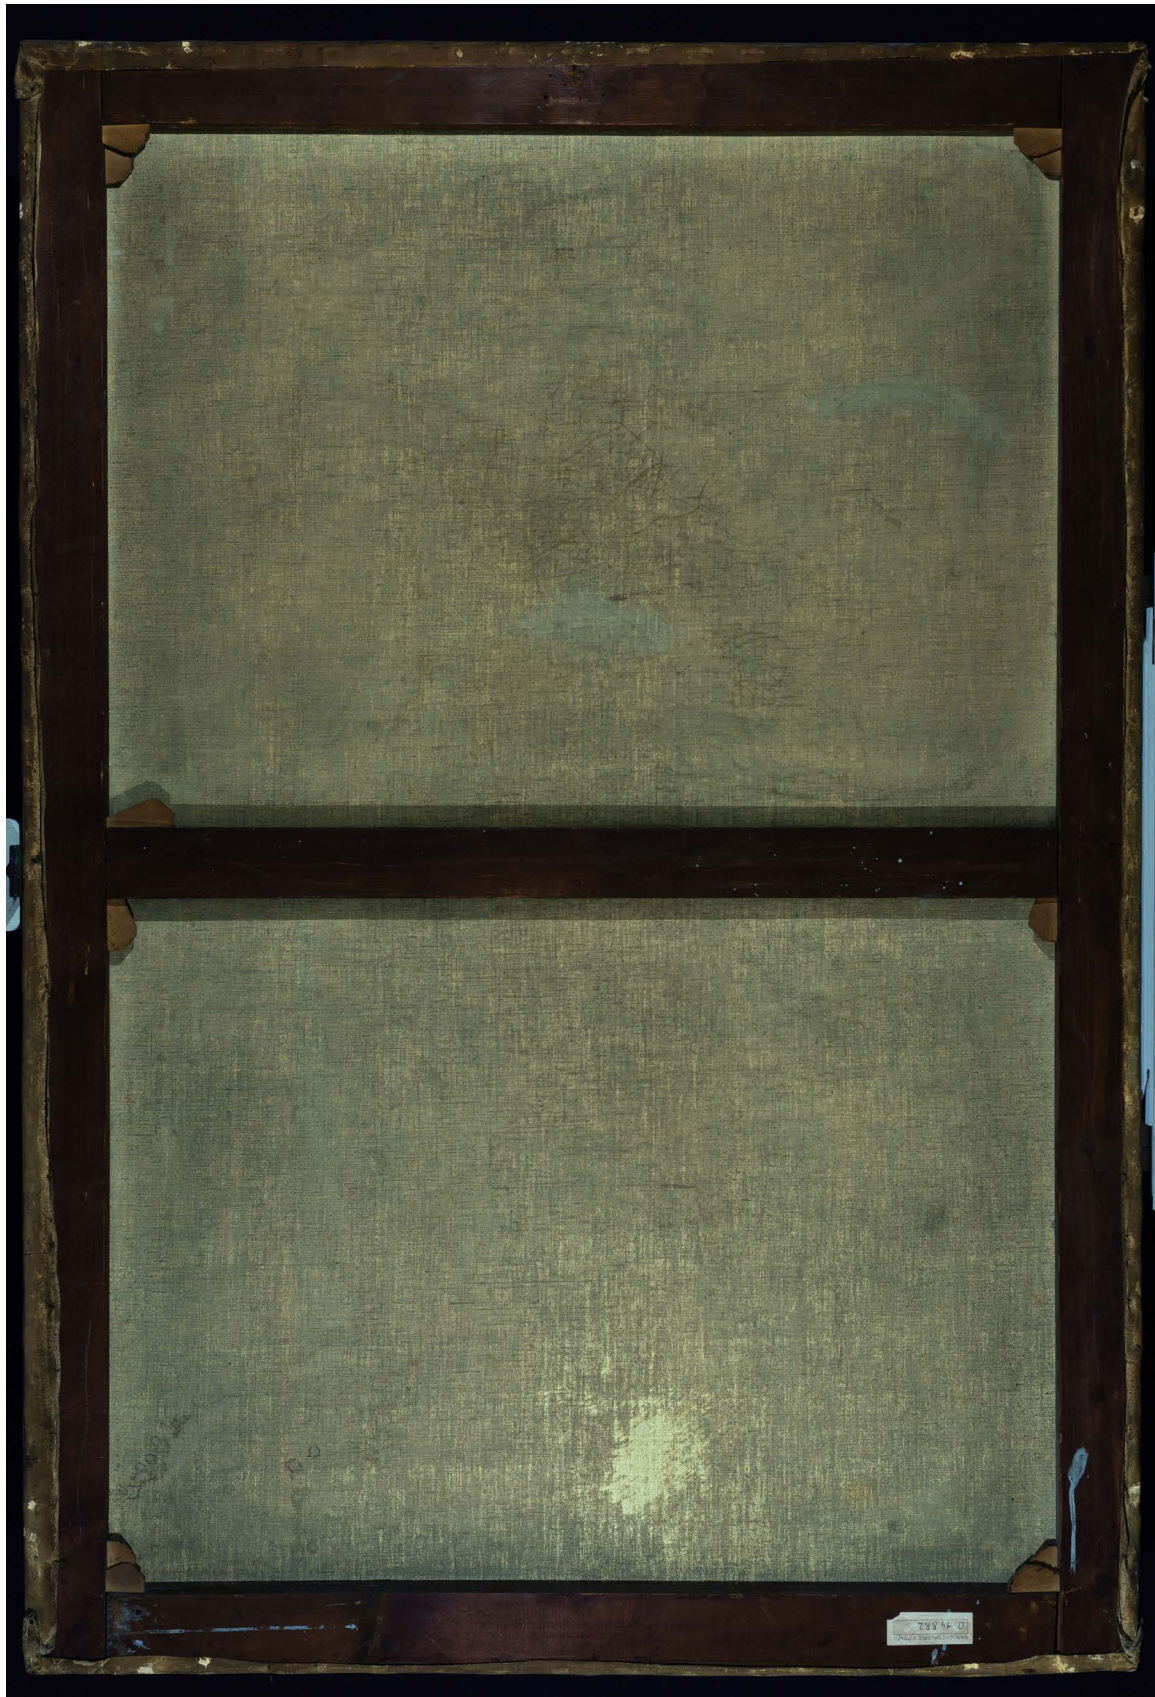
photography in UV luminescence  
back side of the painting

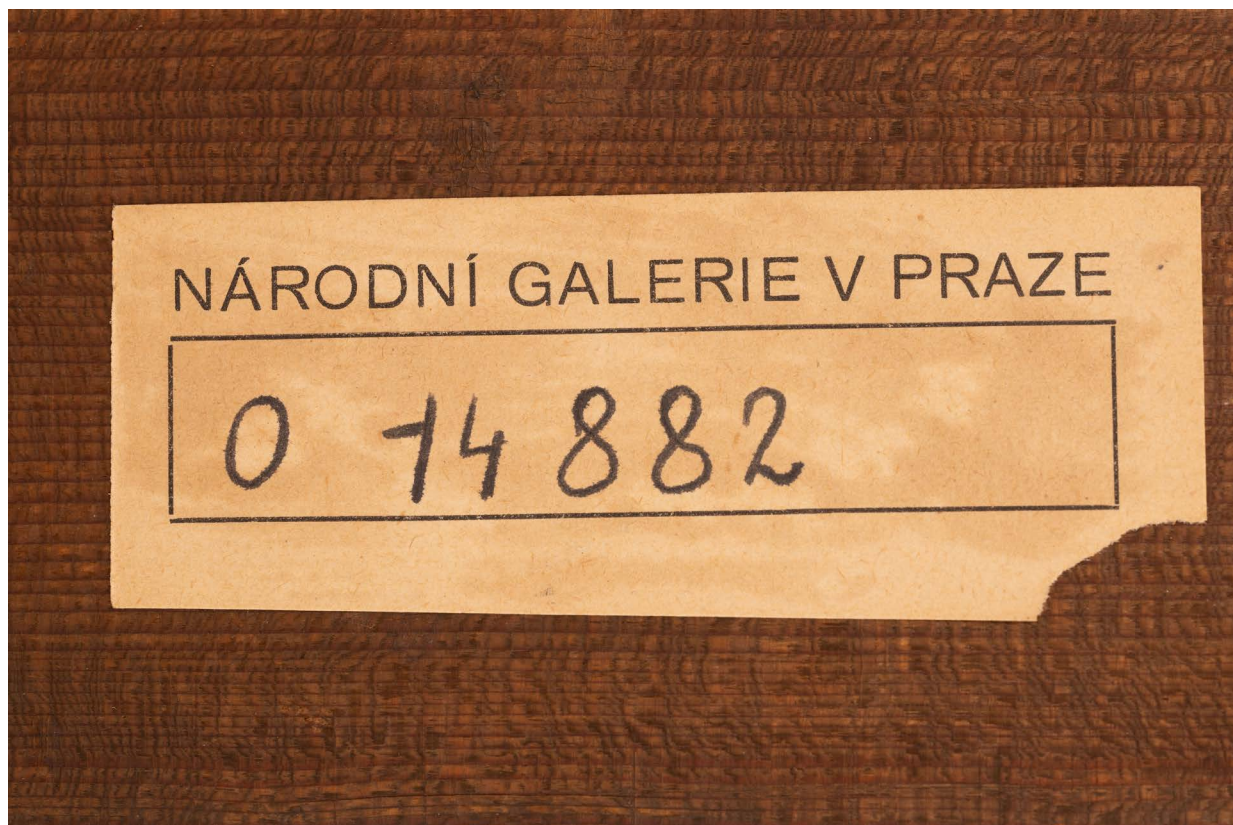
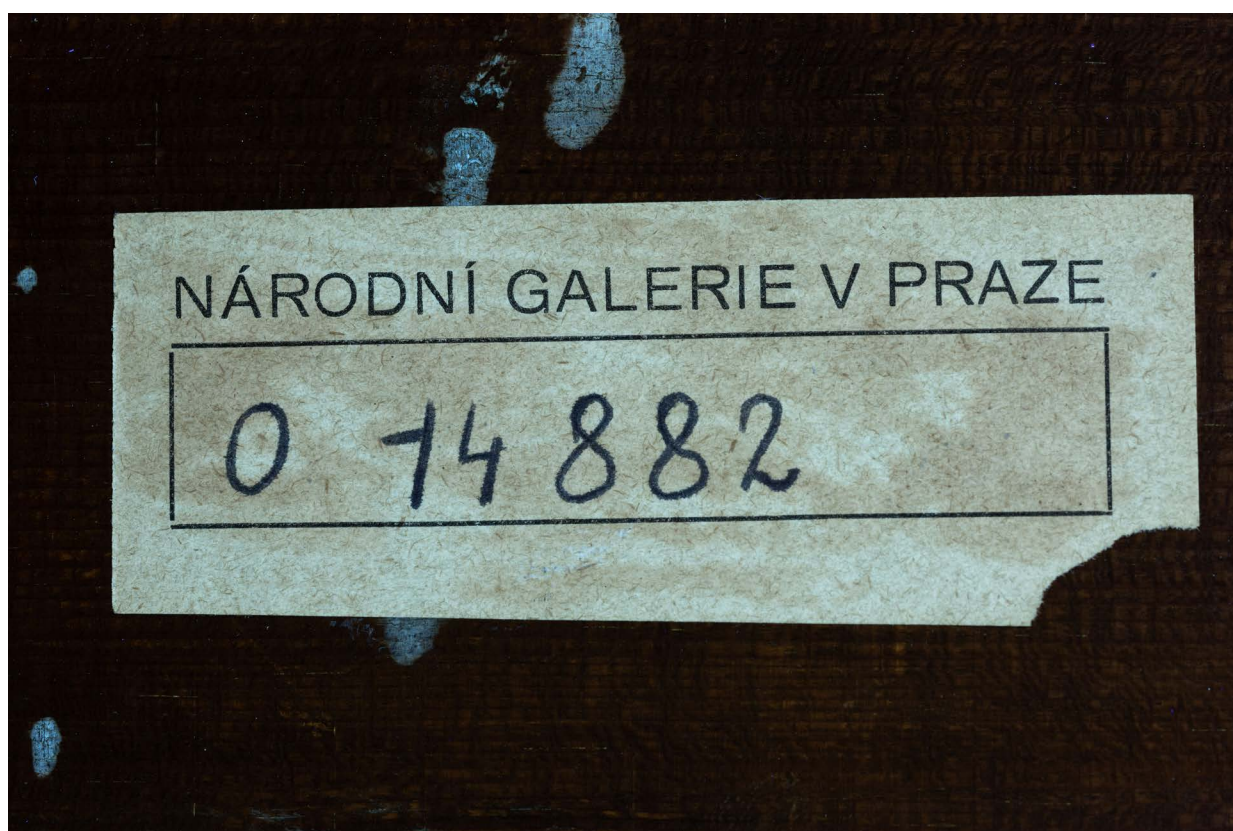
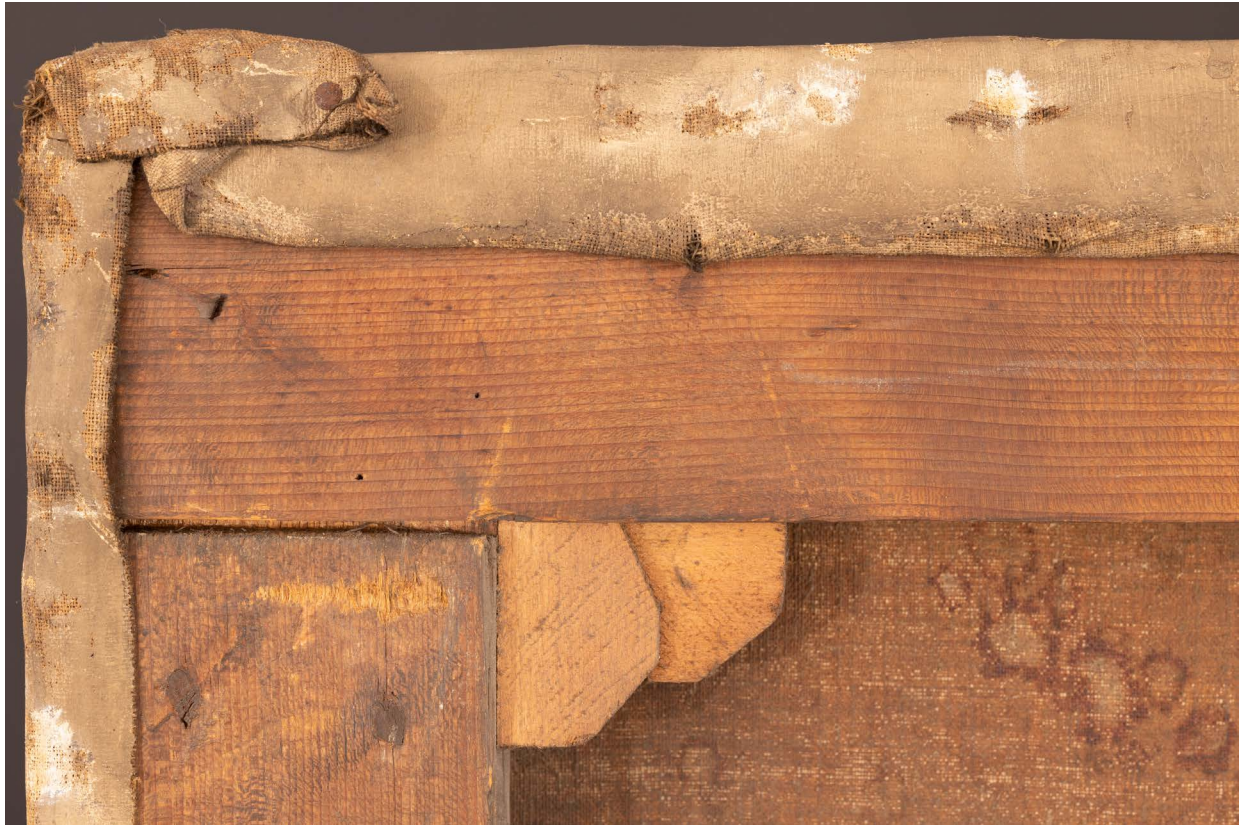
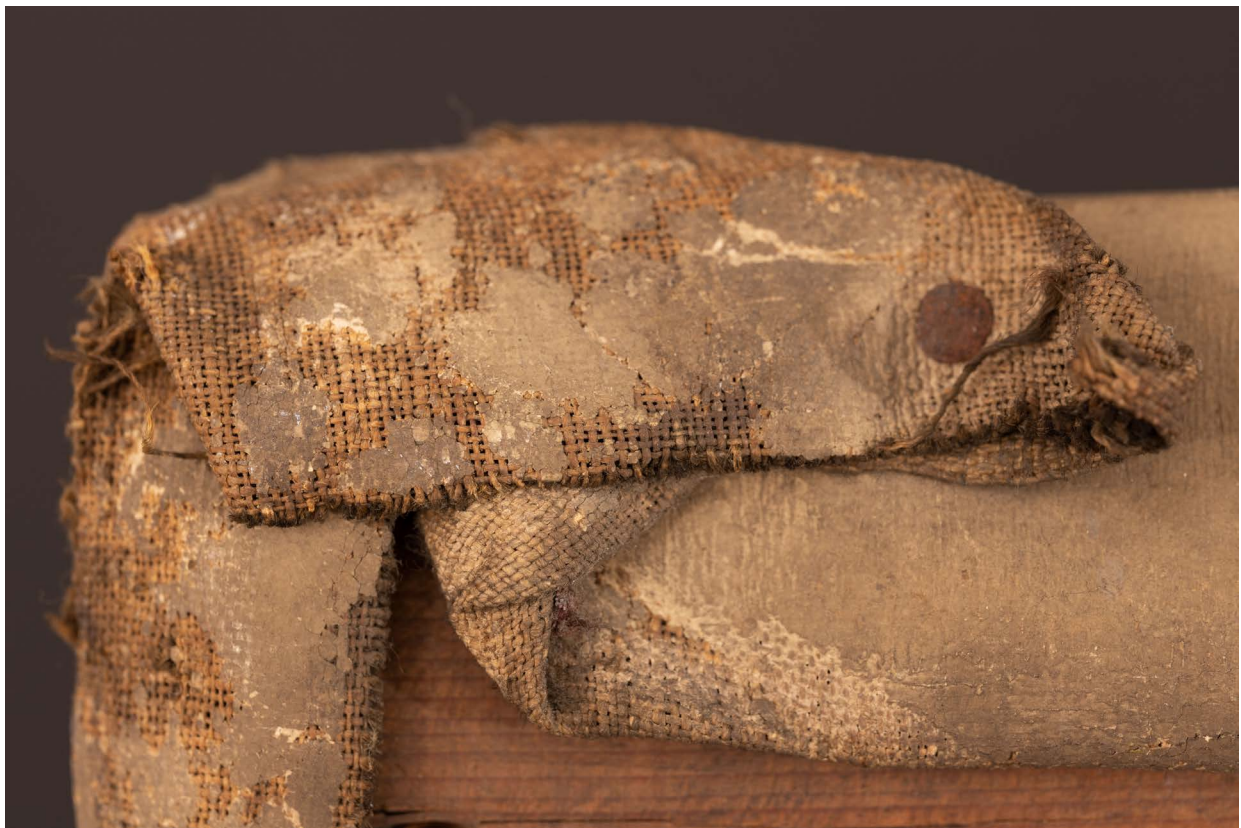
photographs in day light  
back side, details

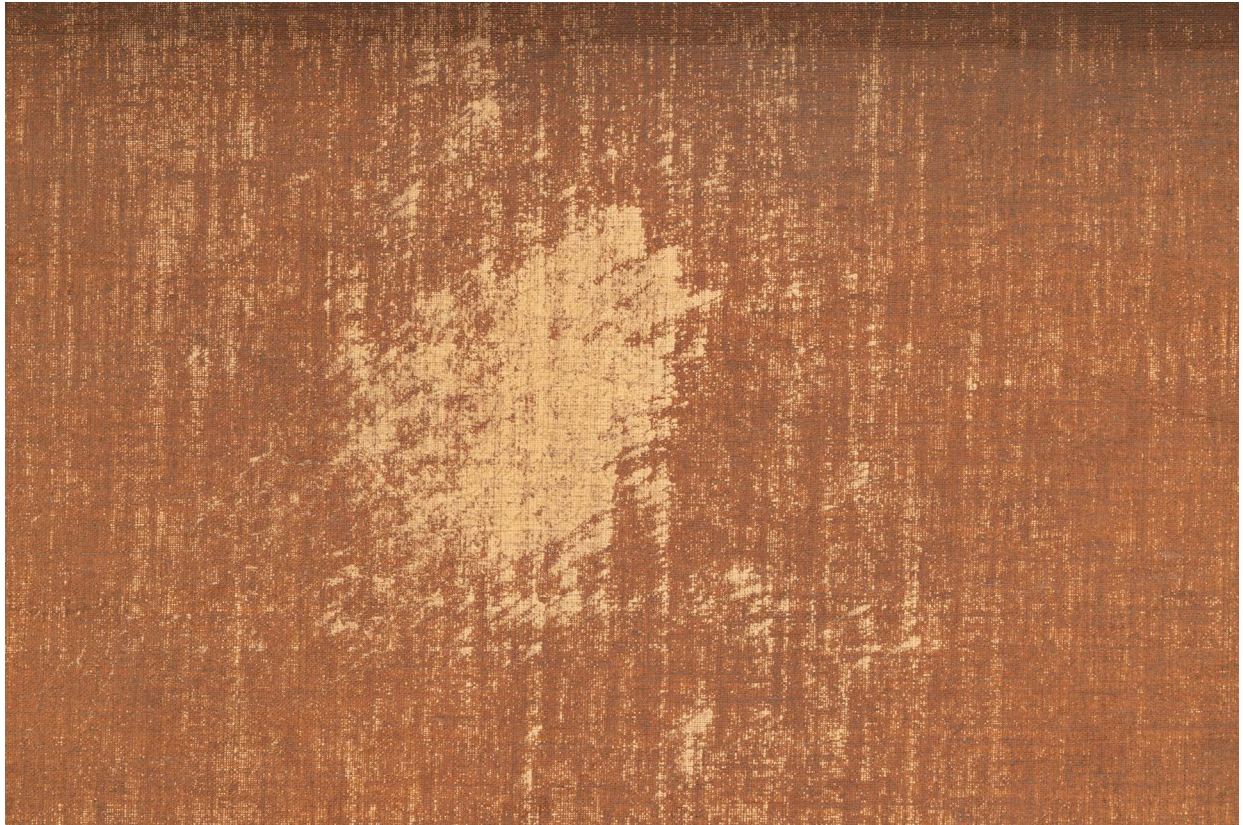
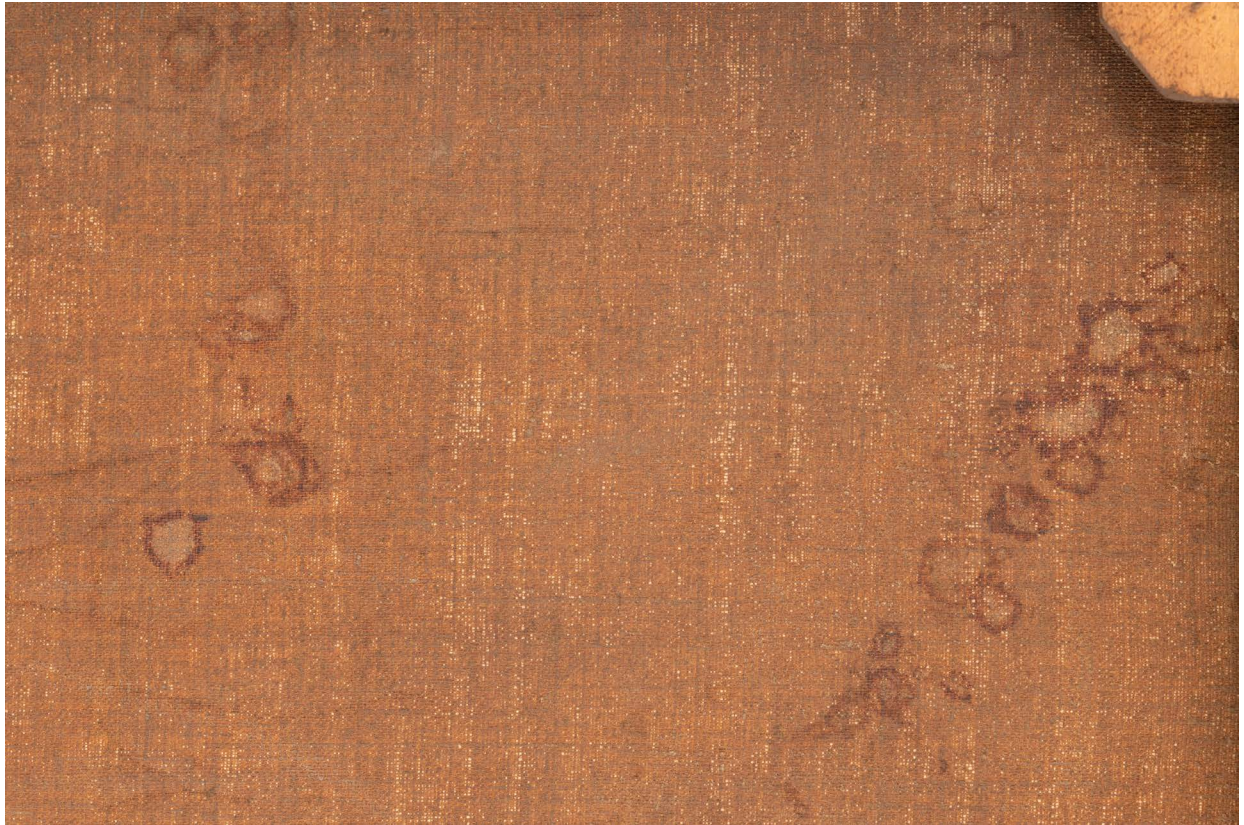
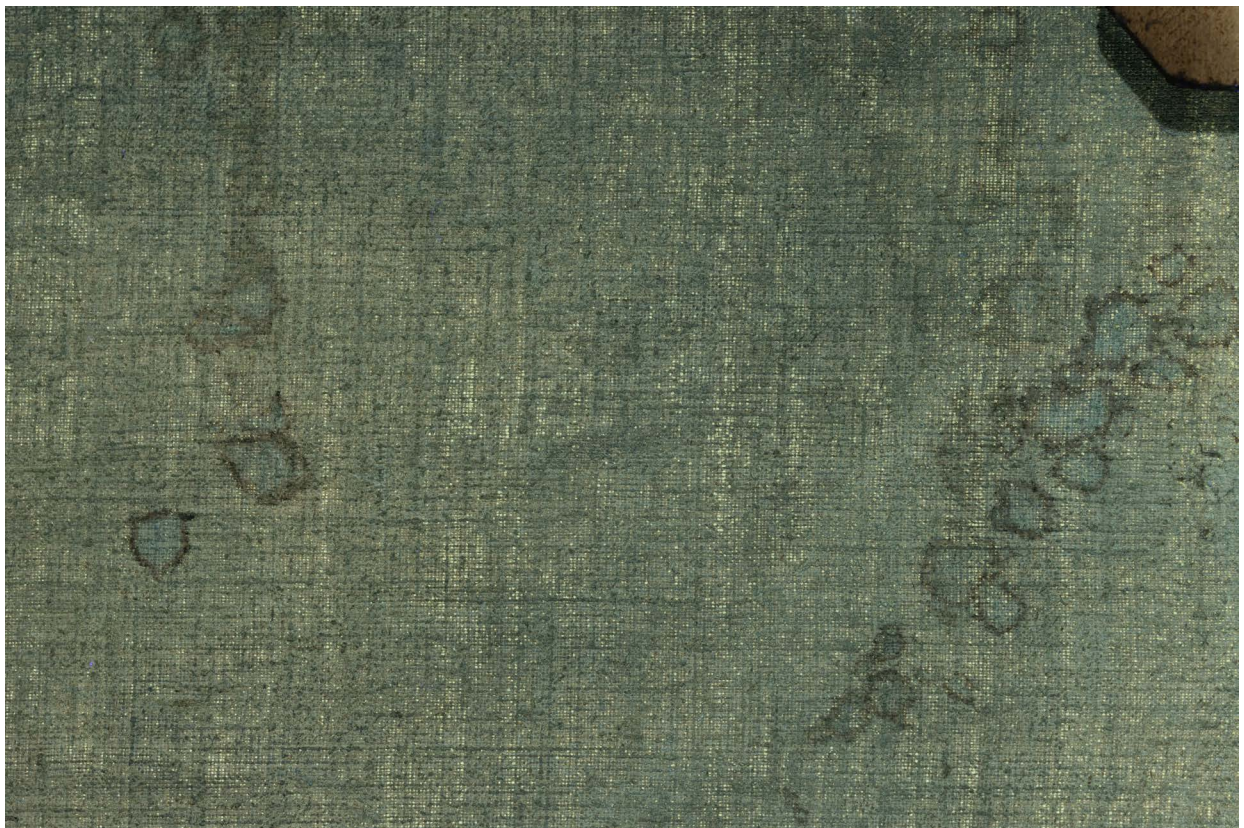
photographs in day light and UV luminescence  
back side, detail

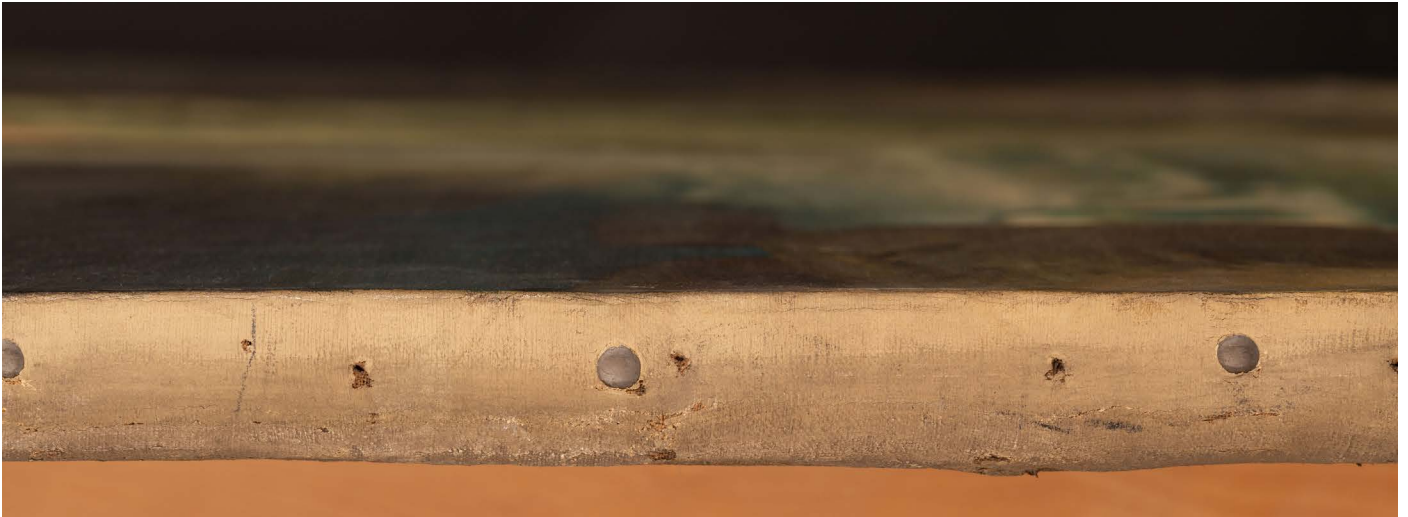
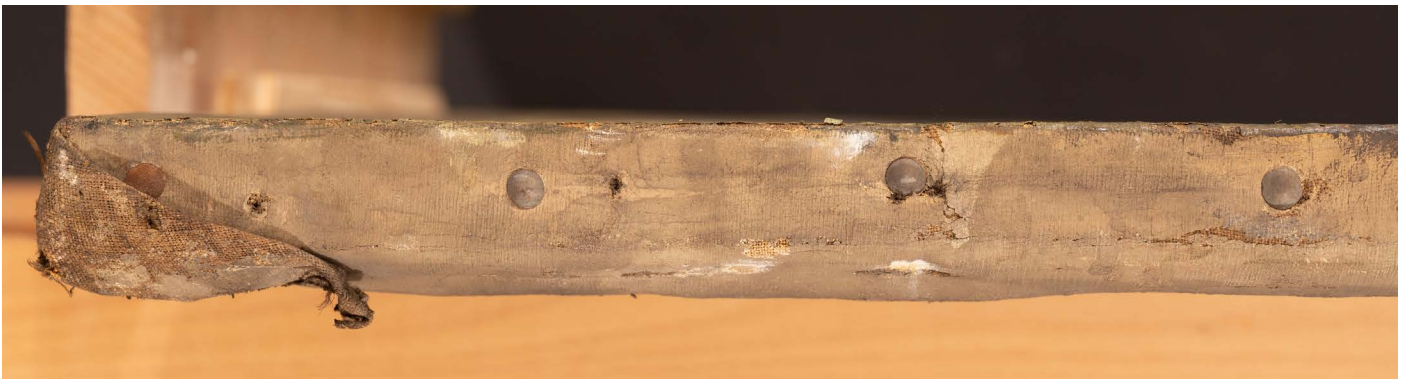
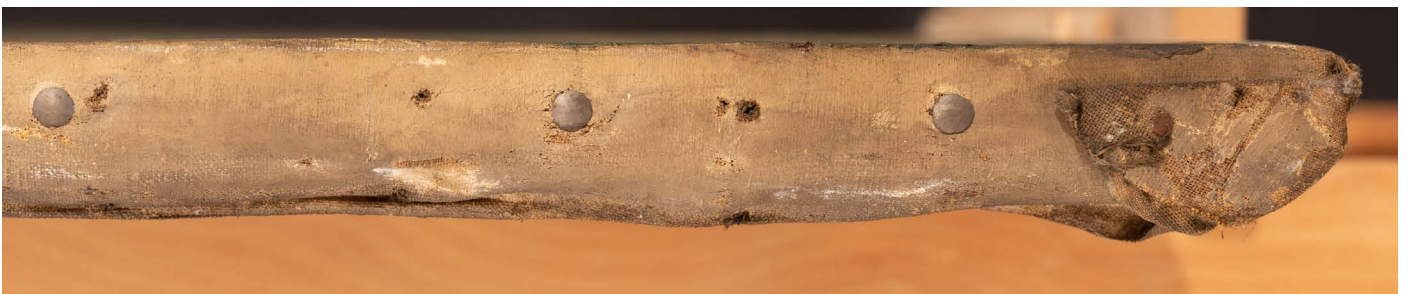
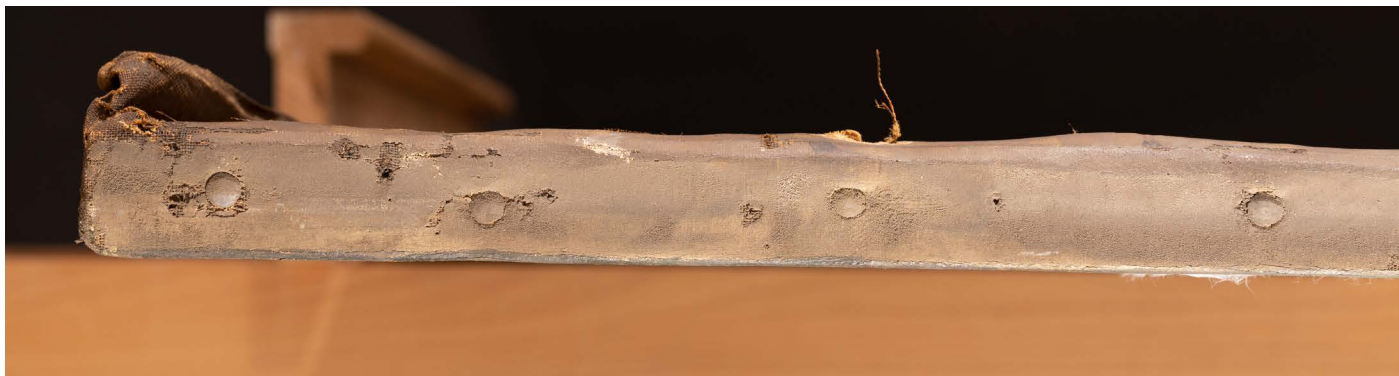
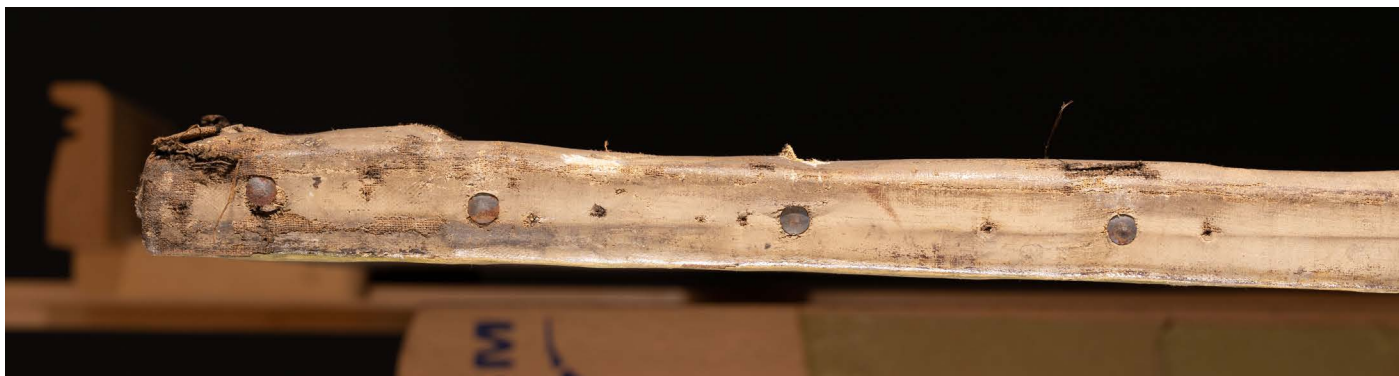
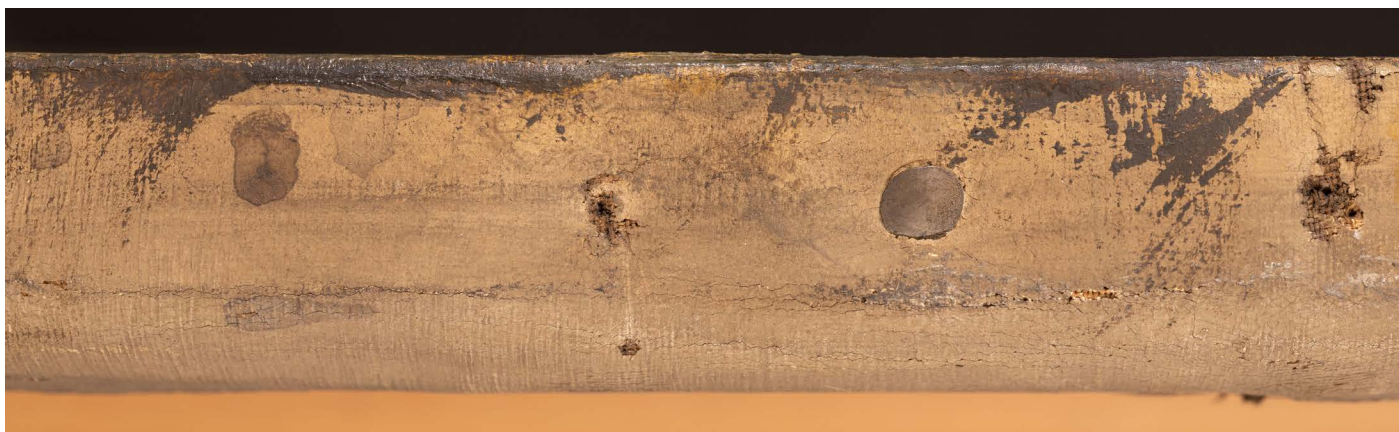
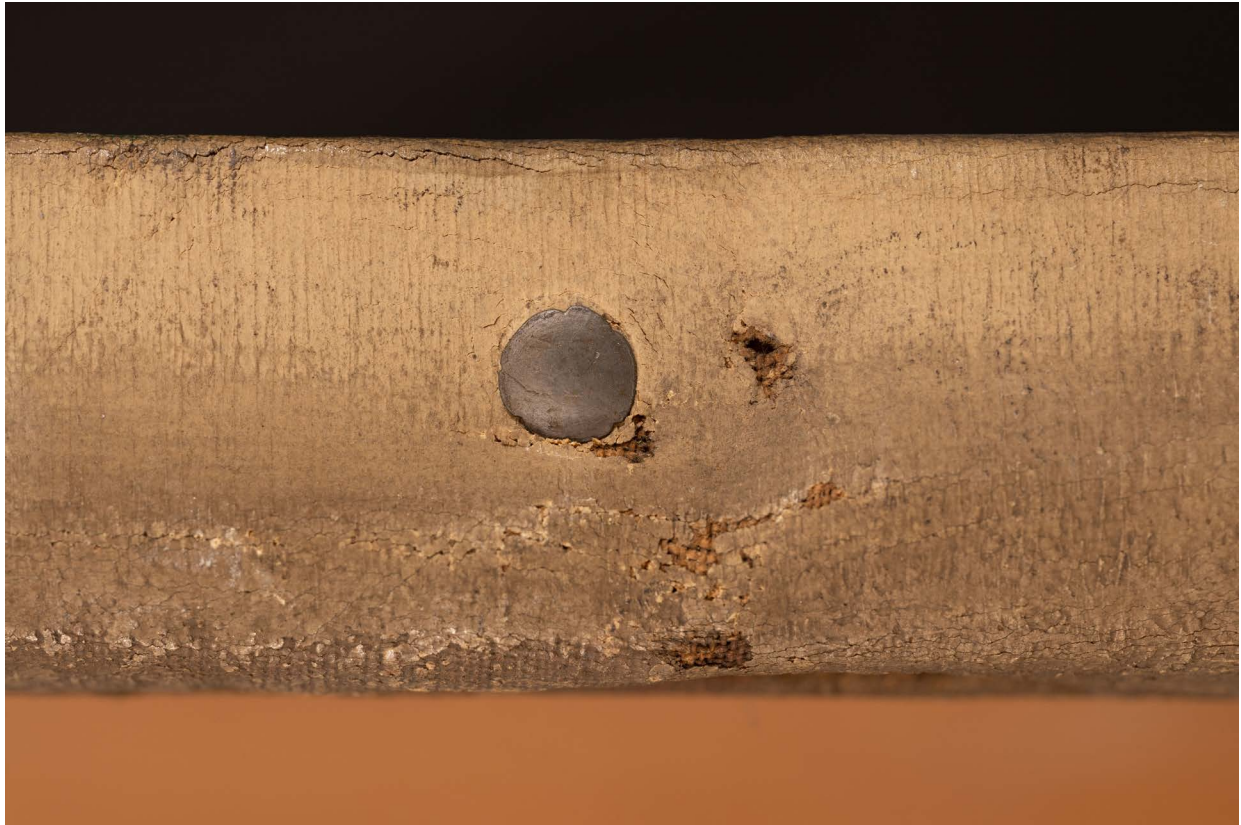
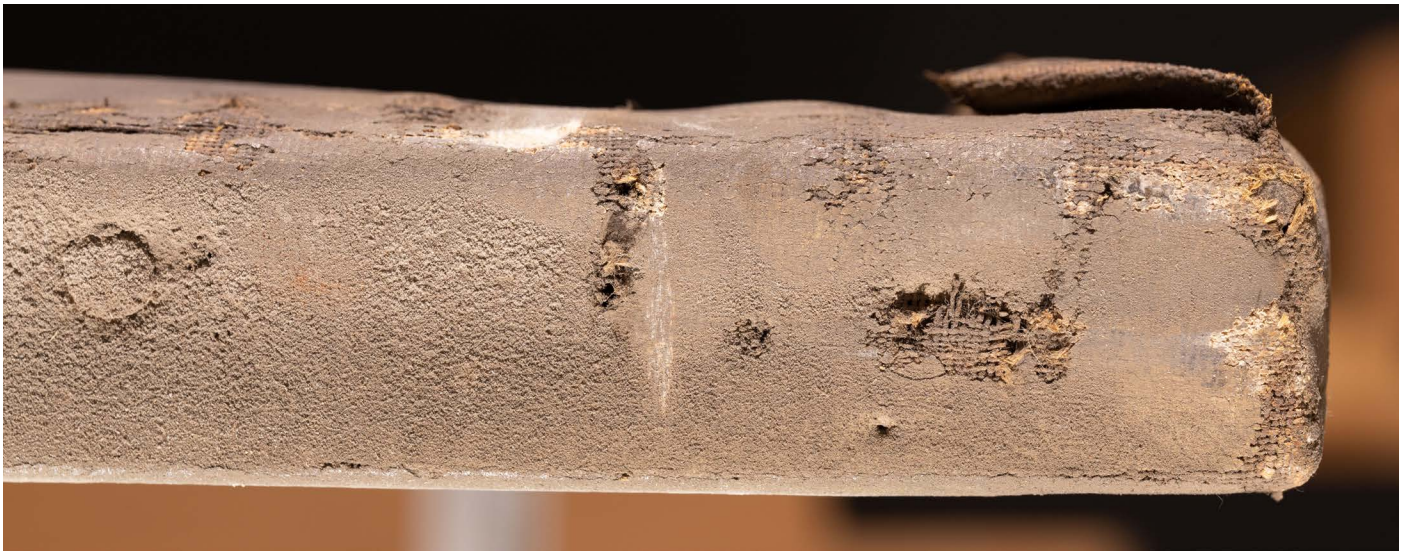
photographs in day light  
details of attachment of the canvas to the stretcher

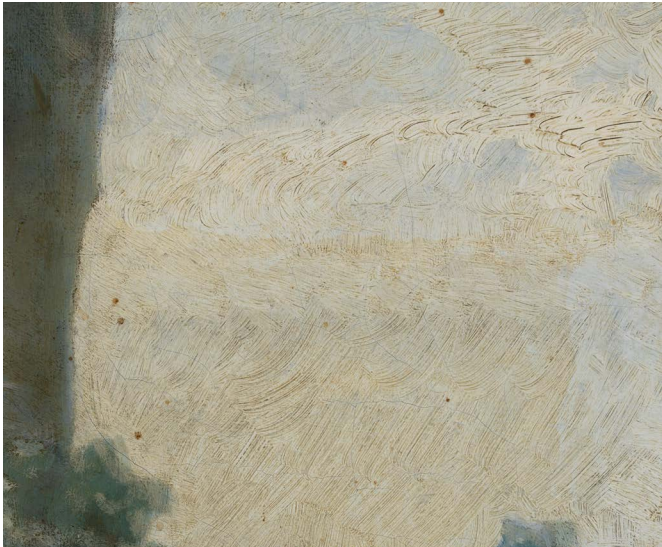
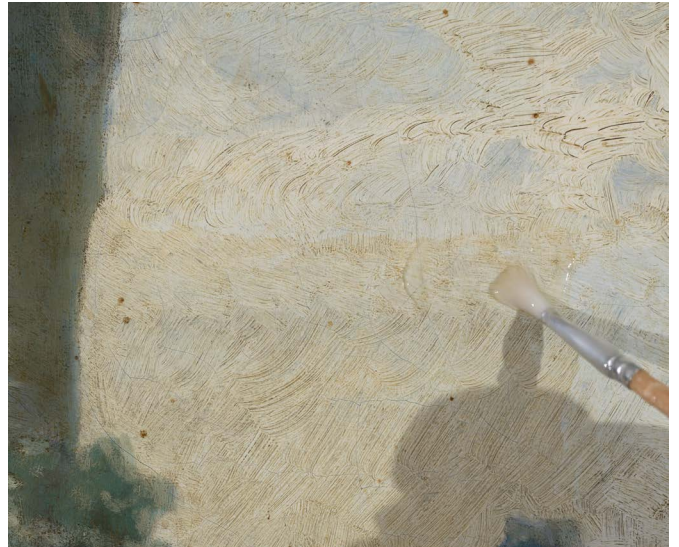
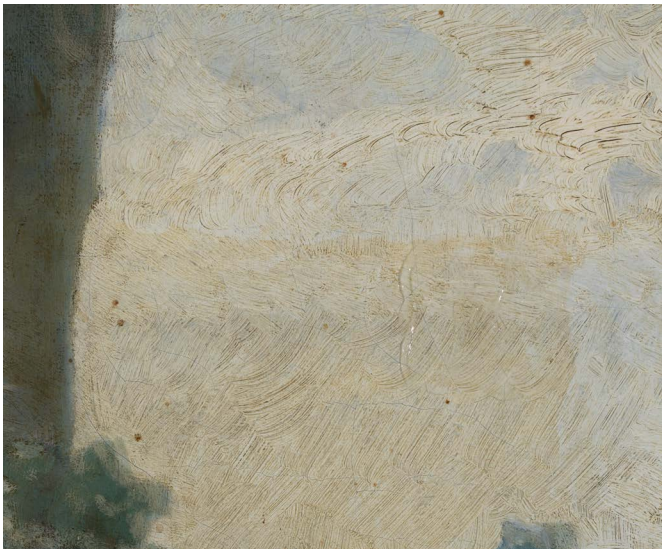
progress of thinning of varnish layer  
photographs in day light and UV luminescence

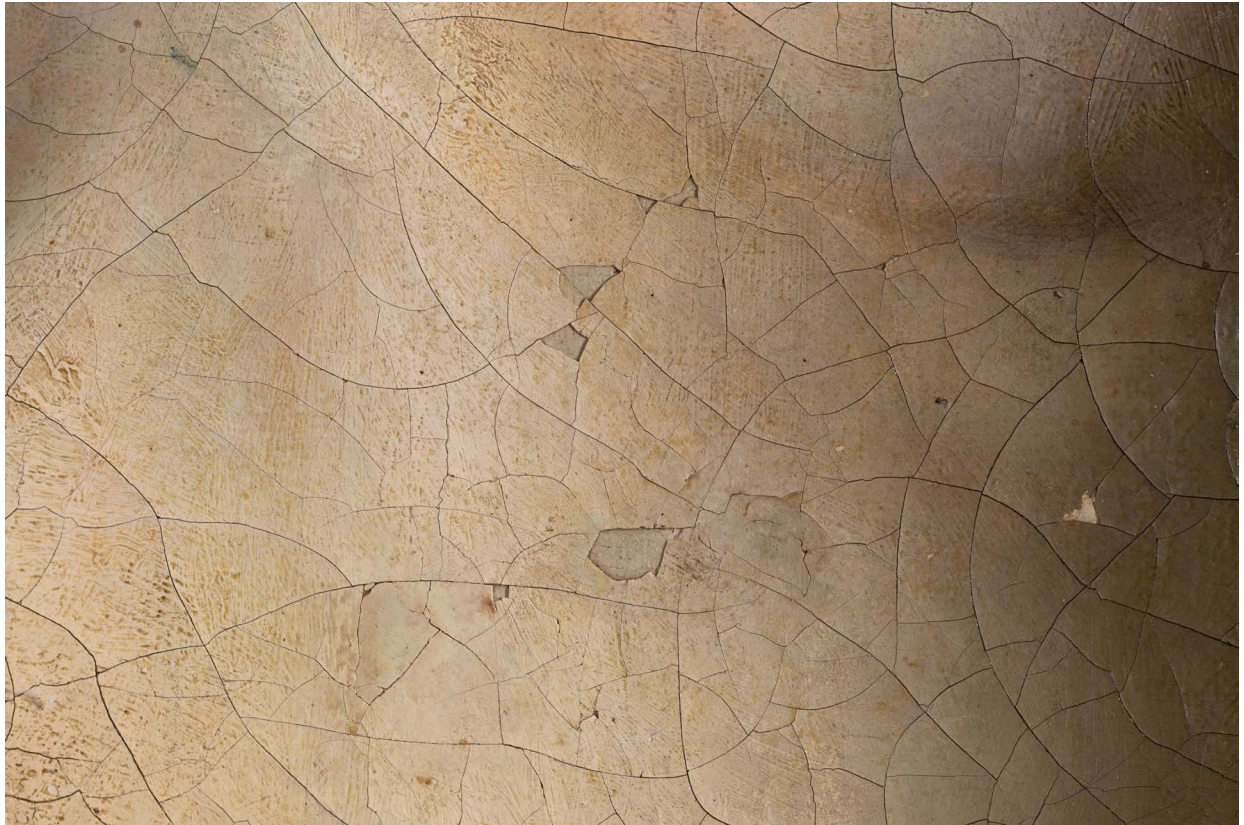
condition after thinning of varnish layer  
photographs in day light and UV luminescence, detail

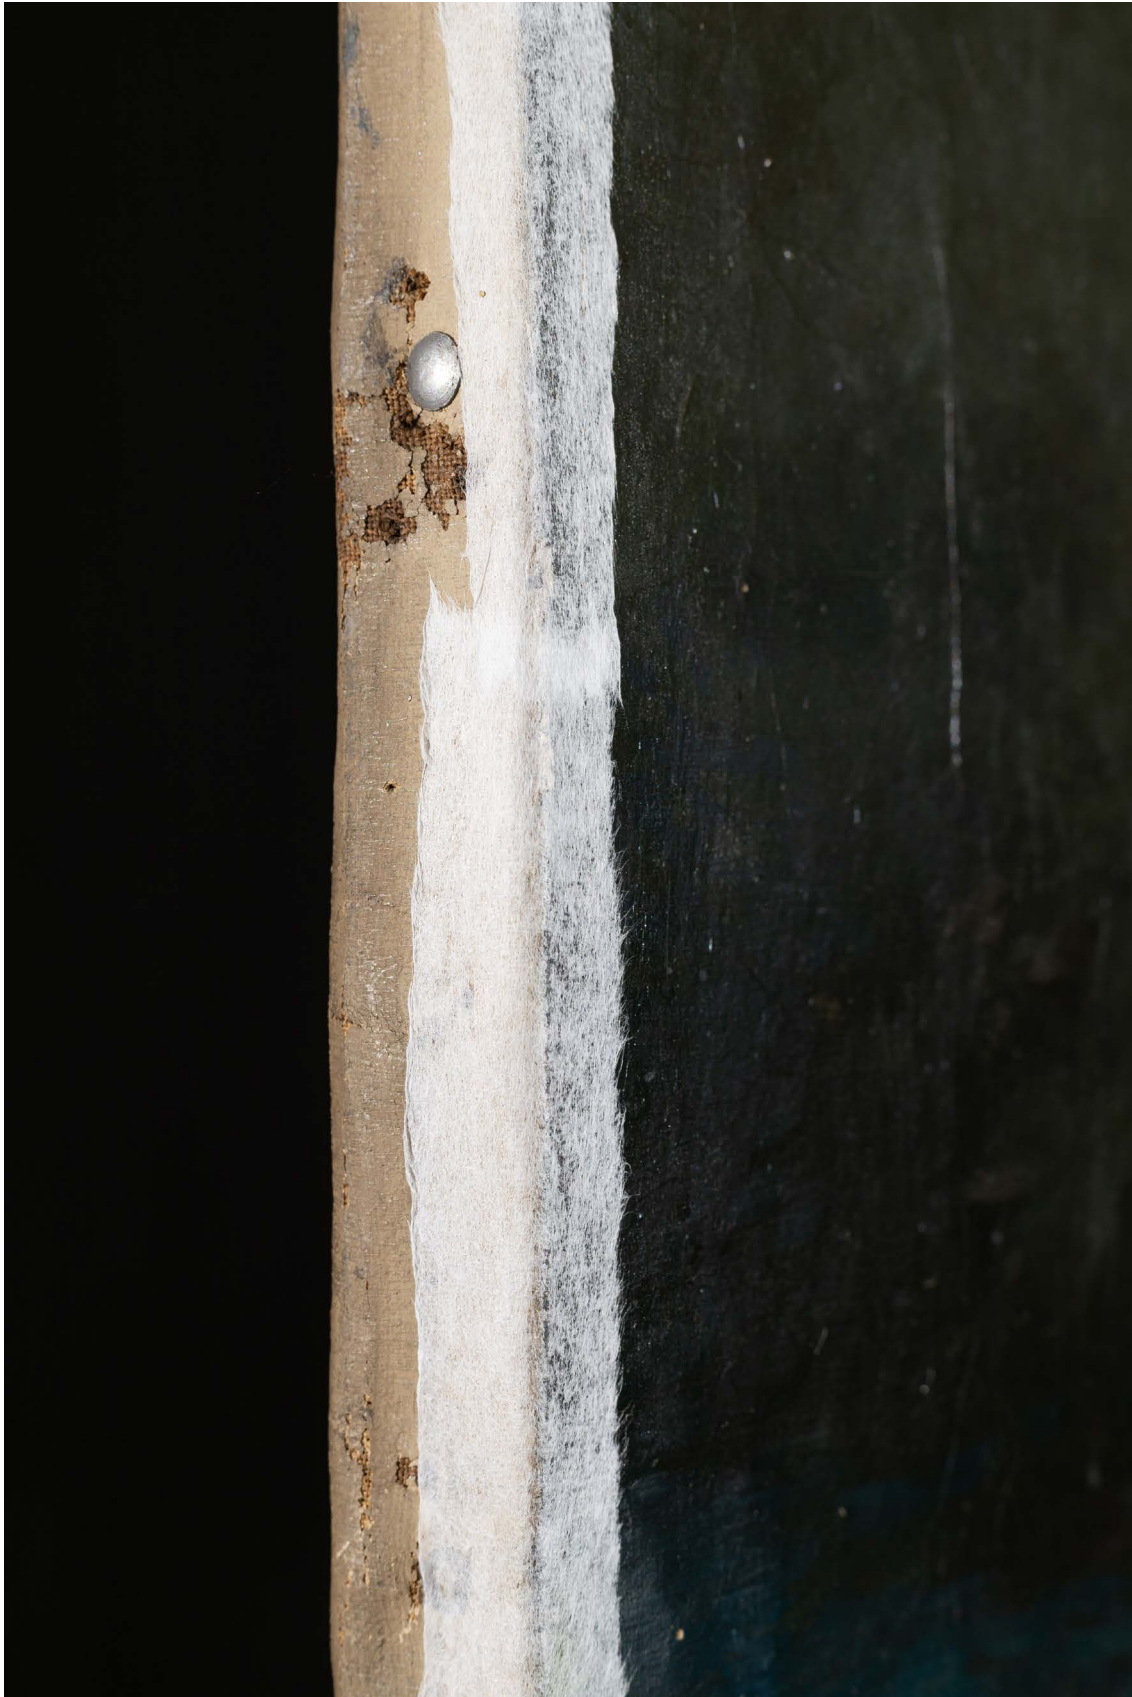
condition after application of facing around the edges  
photography in day light, detail

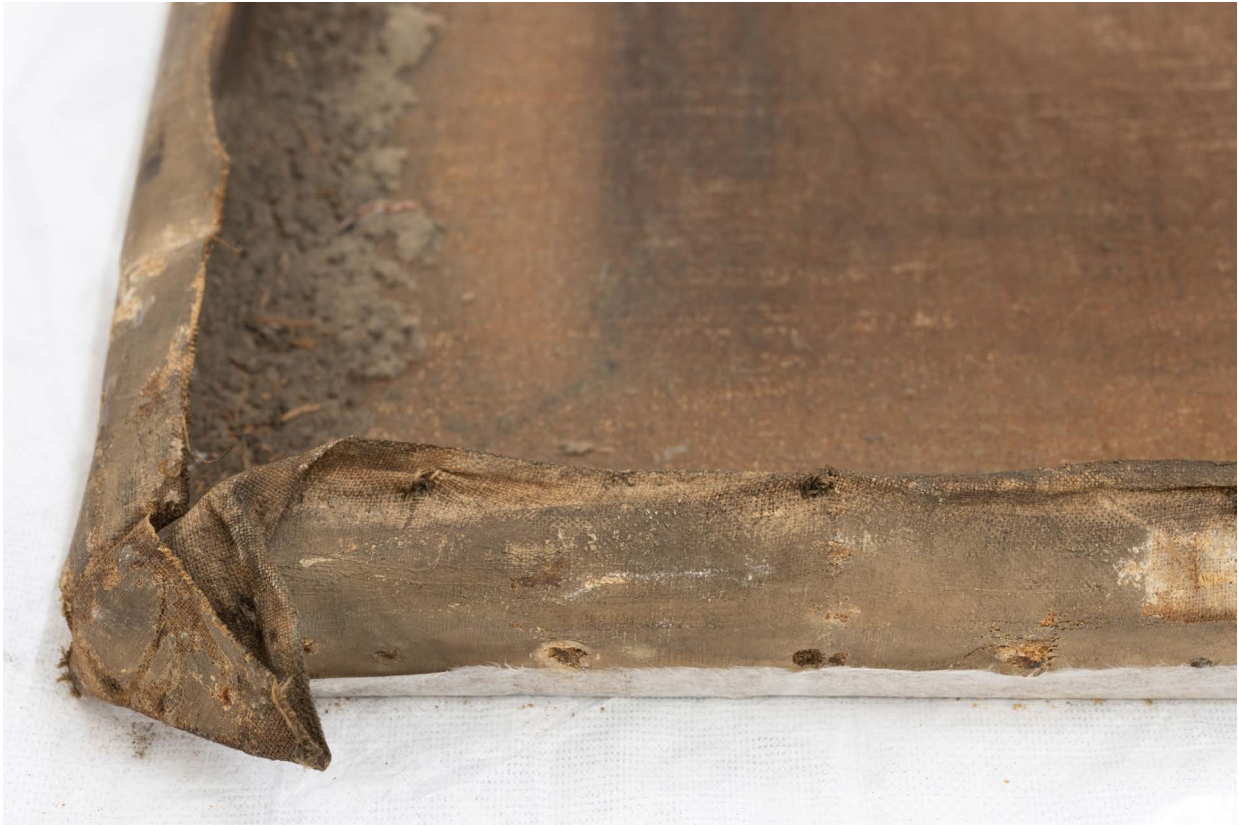
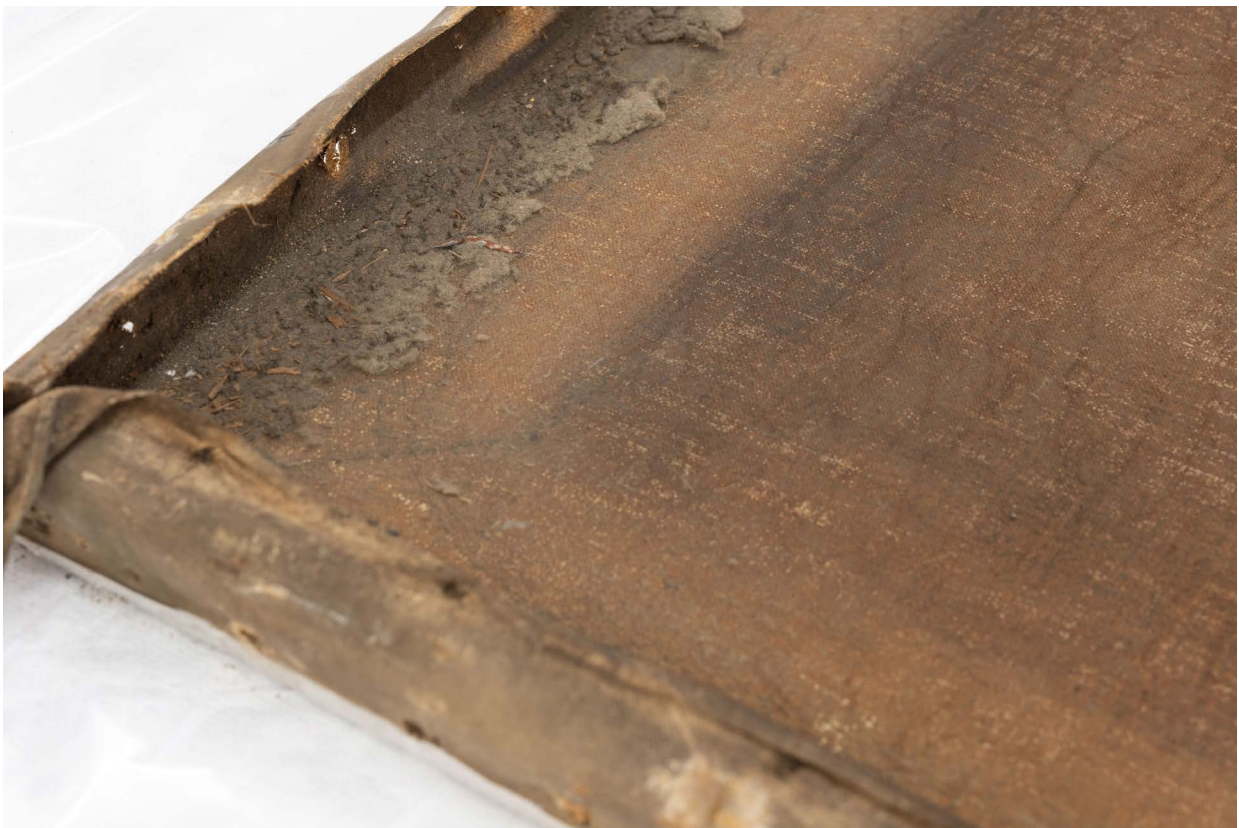
condition after removal from the stretcher  
photographs in day light, details
