# RESTORATION TREATMENT REPORT

## WATER FAIRY

EMIL JOHANN LAUFFER

NATIONAL GALLERY IN PRAGUE

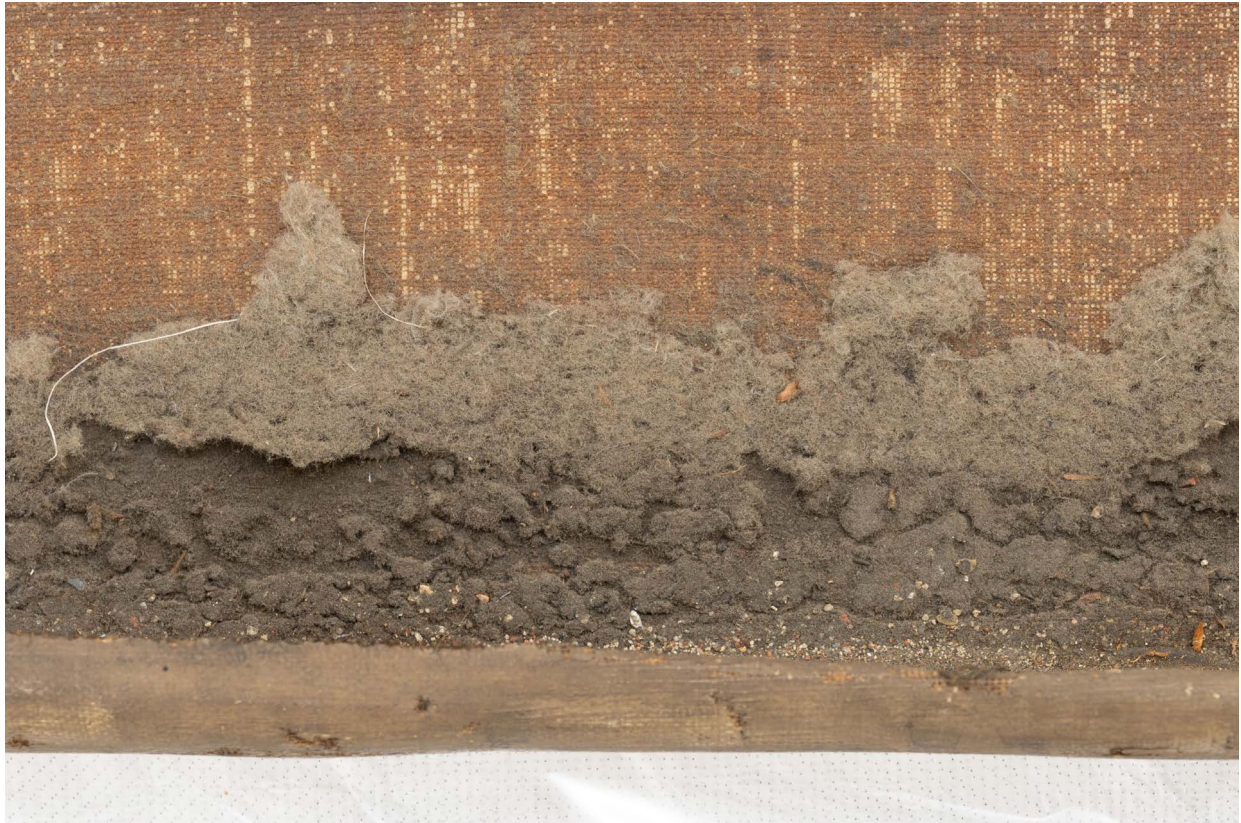
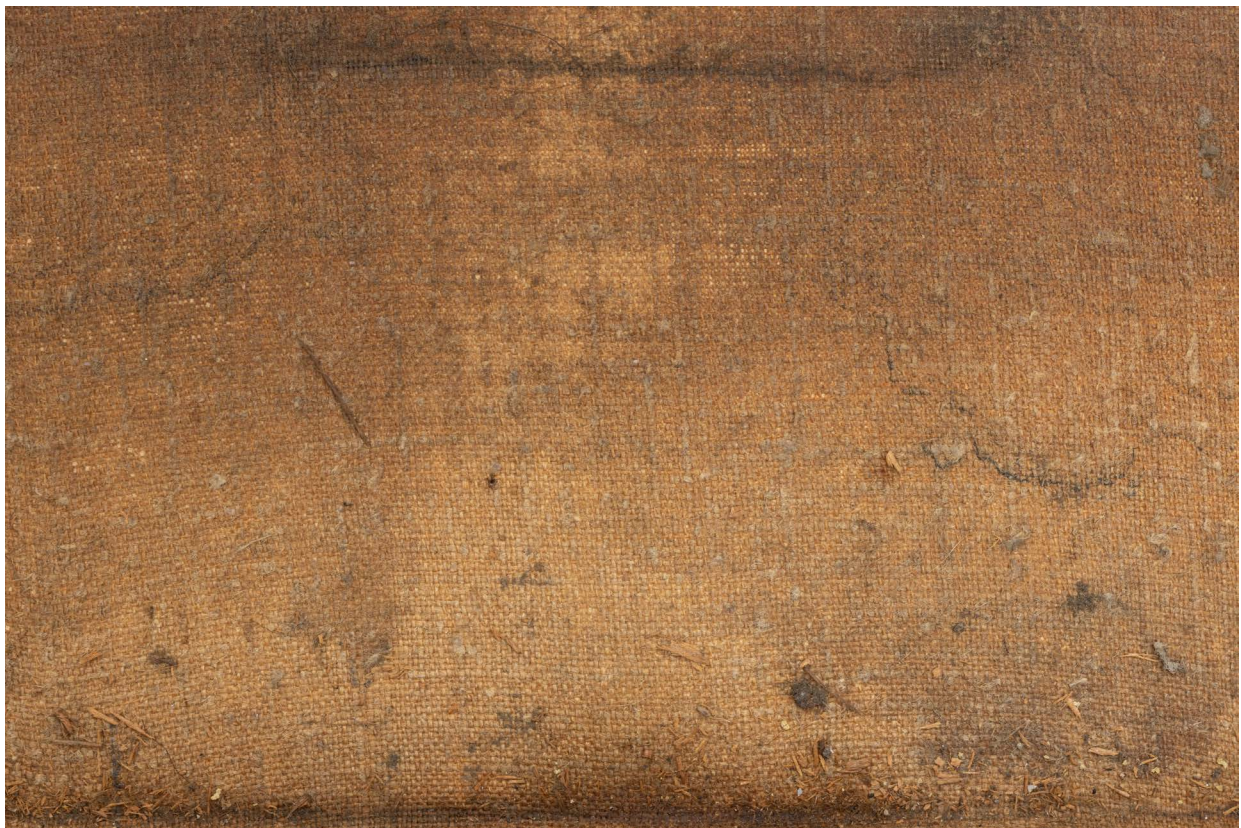
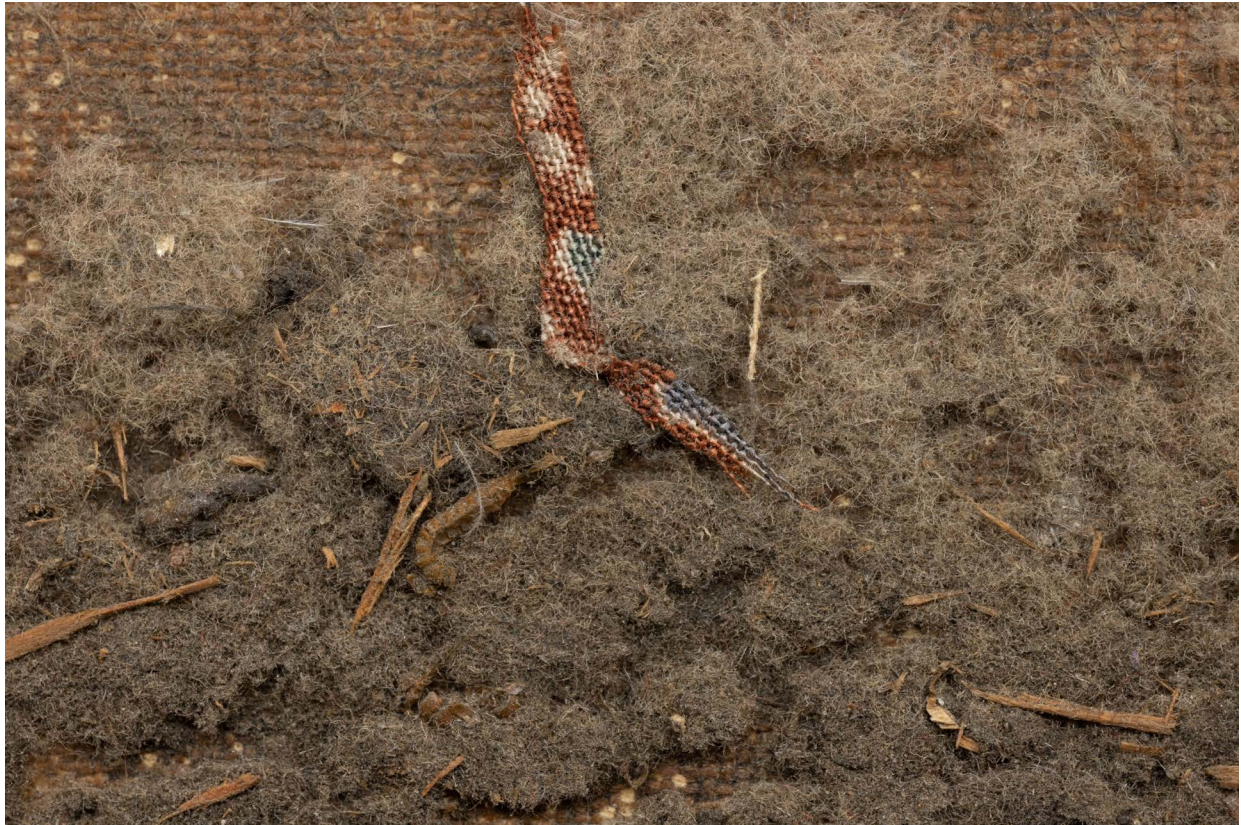
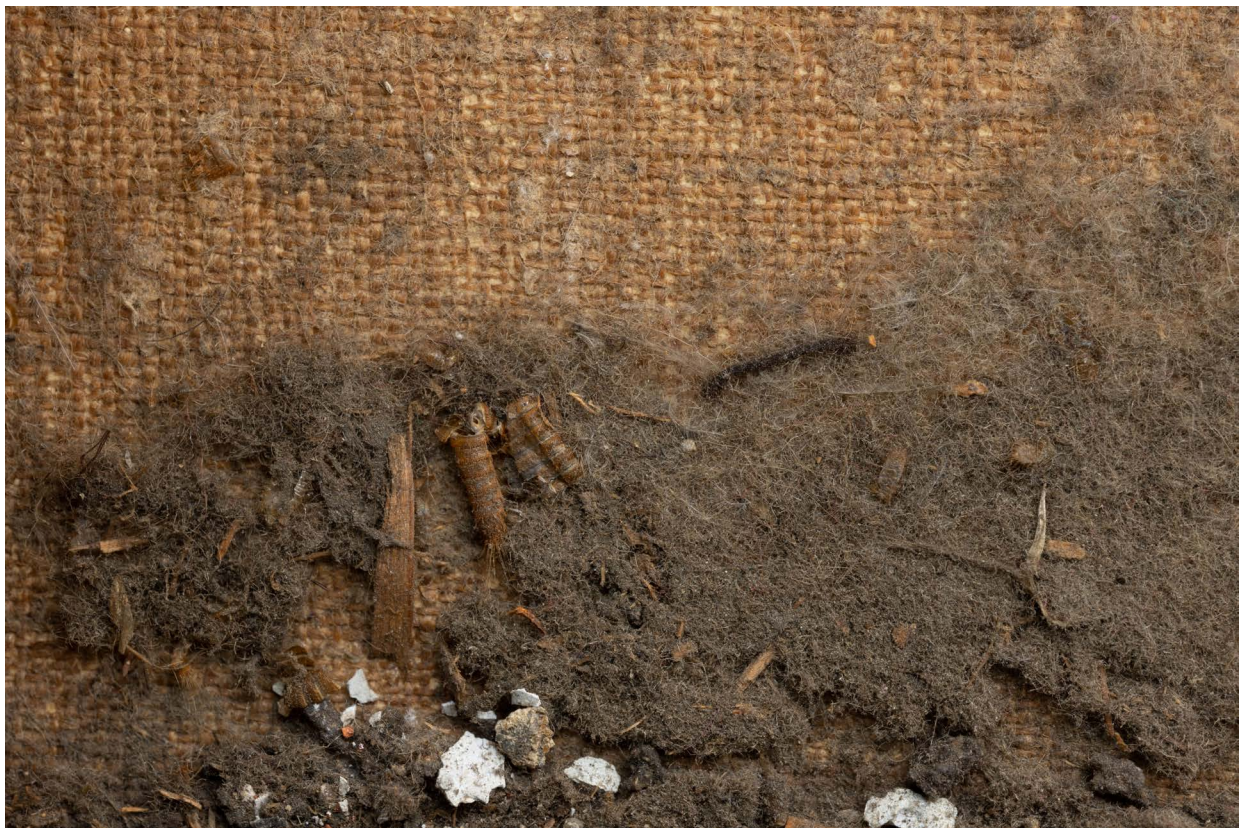
condition after removal from the stretcher  
macrophotographs in day light, details

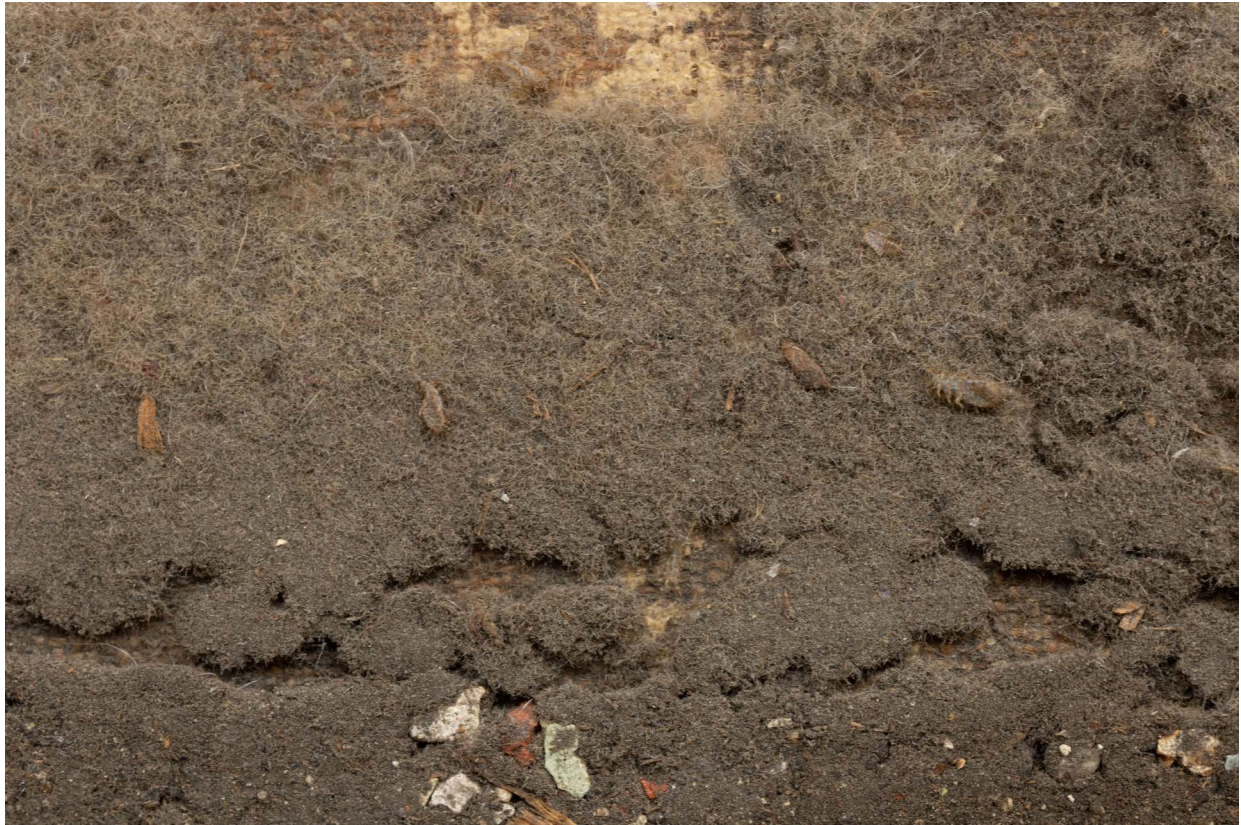
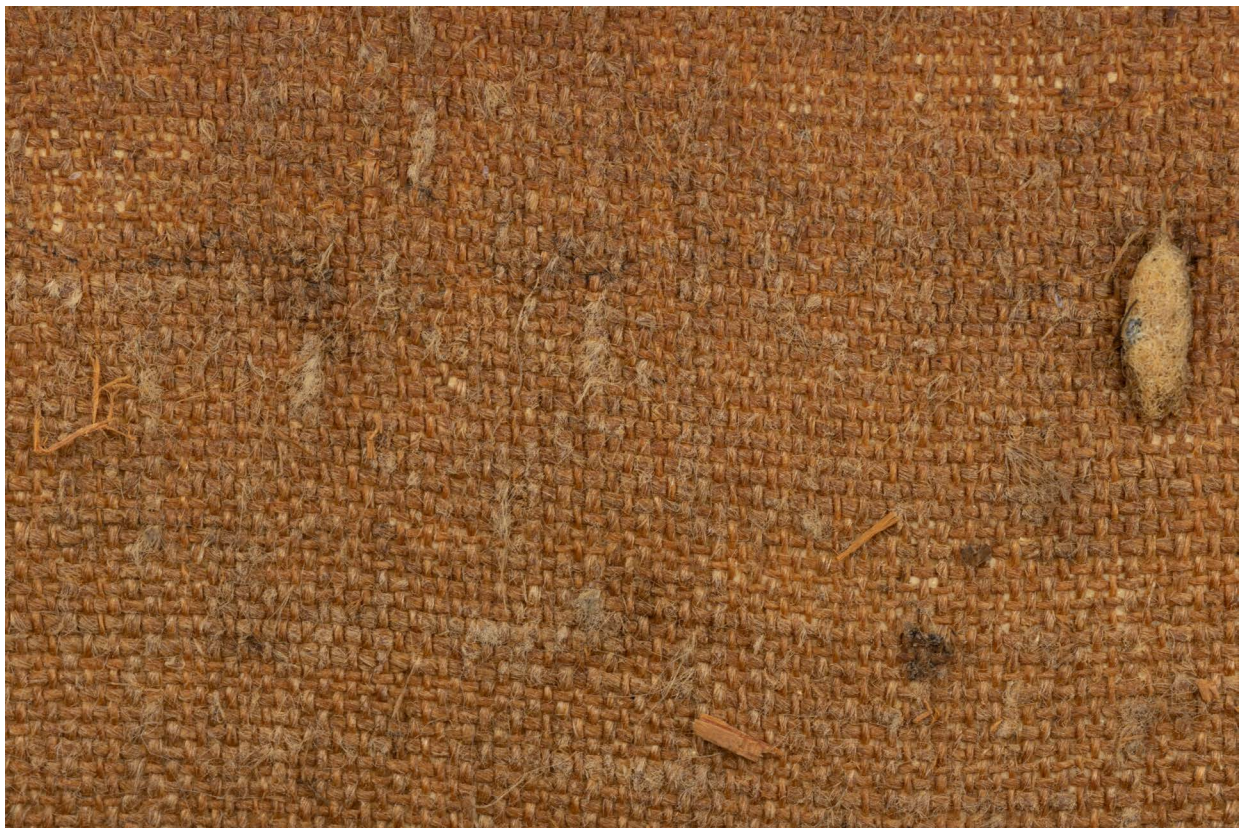
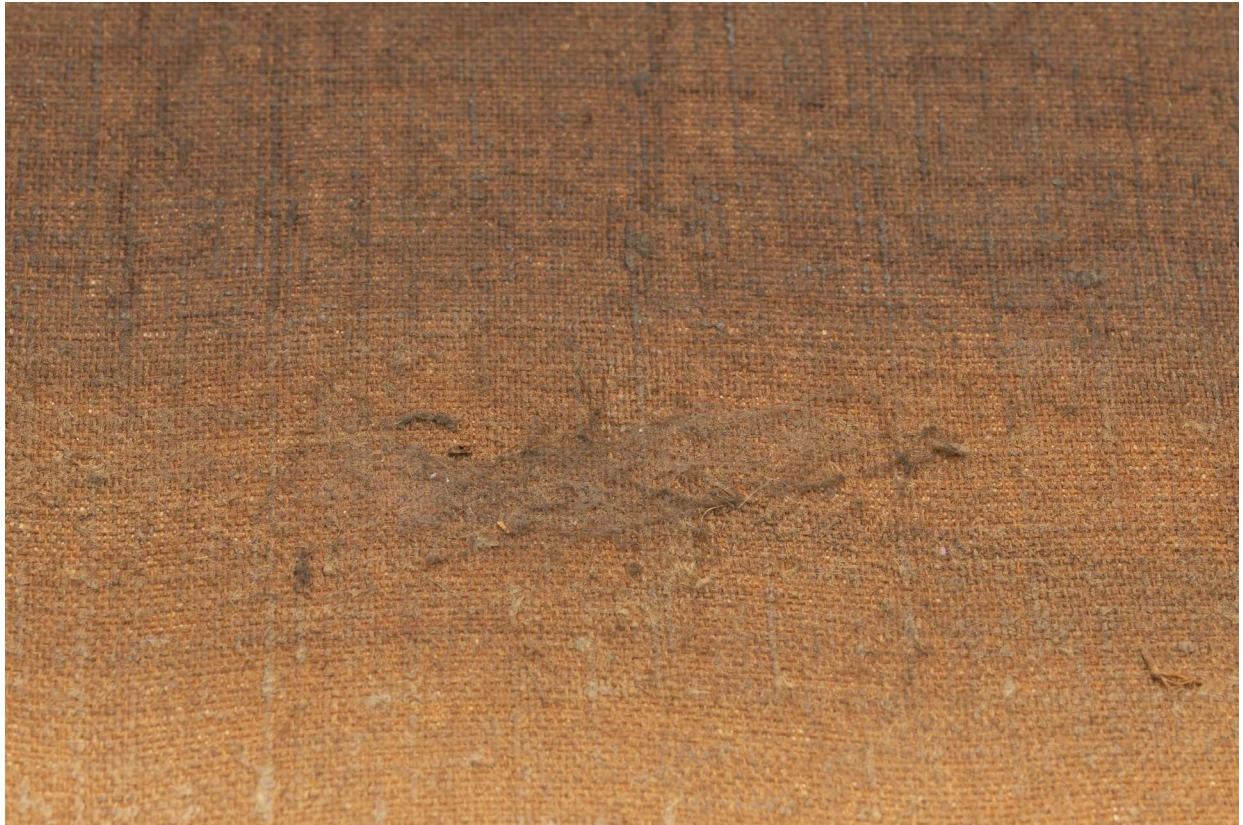
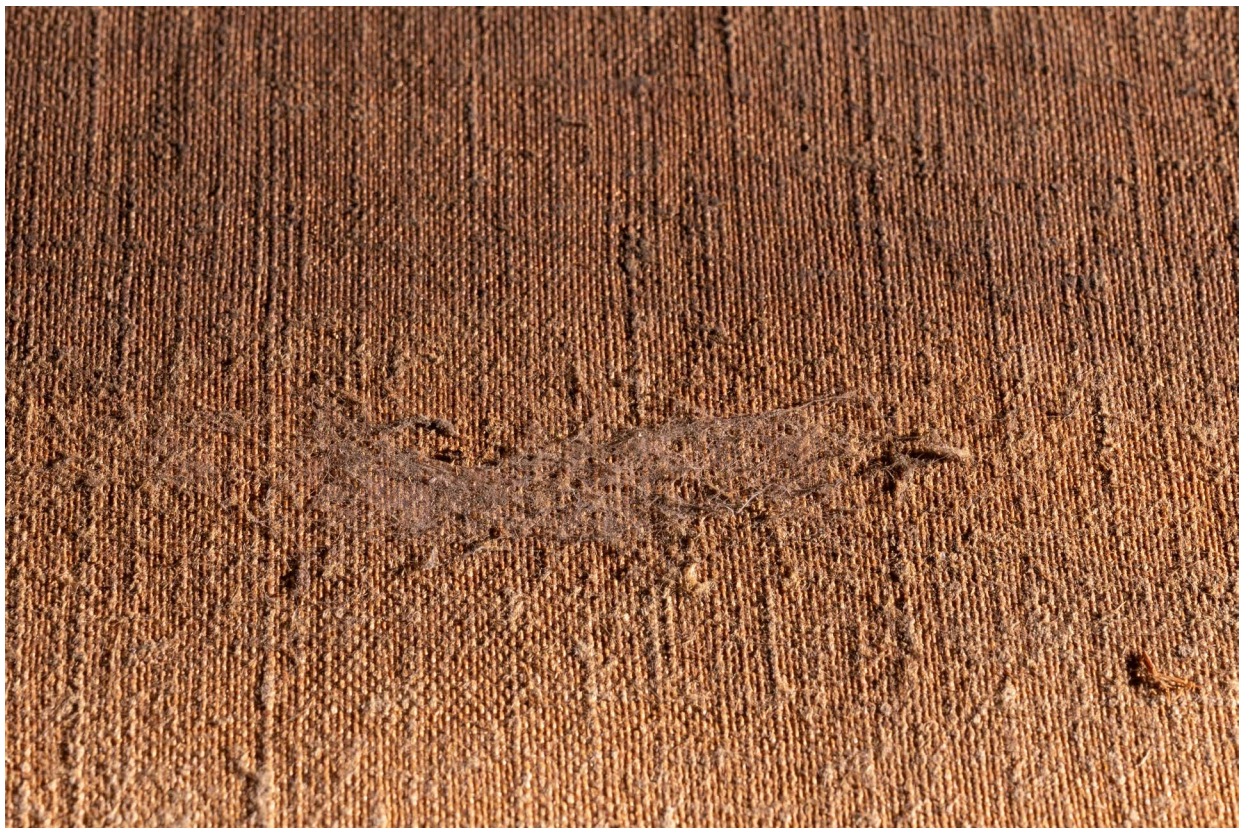
condition after removal from the stretcher  
photographs in day light, details

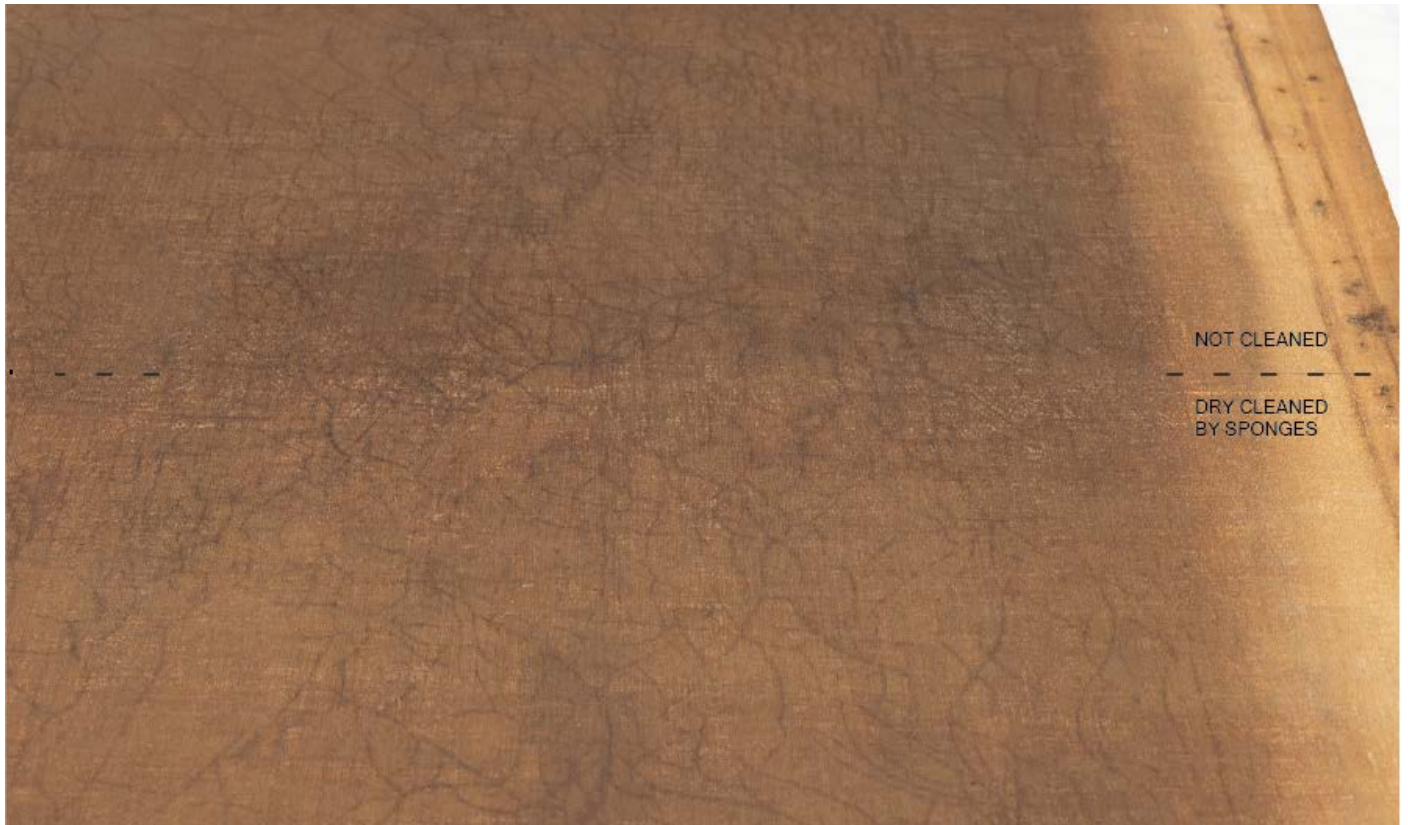
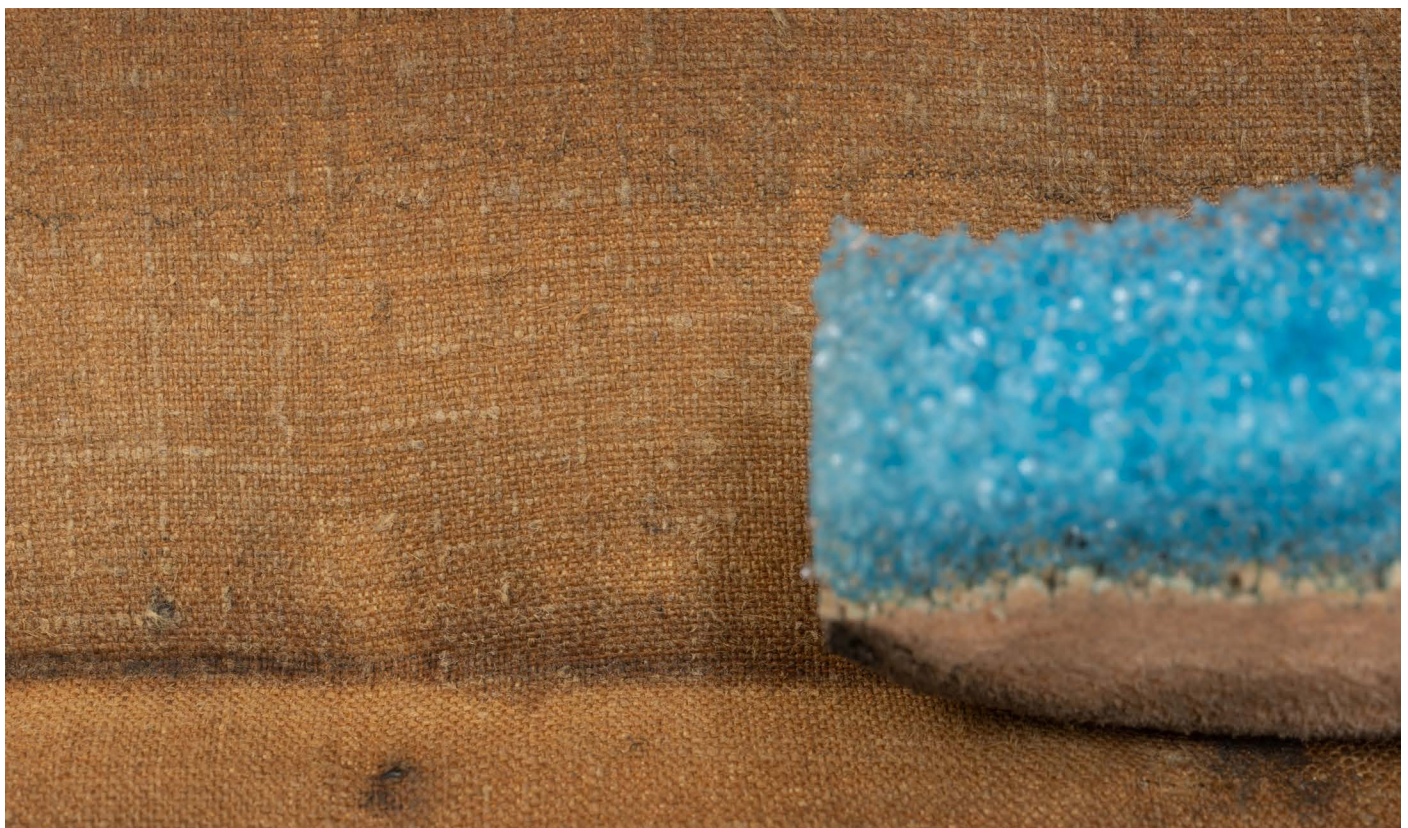
condition after flattening of the edges by local influence of humidity and application of weight  
photography in day light

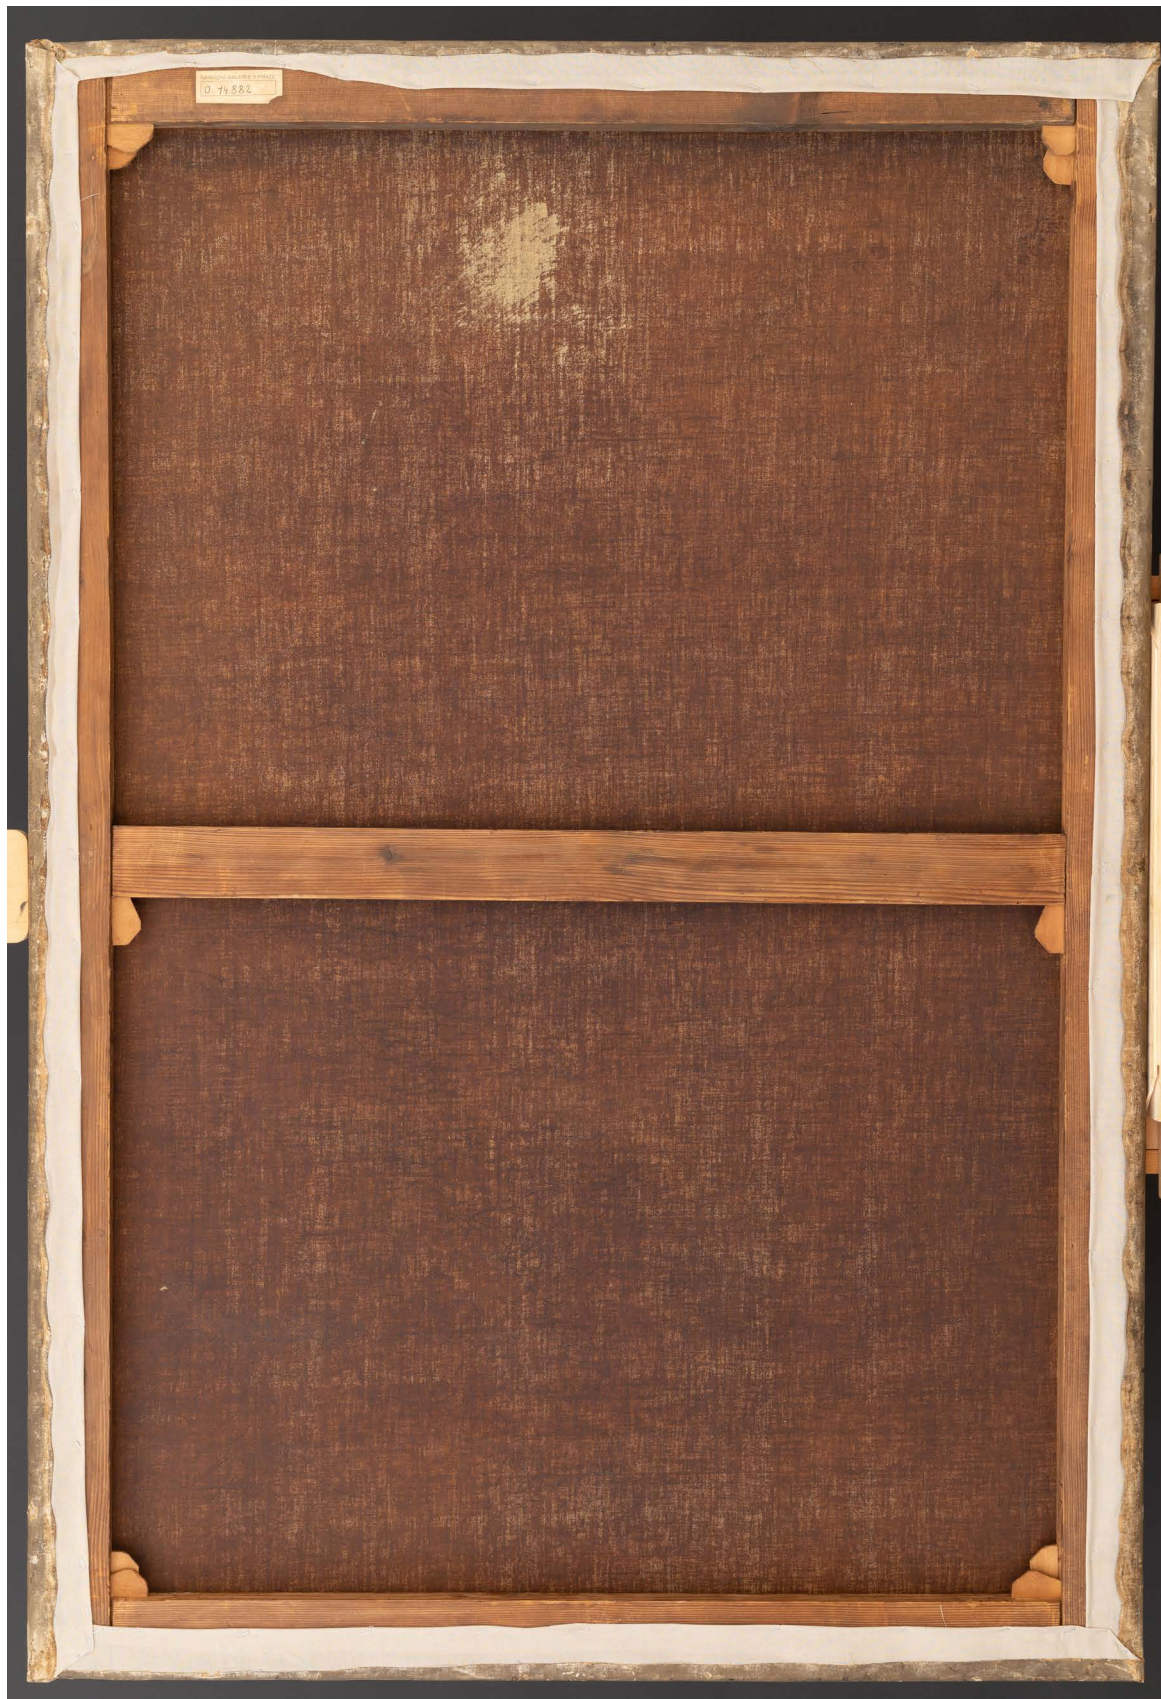
condition after stretching the painting on the stretcher, back side  
photography in day light

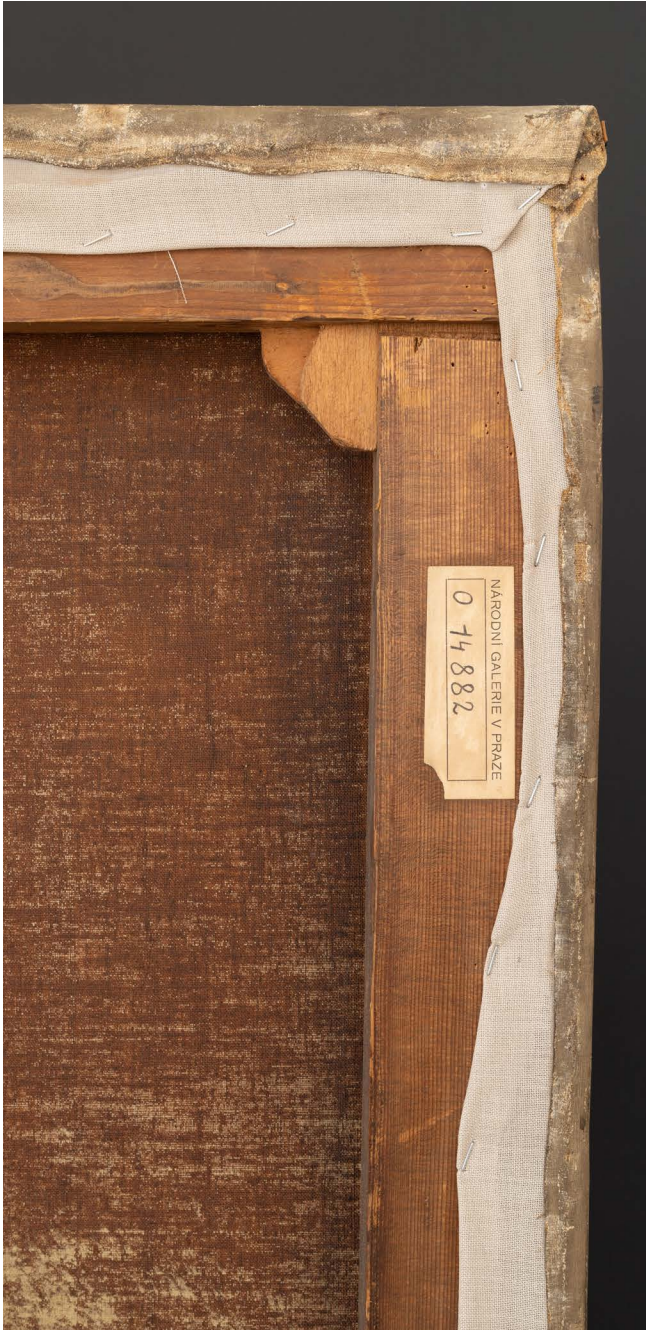
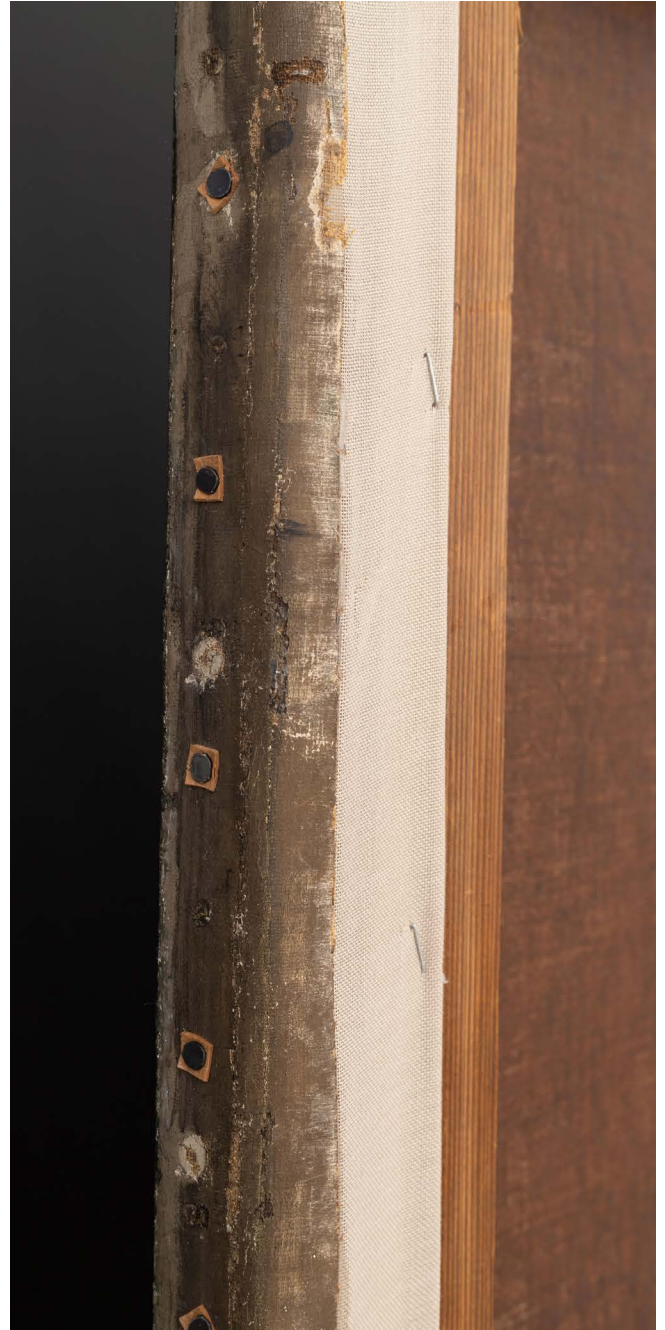
condition after stretching the painting on the stretcher, back side, details  
photographs in day light

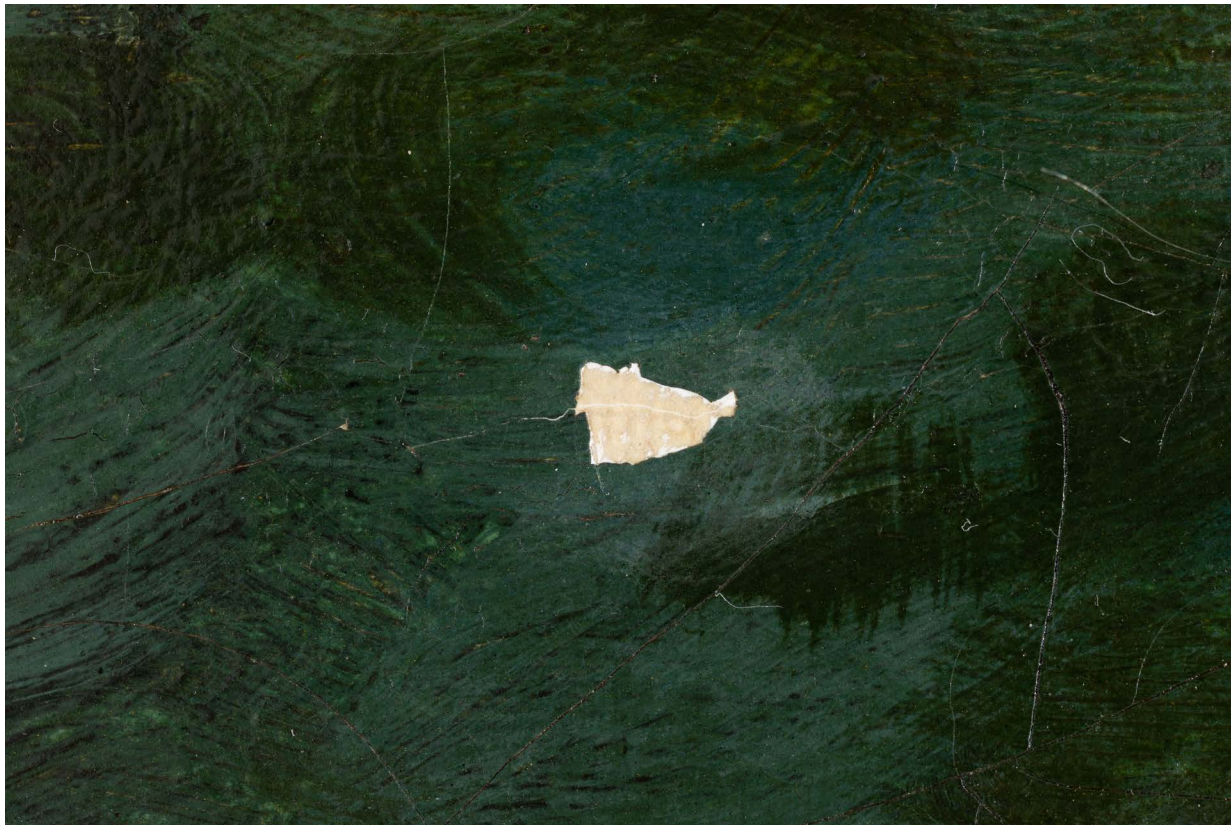
- Several areas of the painting with overpainting and fillers were discovered during the varnish removal. These areas were removed due to color changes and inadequate surface quality. The removal was conducted using isooctane-methyl ethyl ketone-ethanol (proportion 7:2:1) solvent surfactant gel with carbopol.

condition after removal of degraded retouching and unsuitable fillers  
details of losses in paint and ground layer of the painting  
photographs in day light

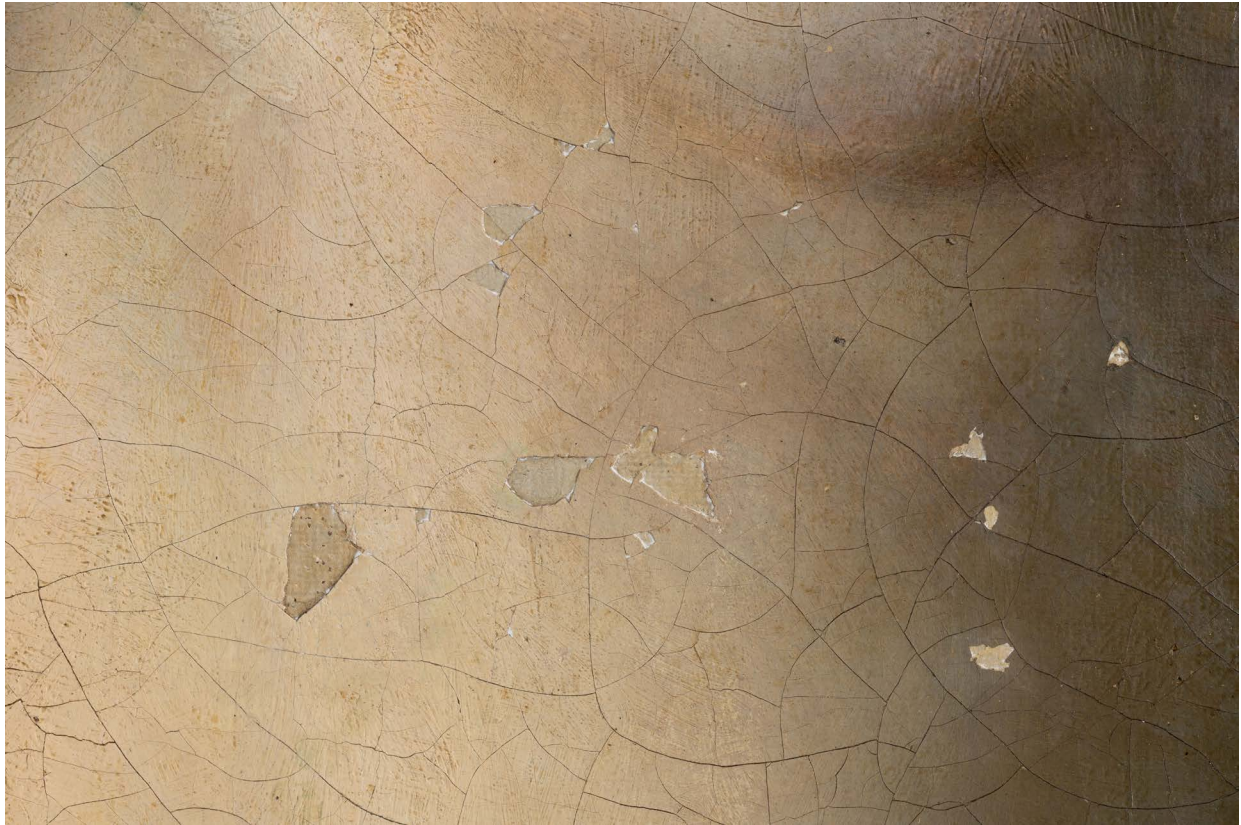
condition after removal of degraded retouching and unsuitable fillers  
details of losses in paint and ground layer of the painting  
photographs in day light

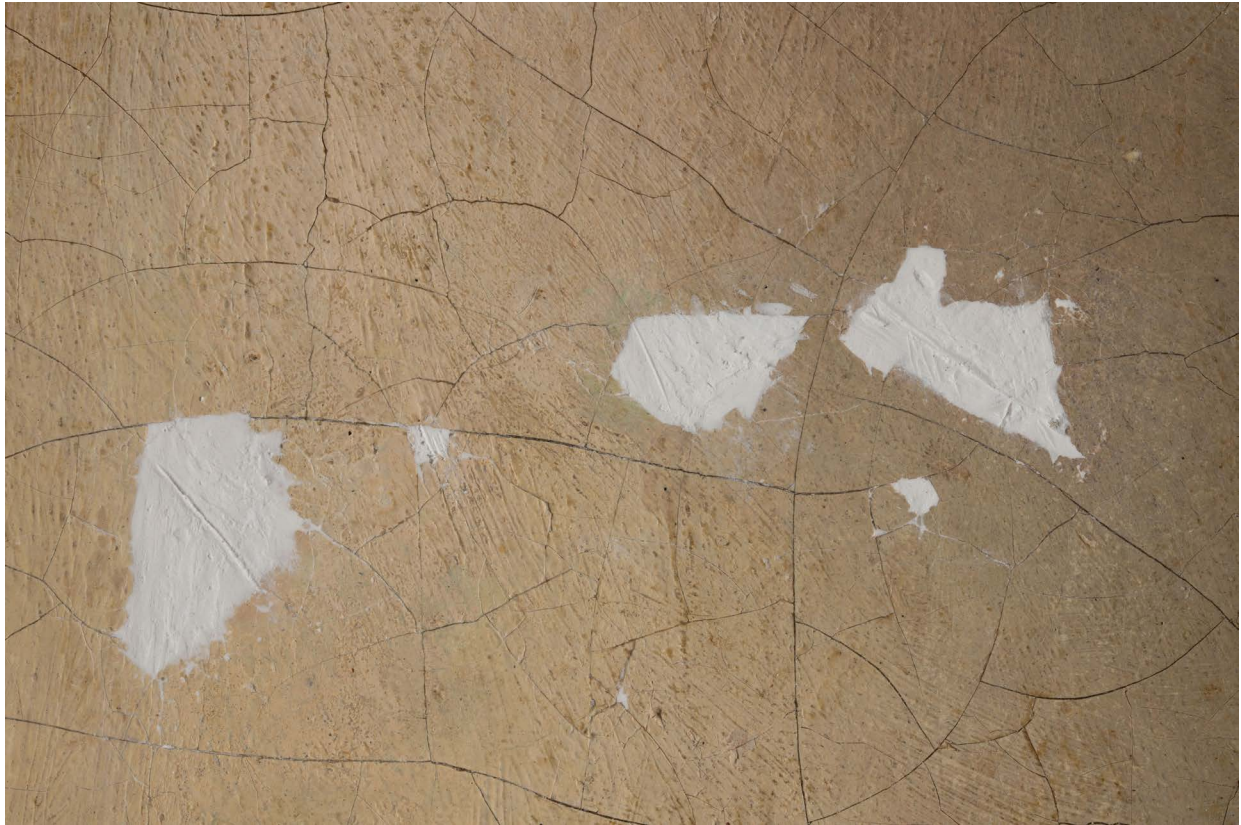
condition after application of fillers inside the defects  
macrophotographs in day and raking light, details

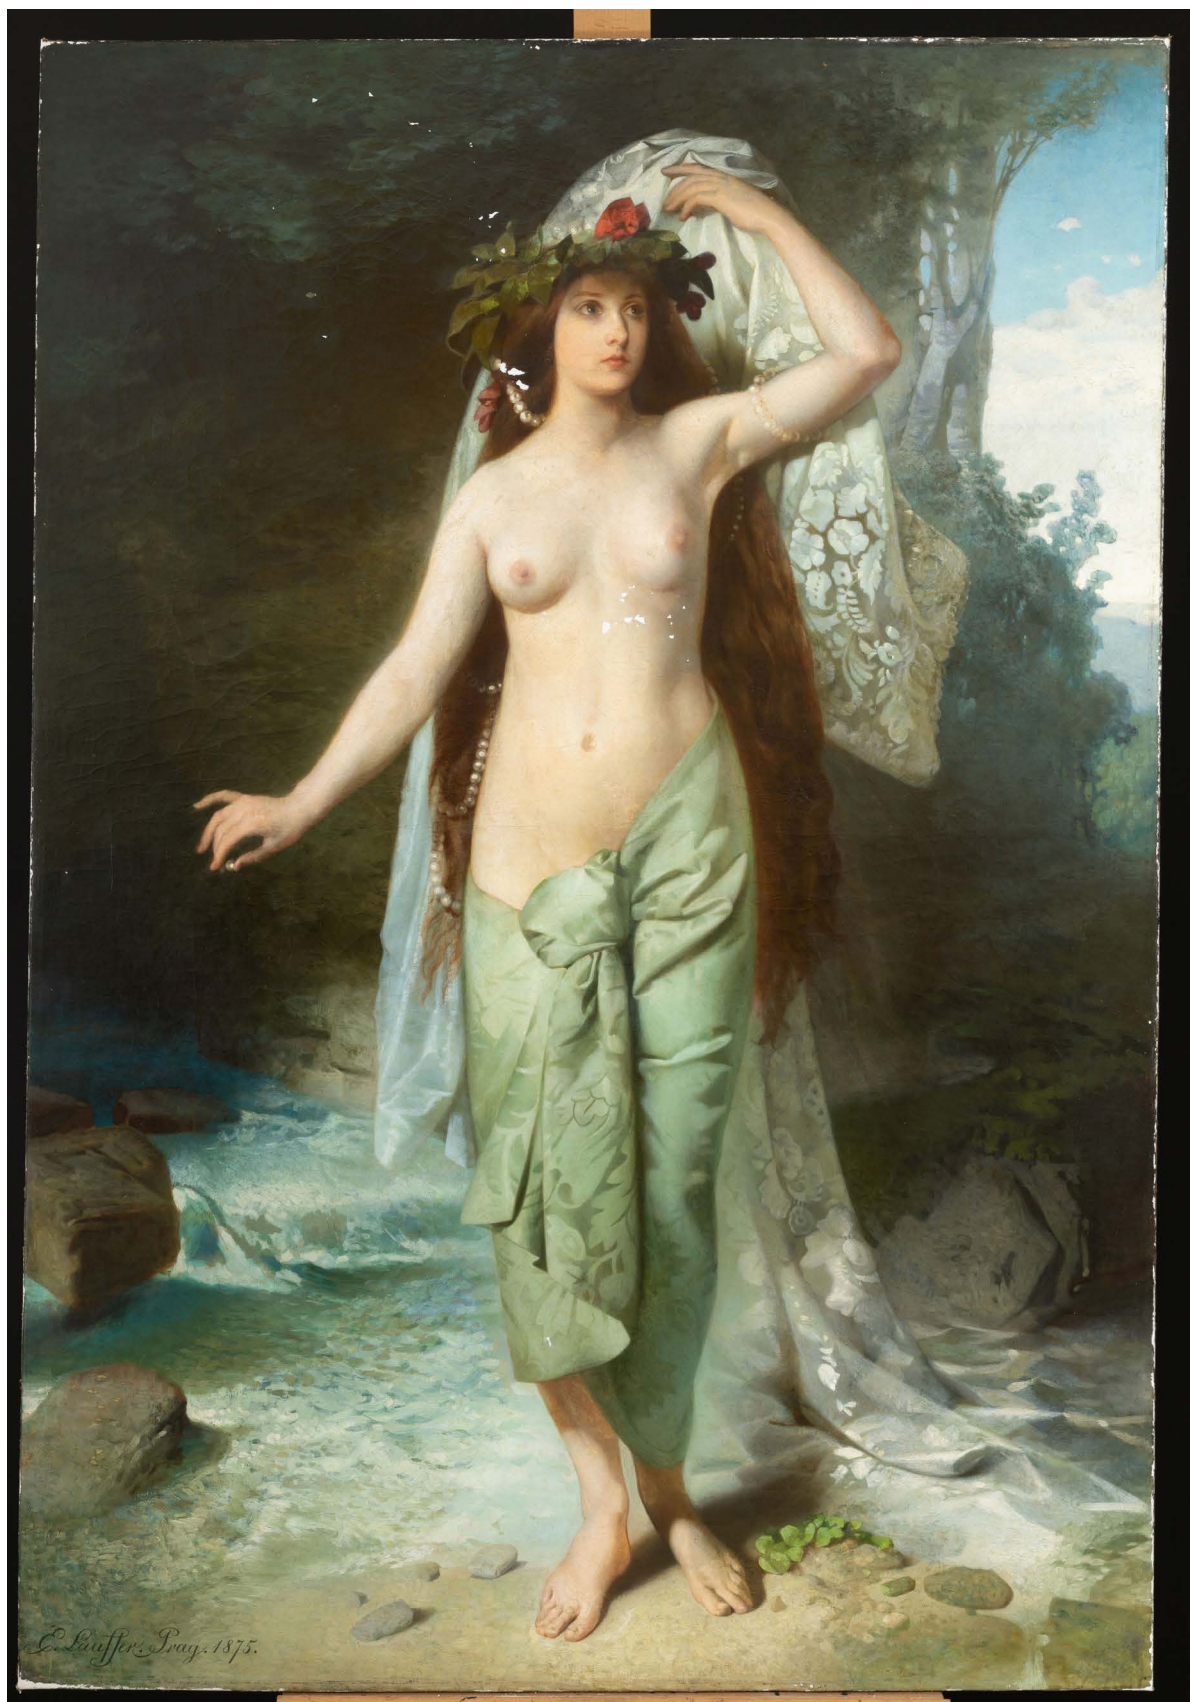
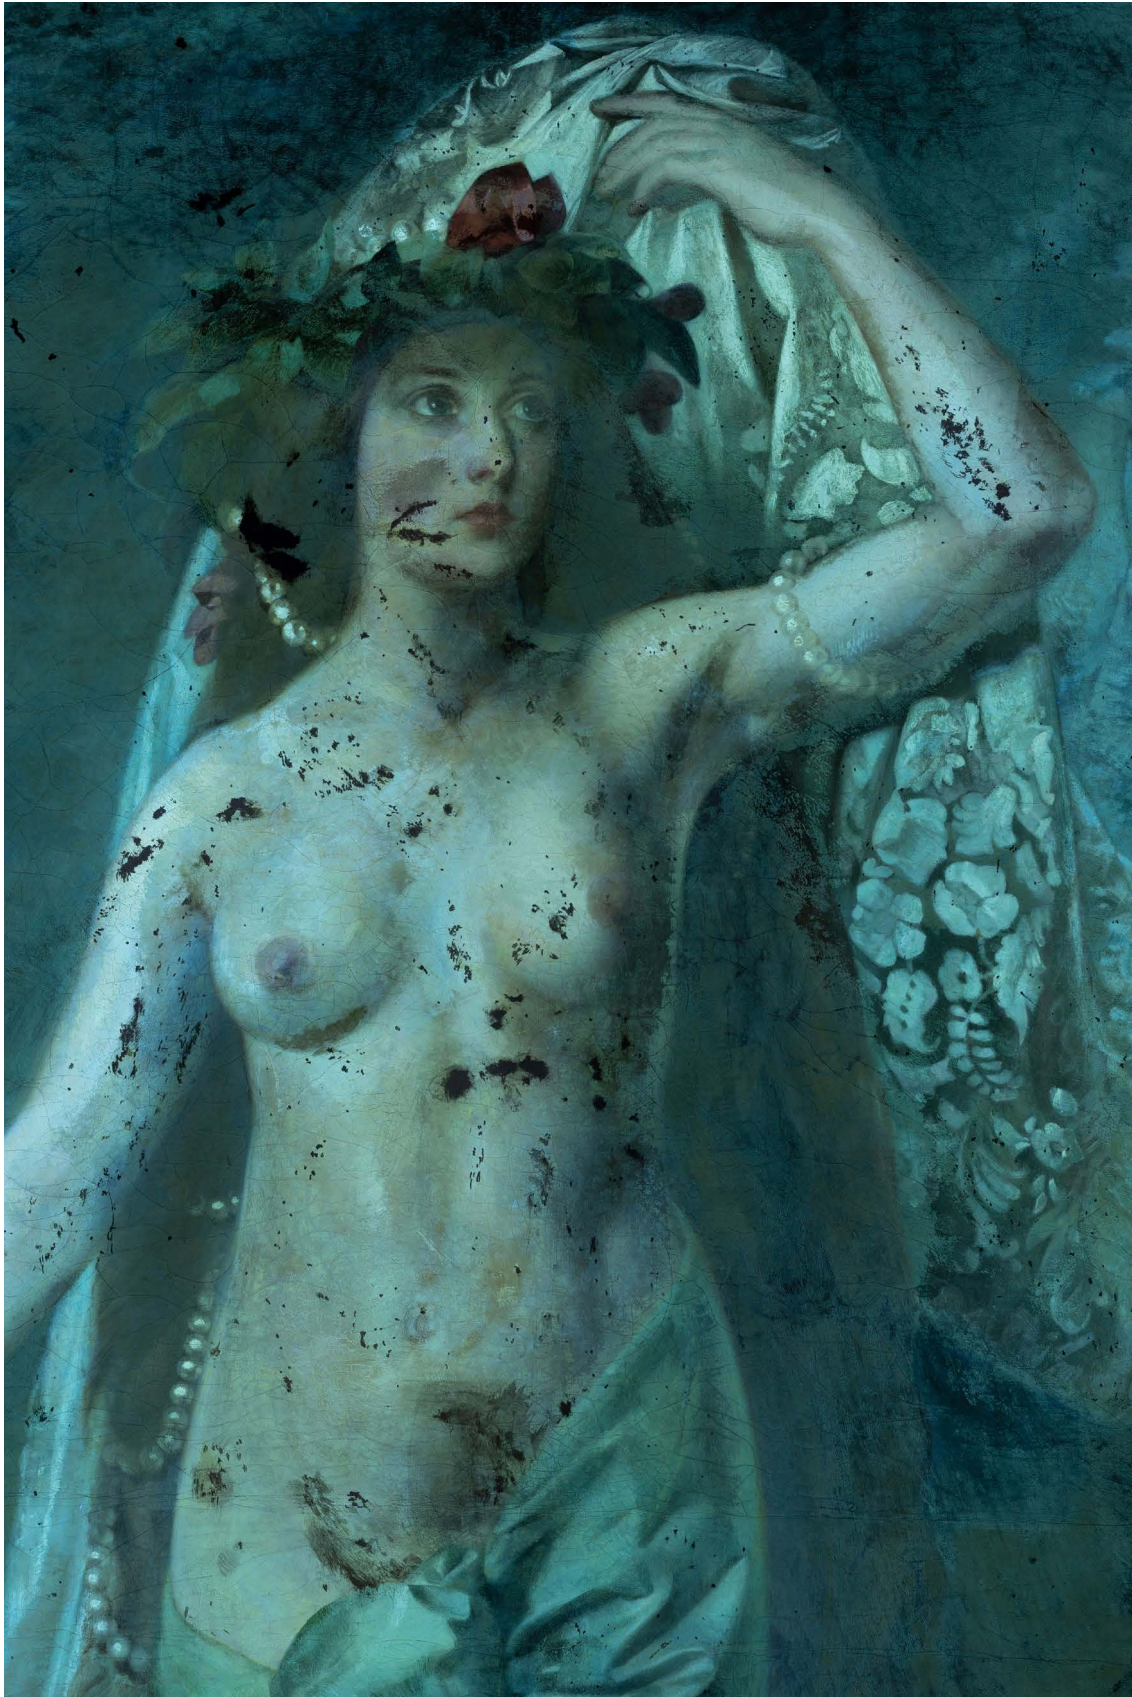
condition after retouching fillers and defects, detail  
photography in UV luminescence
