# RESTORATION TREATMENT REPORT

## WATER FAIRY

EMIL JOHANN LAUFFER

NATIONAL GALLERY IN PRAGUE

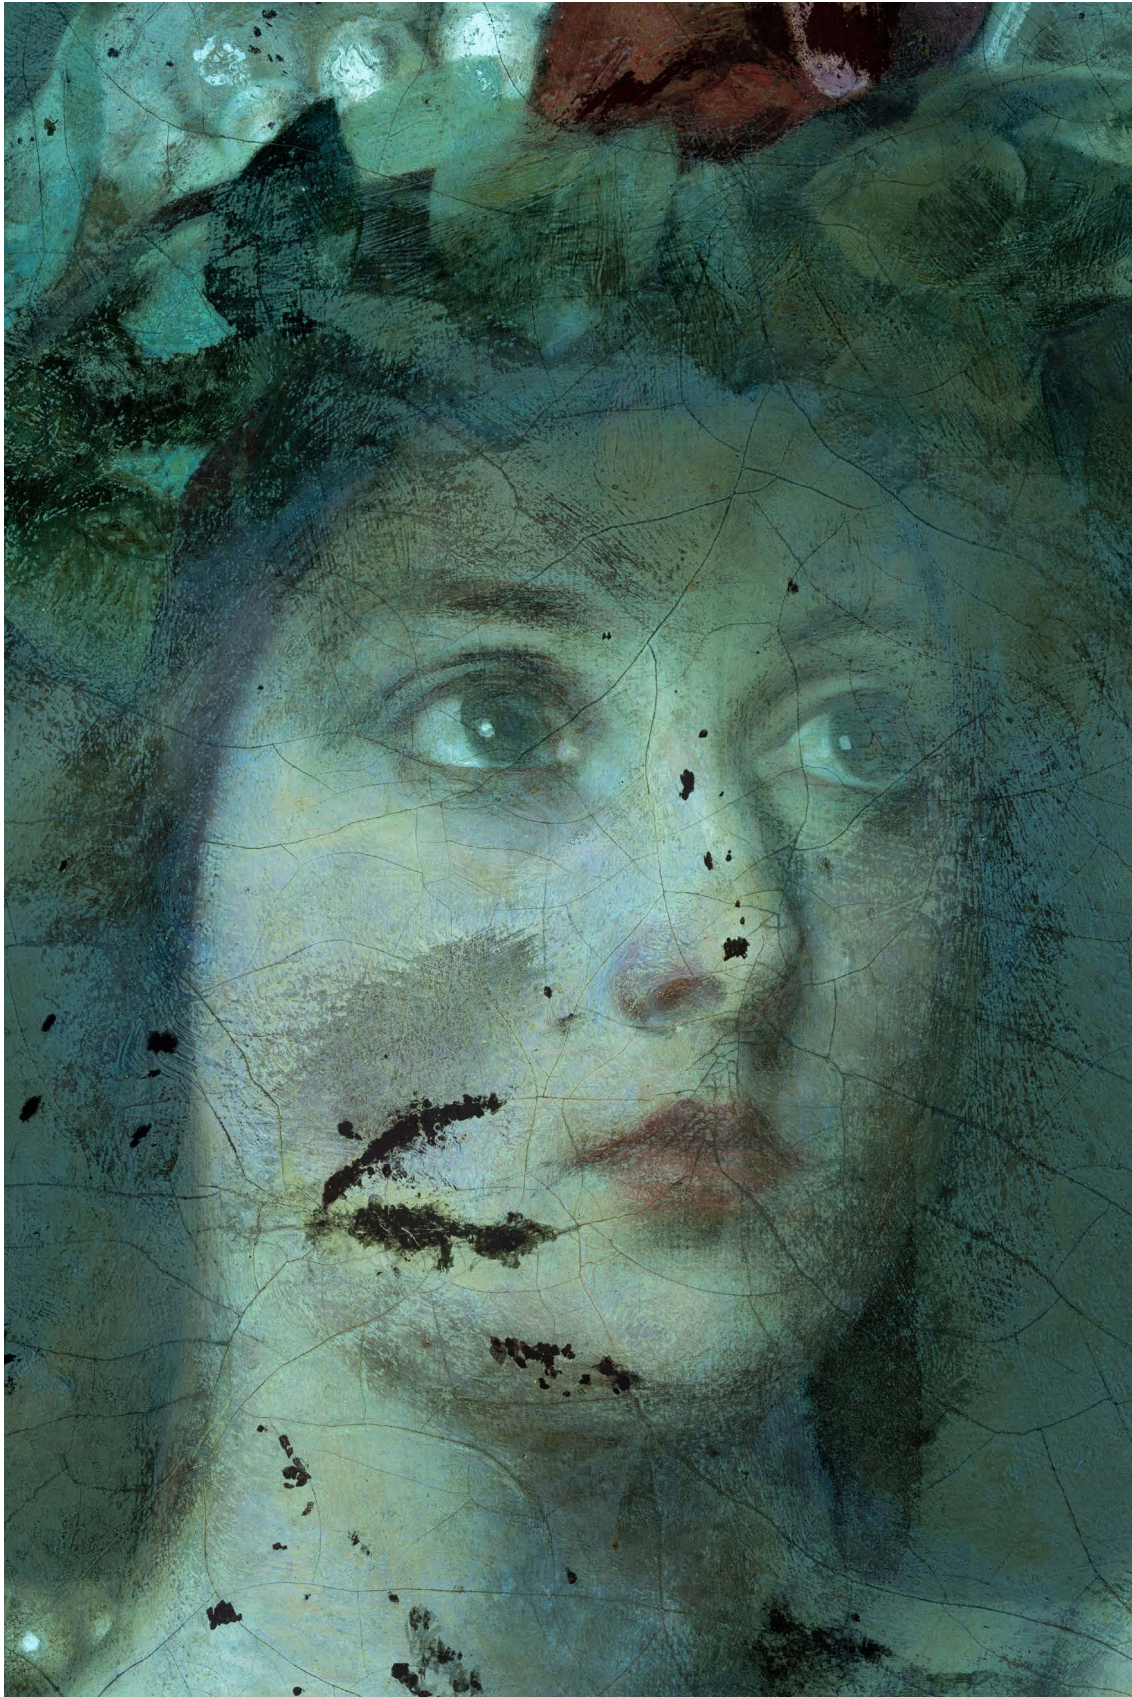
condition after retouching fillers and defects, detail  
photography in UV luminescence

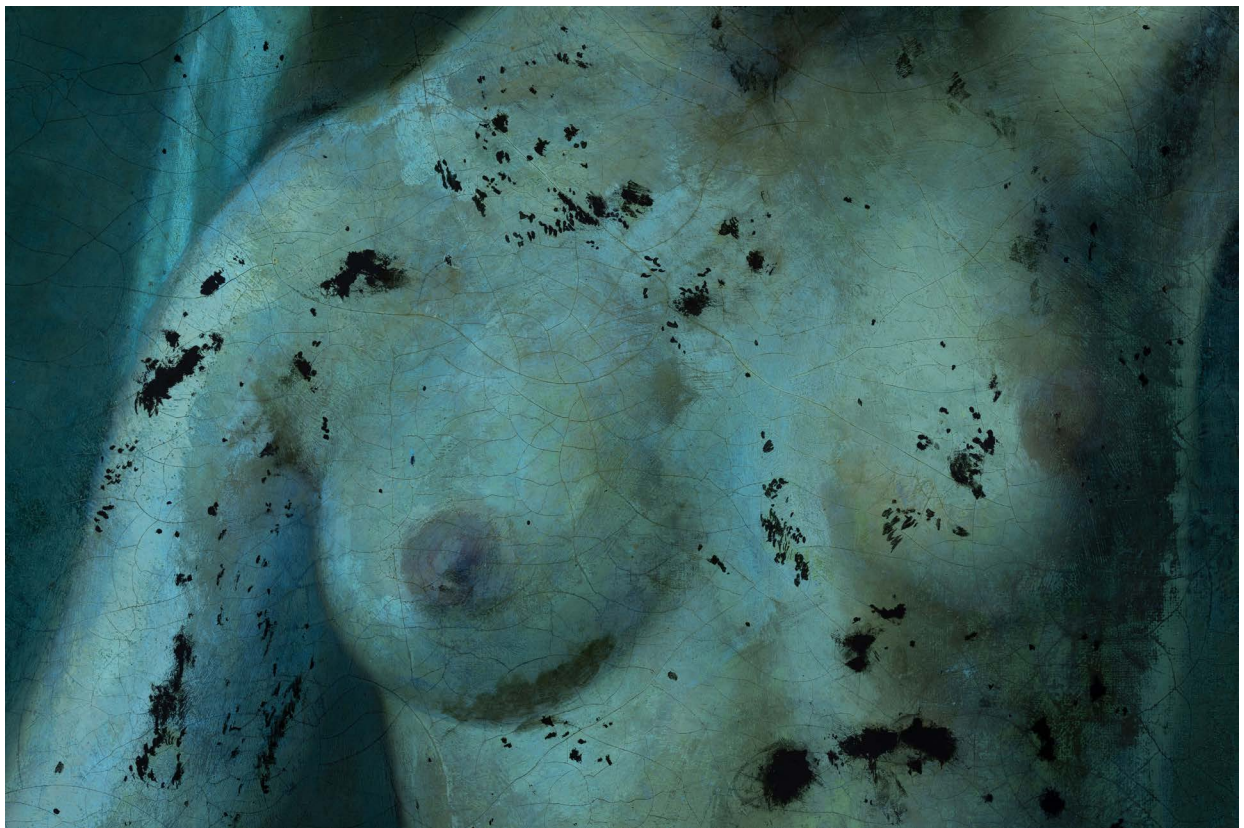
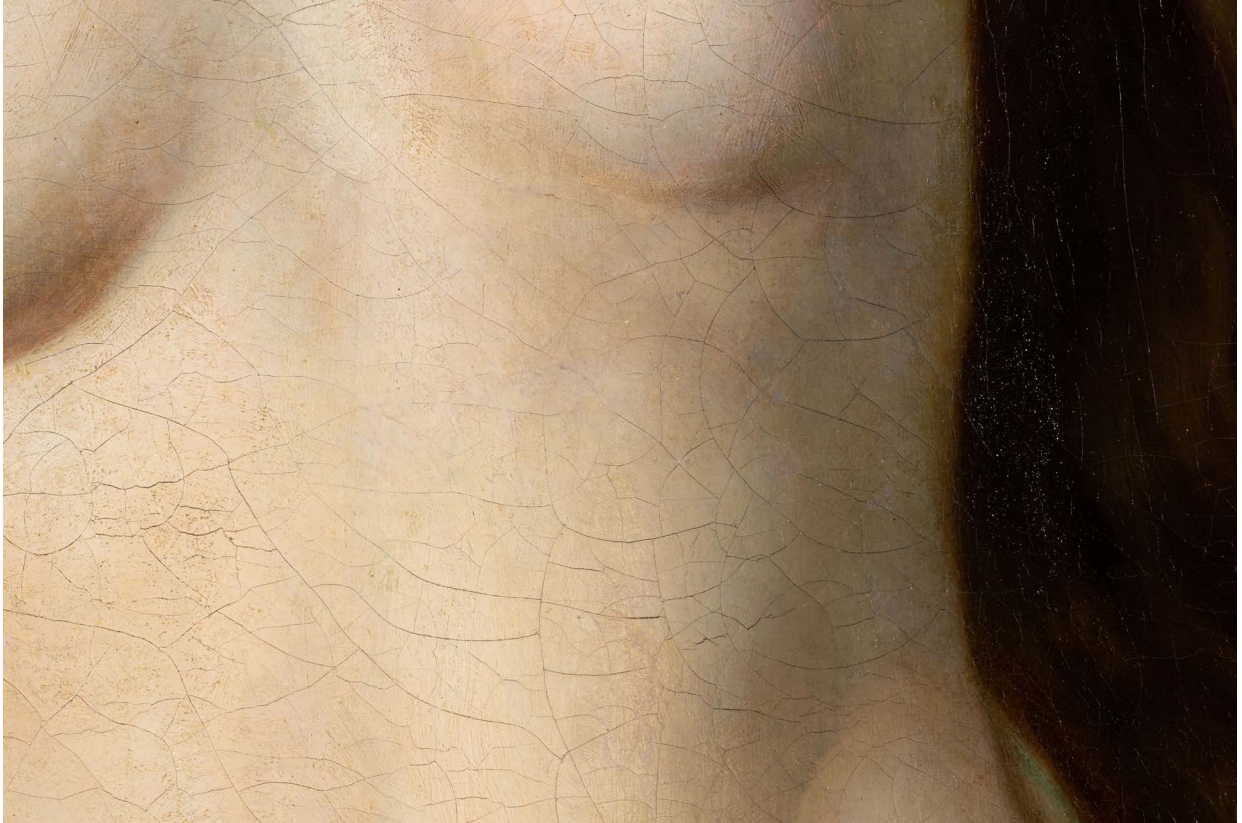
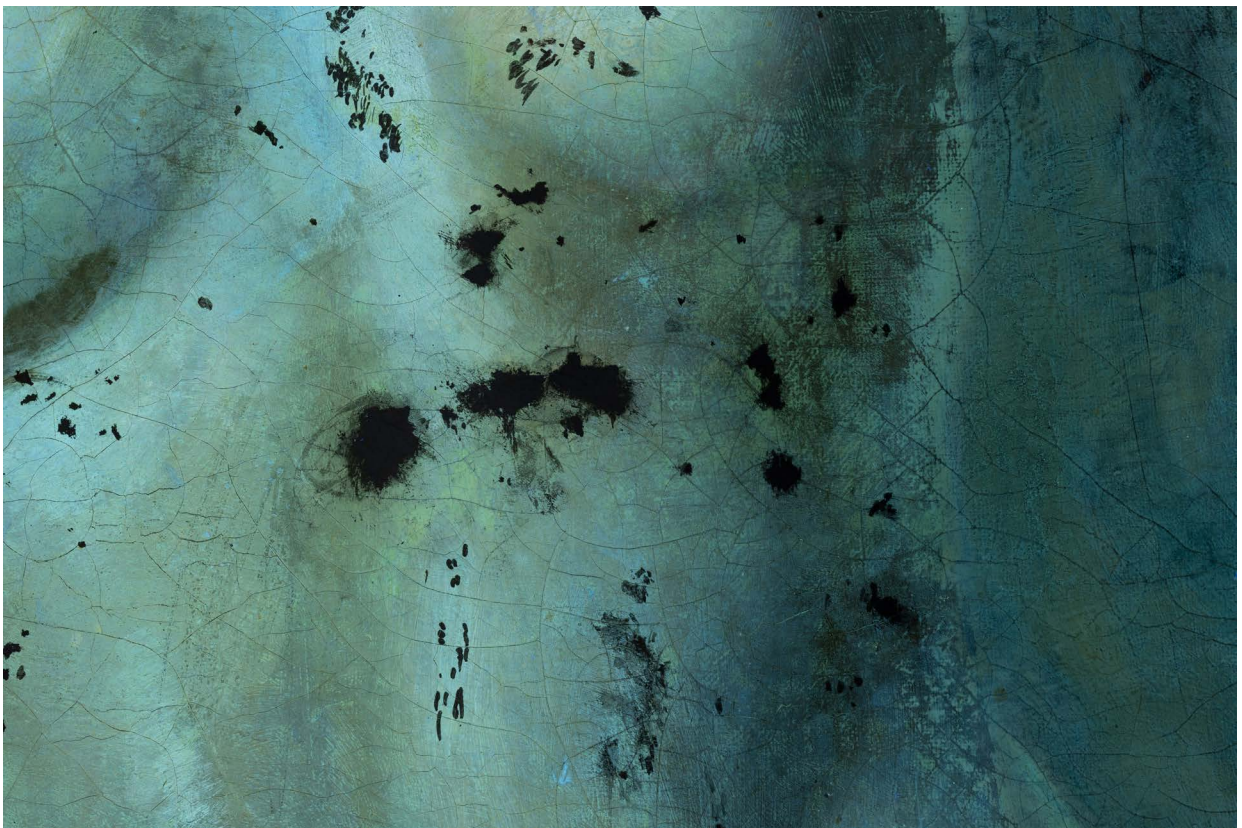
condition after retouching fillers and defects, detail  
photographs in day light and UV luminescence

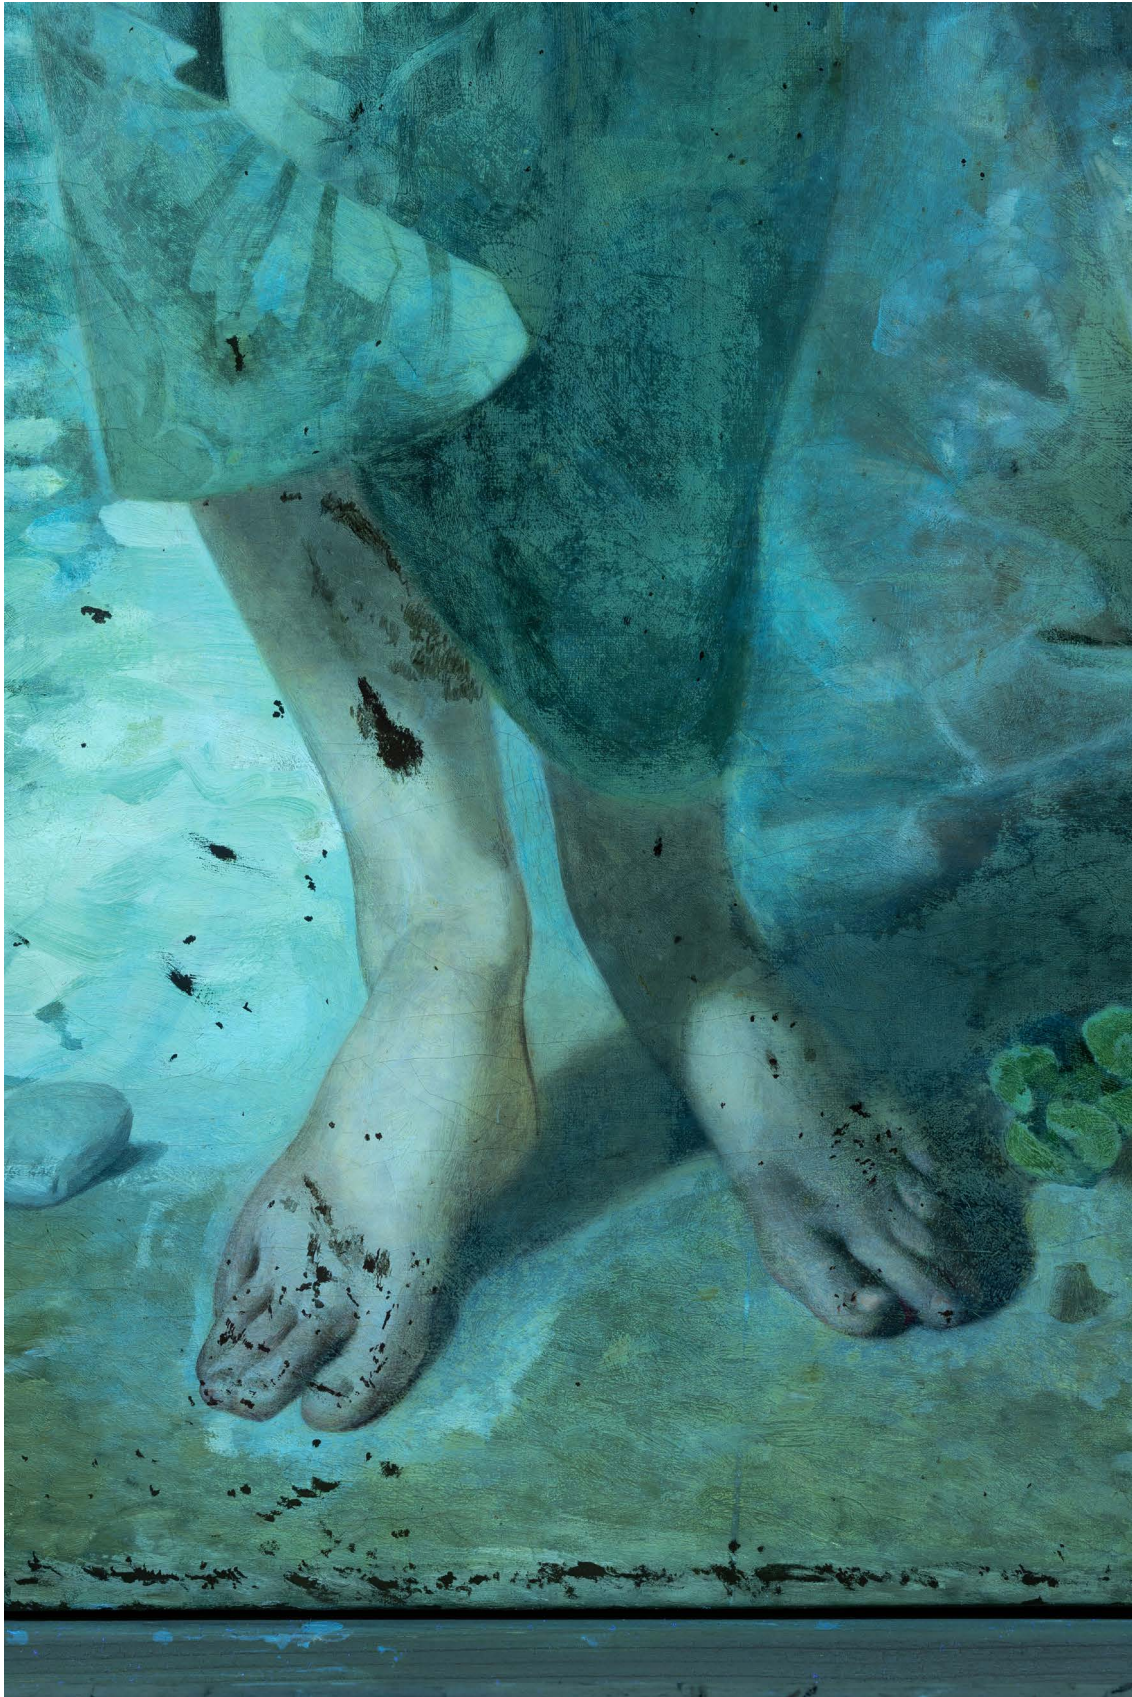
condition after retouching fillers and defects, detail  
photography in UV luminescence

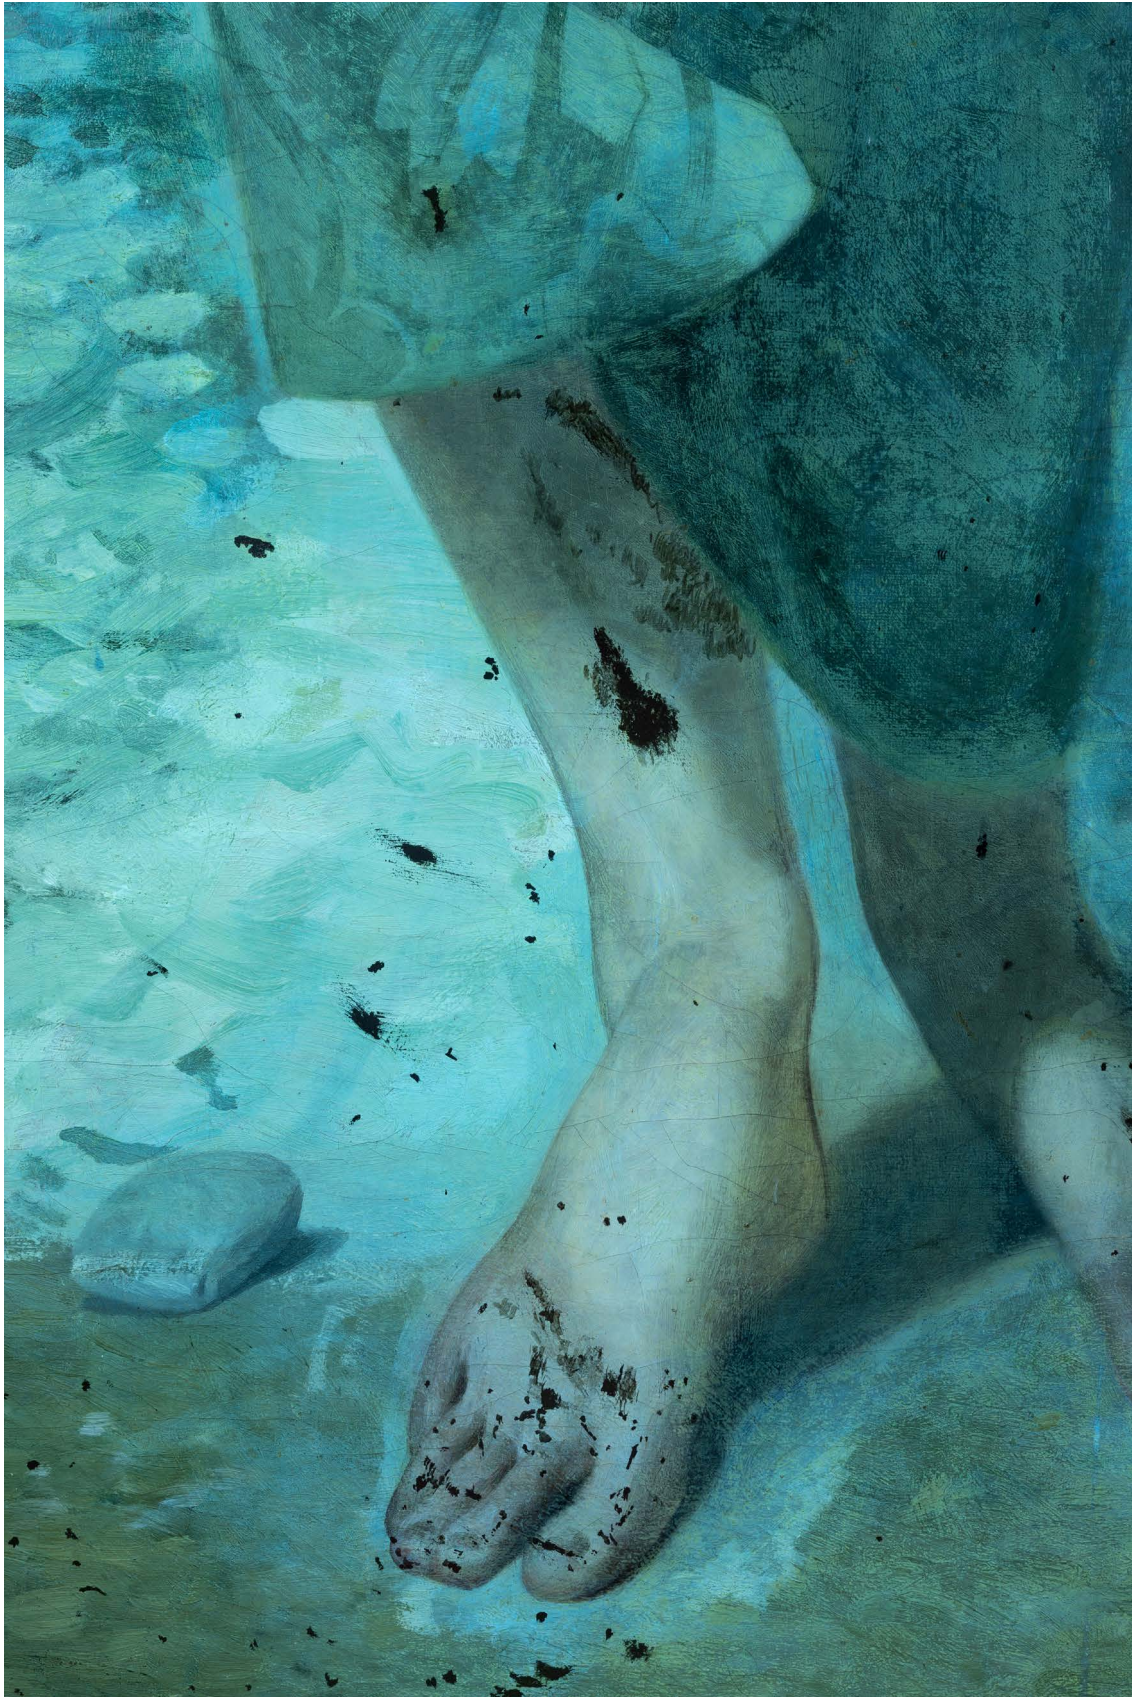
condition after retouching fillers and defects, detail  
photography in UV luminescence

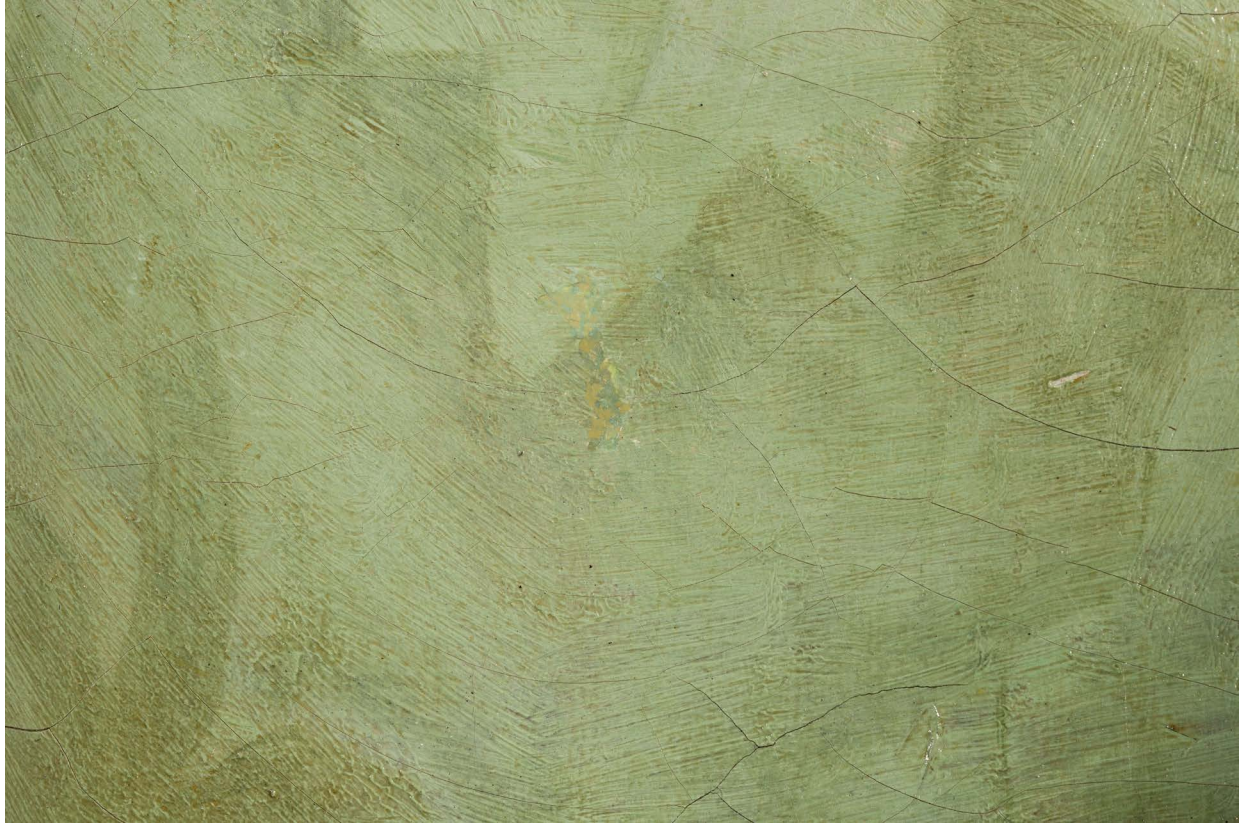
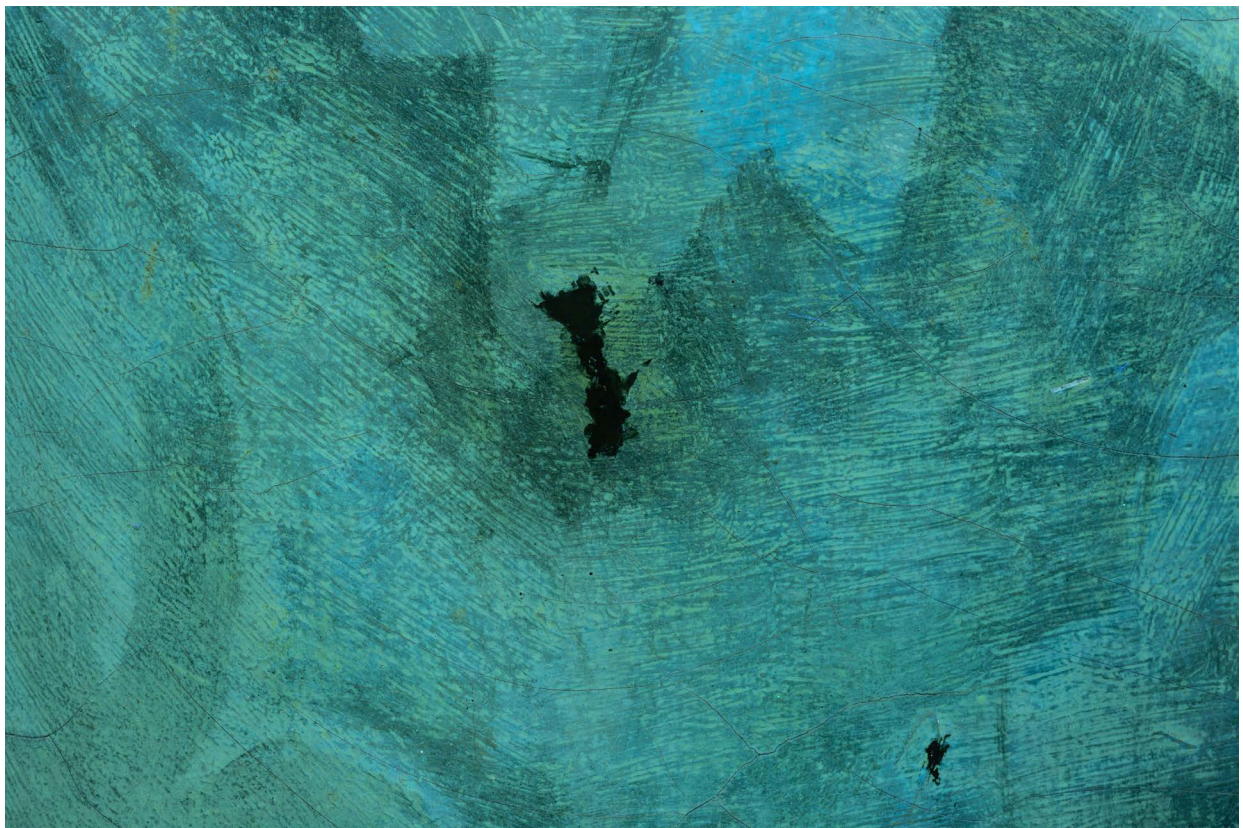
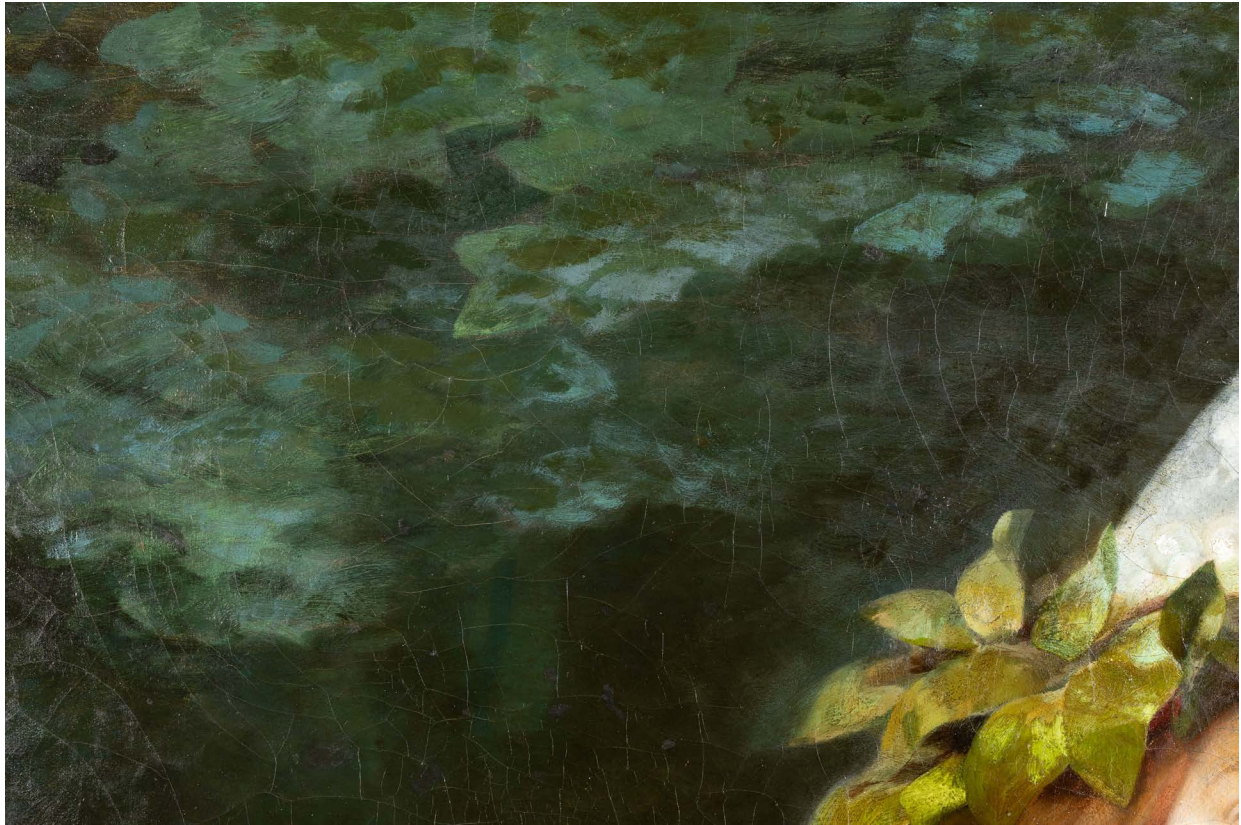
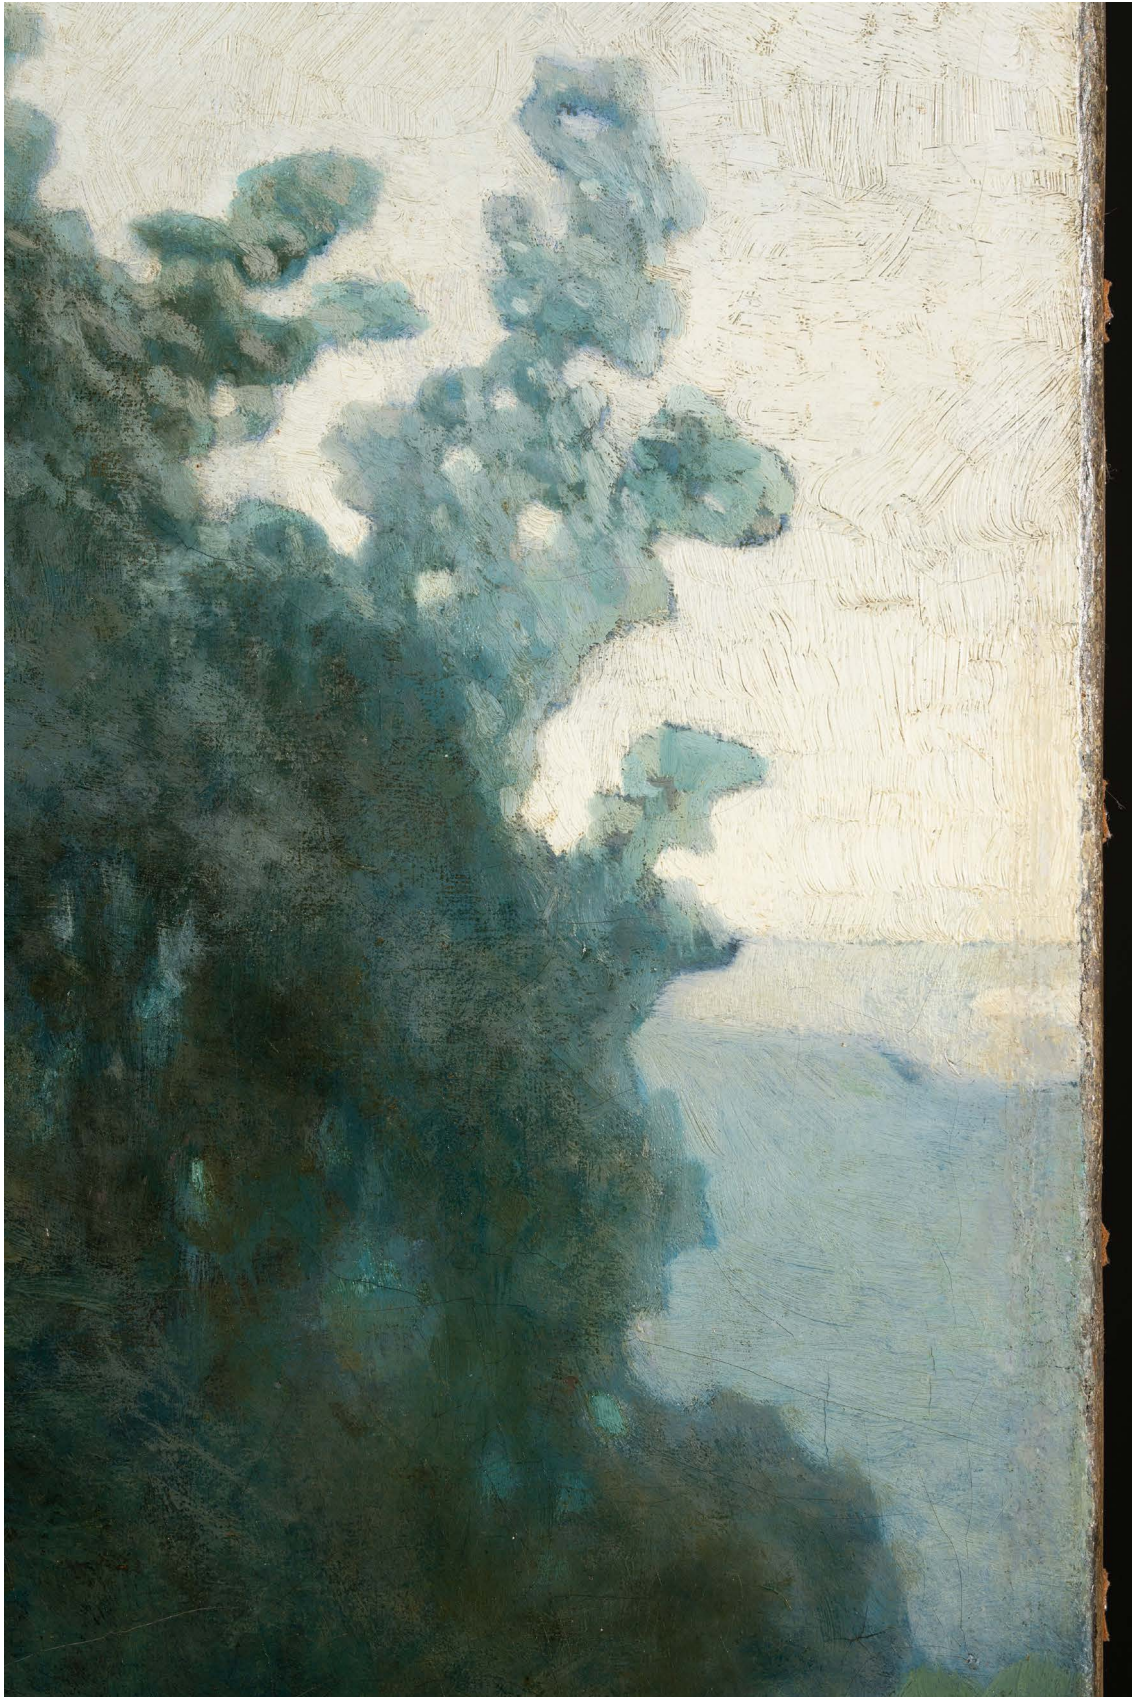
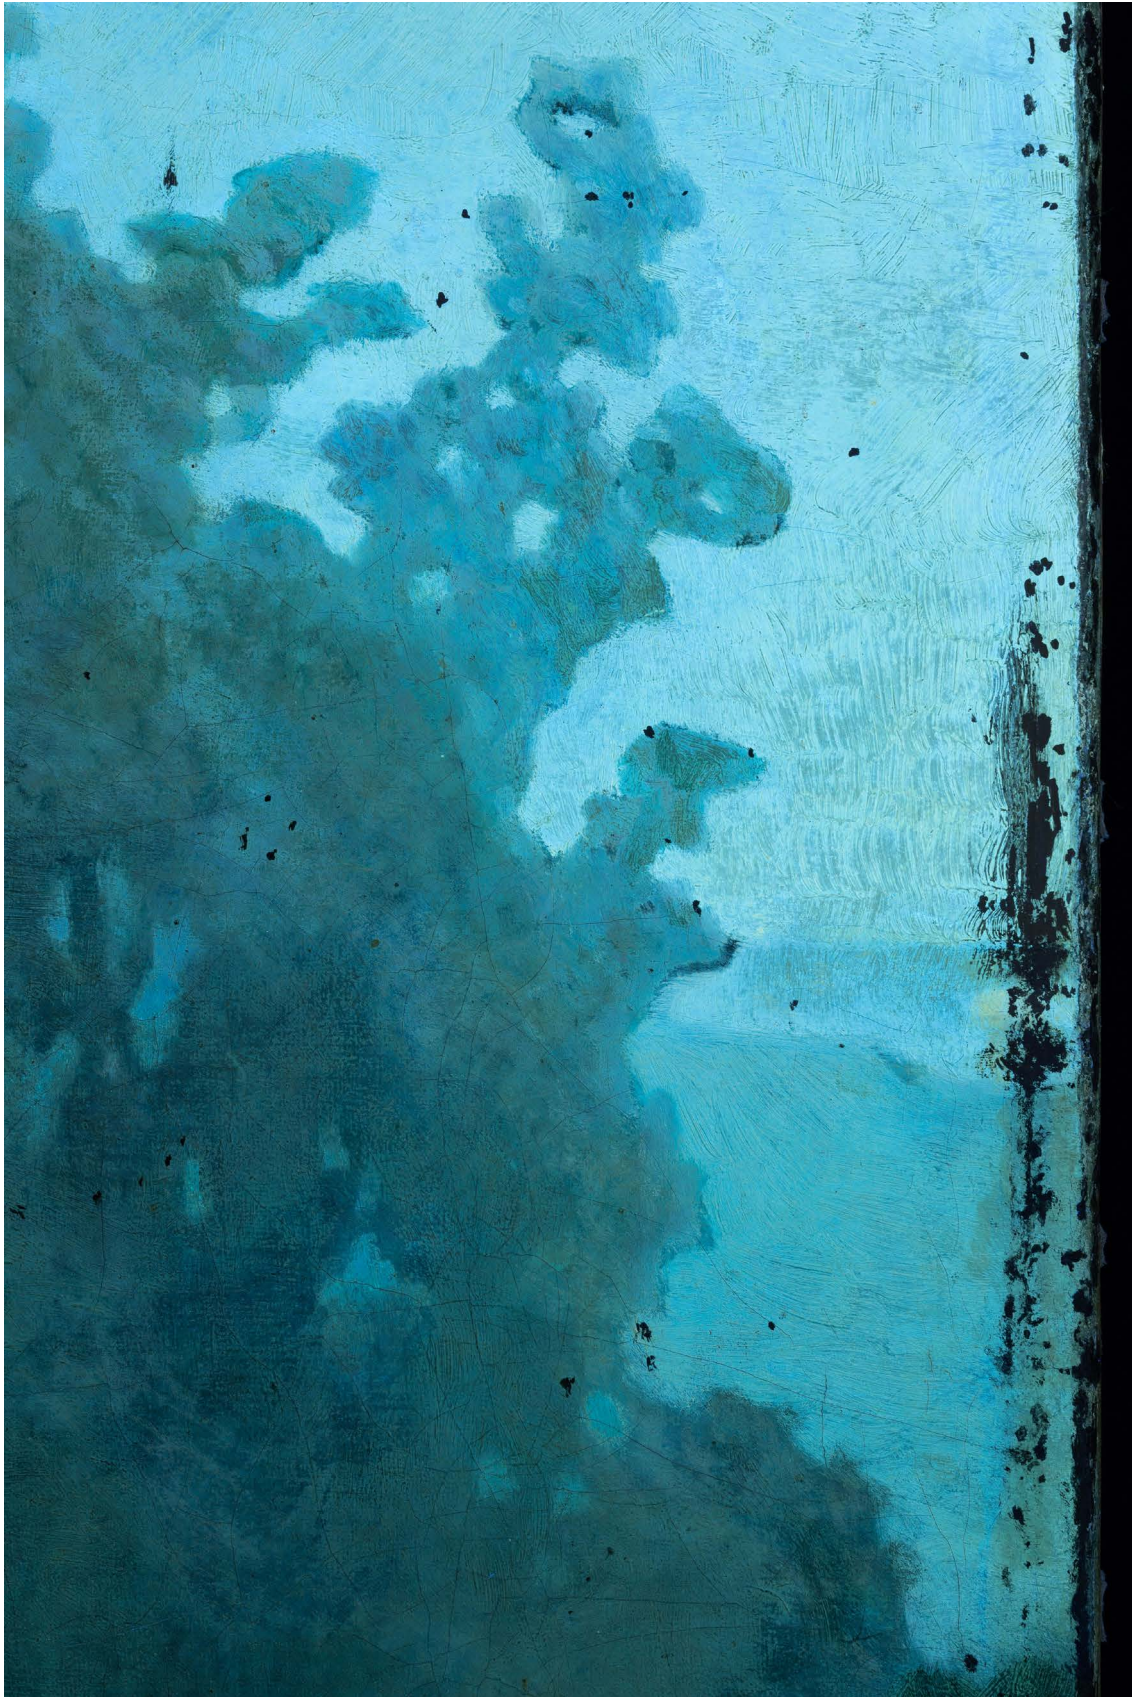
condition after retouching fillers and defects, detail  
photography in UV luminescence
